An Inventory of Calhoun County Road Stream Crossings

{ By: Brooke Mainville and Brett Riser

Calhoun County Road Stream Crossing Inventory 2016

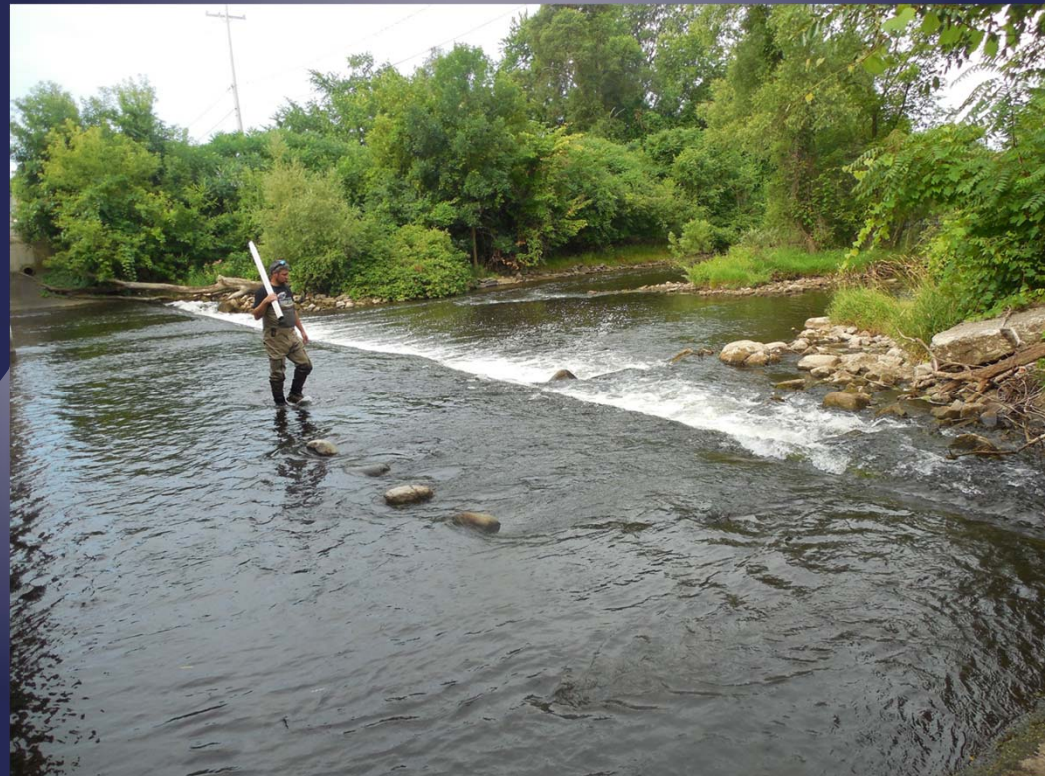
Fish Passage - Battle Creek

- Small Cofferdam below Washington St. Bridge
- Bridge spans the river but still a fish passage issue

- Swimming depths
- Velocity
- Burst speed
- Step height

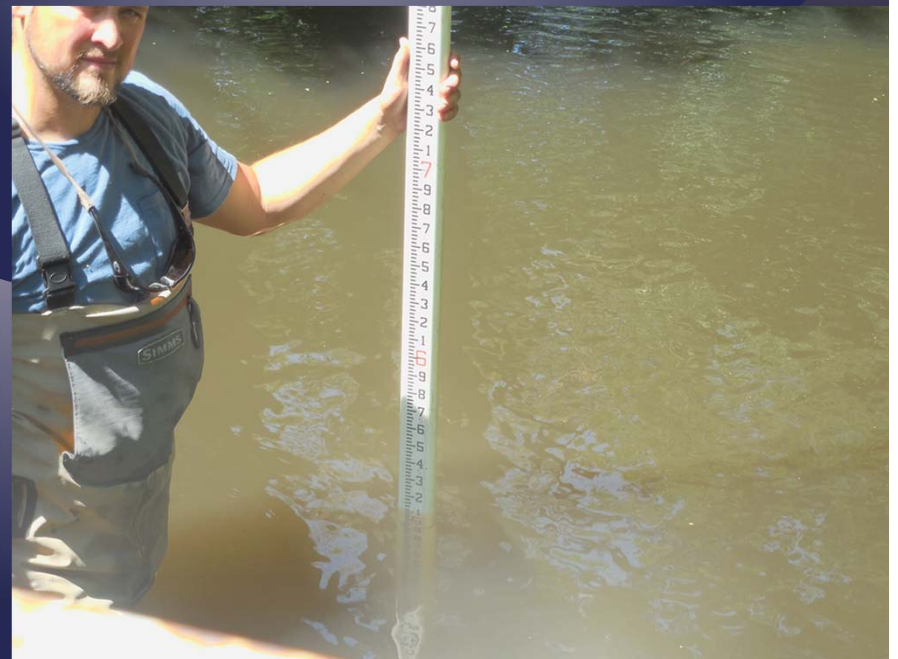
Buried.....

- Culvert is completely buried
 - Sediment aggradation ranging from ~1-2 ft.
 - Undersized and crushed
 - Buried under the water surface 2.7 ft.
 - Drainage problem - Intercounty Drain
 - Fish passage issue?

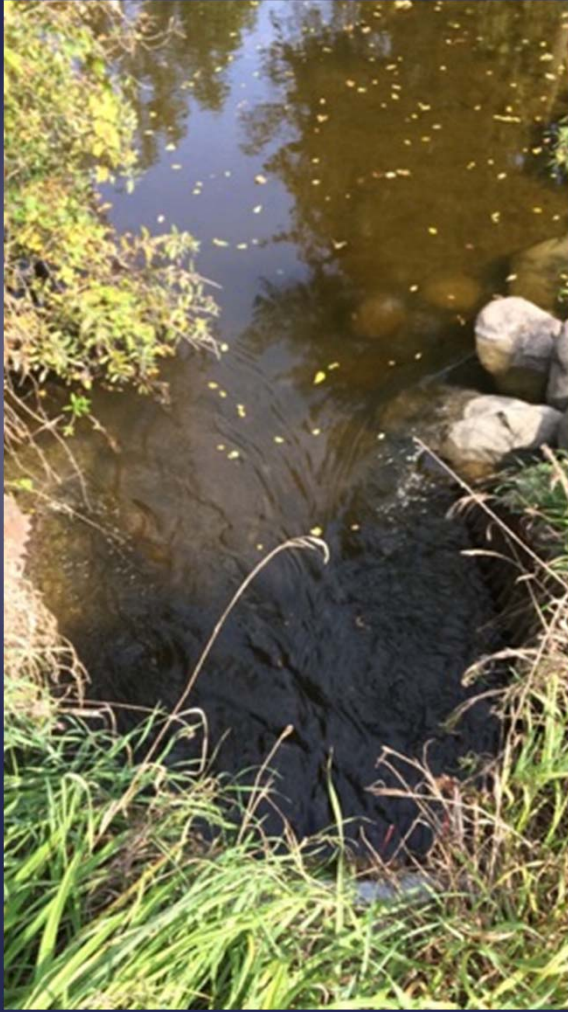
Fish Passage - Rice Creek

- 28 Mile Rd. stream crossing
 - undersized, slope, 62 ft in length.
- Disconnects a significant lentic (lake) system
 - Fish community
- Drainage - Controversial

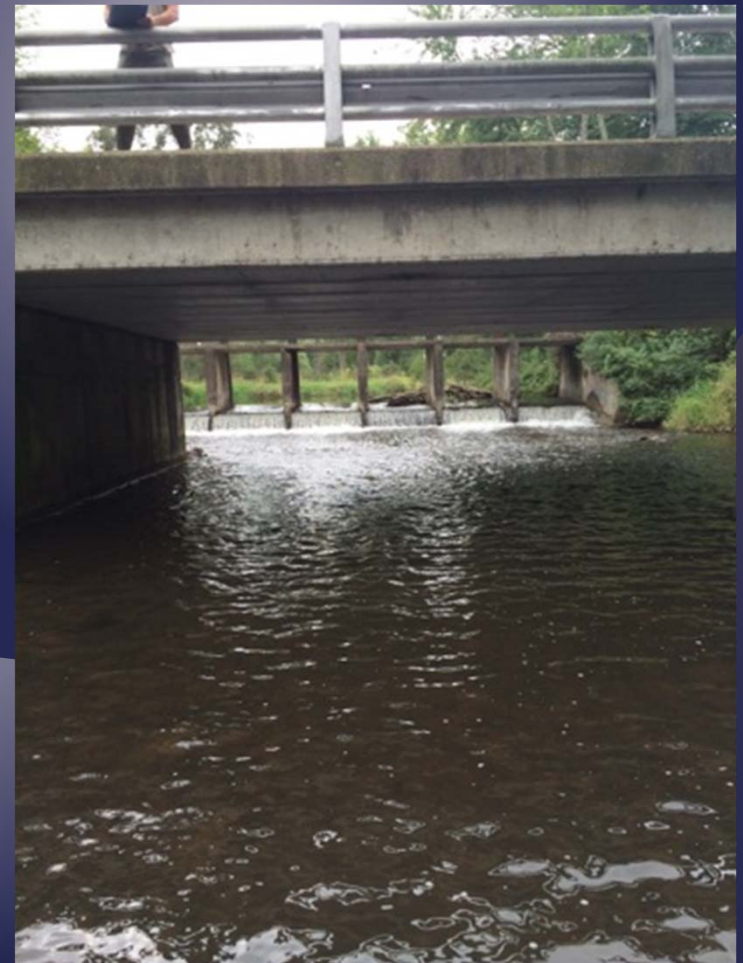
Fish Passage - South Branch of the Kalamazoo

- L- Drive
 - Span bridge with associated coffer dam and concrete skirt
- 8.44 Miles upstream from confluence

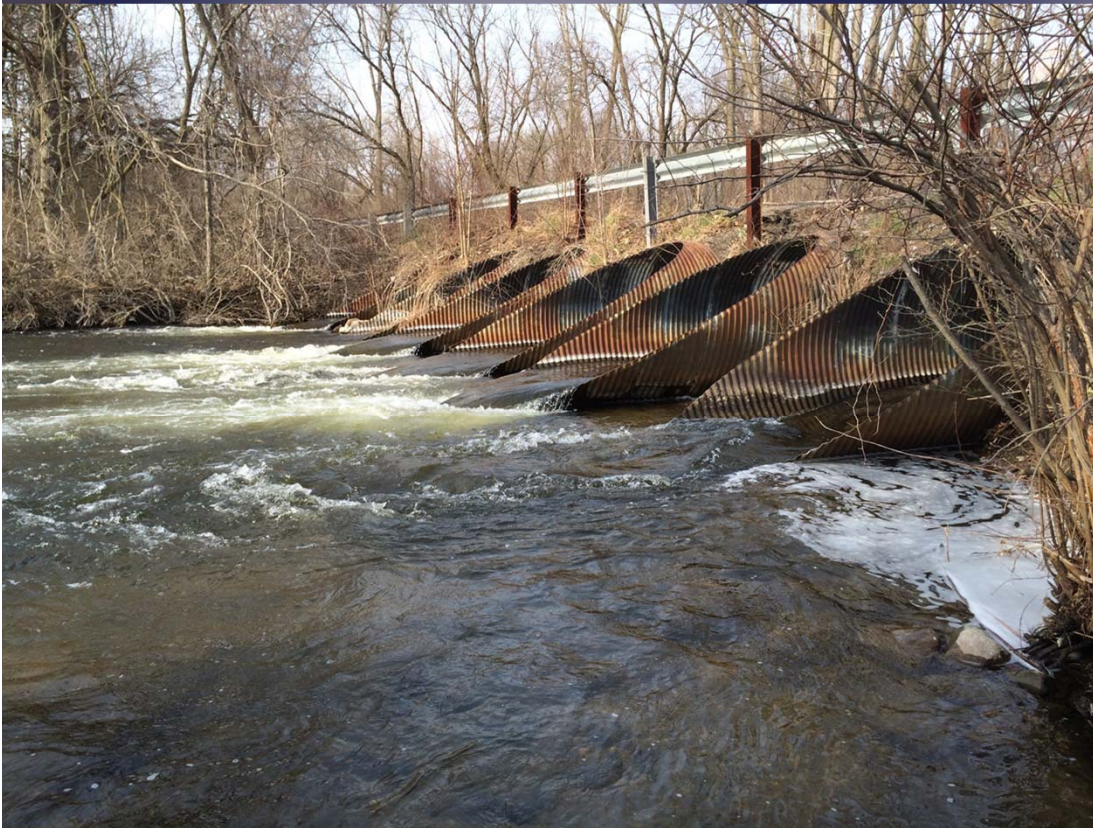
Fish Passage - North Branch

- Road stream crossing in the lower reaches of the N. Branch.
- Multiple culvert system
 - Span bridge
- Current Characteristics;
 - Velocities, cascading, blockage, sediment transport

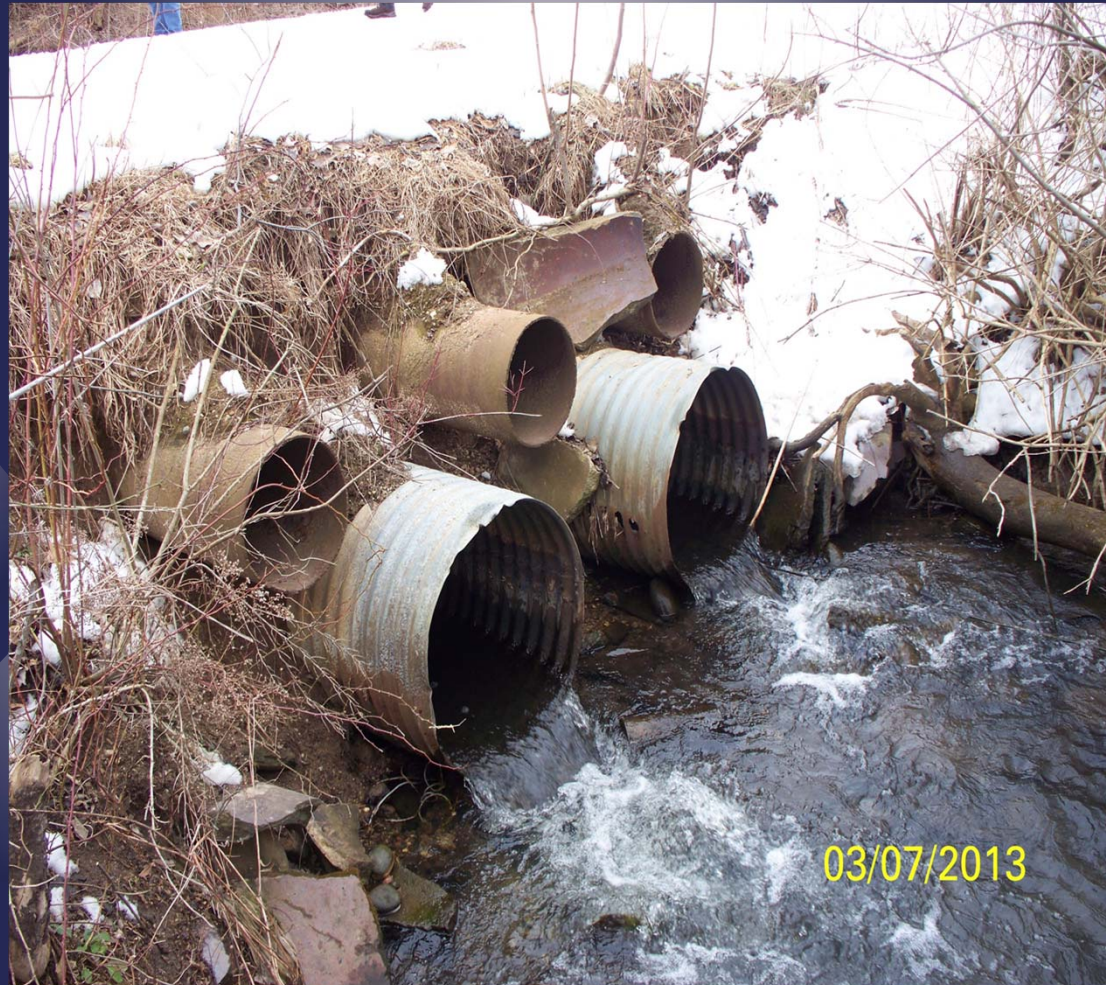
Pigeon Creek - Culvert Remediation

- Road Dept. partnership
- Undersized, perched
- Impassible velocities
- Potentially dangerous road stream crossing
- Fish and aquatic organism barrier
