Michigan Lakes— Ours to Protect

2015 Data Report
for
Hicks Lake, Osceola County

Site ID: 670062

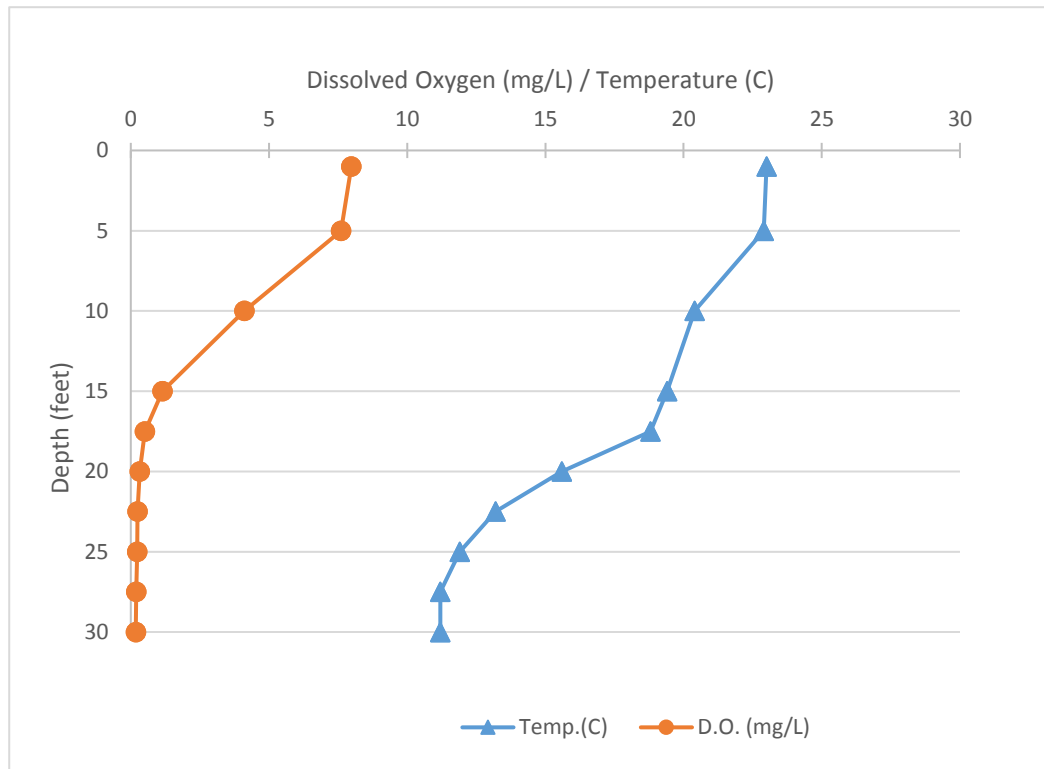
9/9/2015

Dissolved Oxygen and Temperature Profile

Depth (ft)	Temp.(C)	D.O. (mg/L)
1	23	7.98
1	23	7.98
5	22.9	7.61
5	22.9	7.61
10	20.4	4.11
10	20.4	4.11
15	19.4	1.15
15	19.4	1.15
17.5	18.8	0.51
17.5	18.8	0.51
20	15.6	0.33
20	15.6	0.33
22.5	13.2	0.24
22.5	13.2	0.24
25	11.9	0.23
25	11.9	0.23
27.5	11.2	0.2
27.5	11.2	0.2
30	11.2	0.18
30	11.2	0.18
