# Road- Stream Crossing (RSX) Assessment North Branch White River

\*White River Watershed Partnership

#Oceana County Road Commission

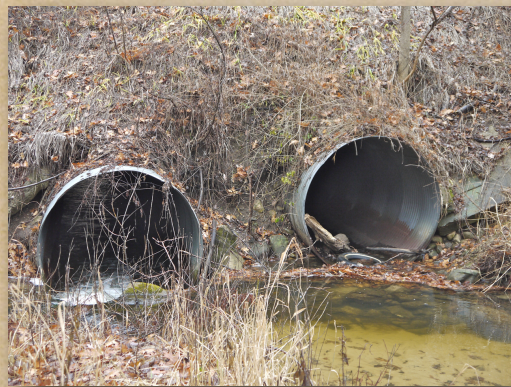
Inlet

Before improvement: "A dam with a hole in it"

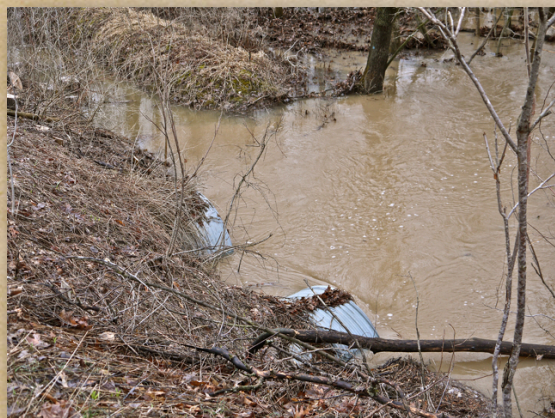
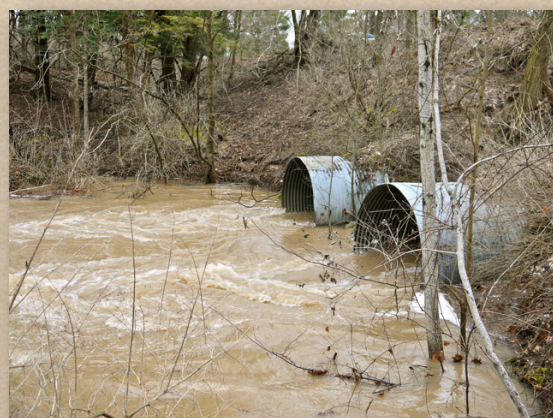
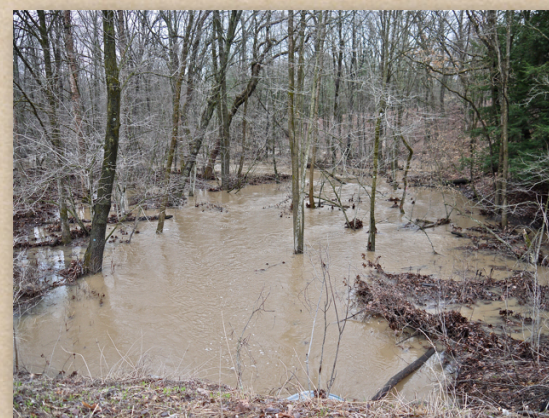
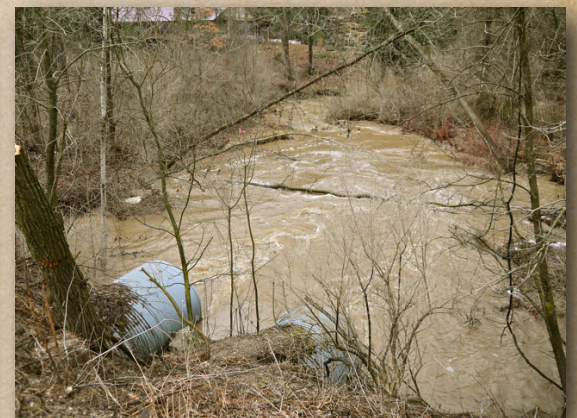
Perched, misaligned, partly blocked, too small, erosion, sediment retention, etc.  
May have been the worst RSX in the county.

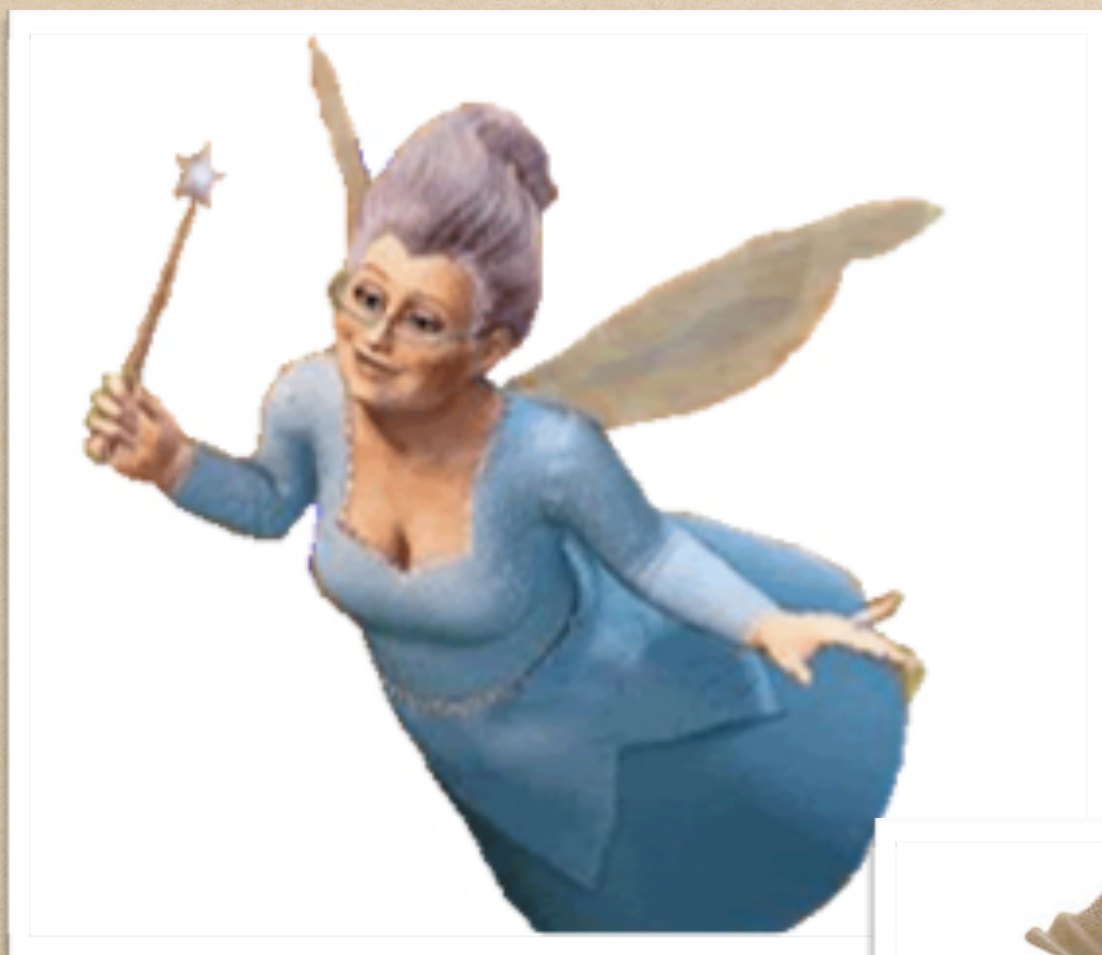
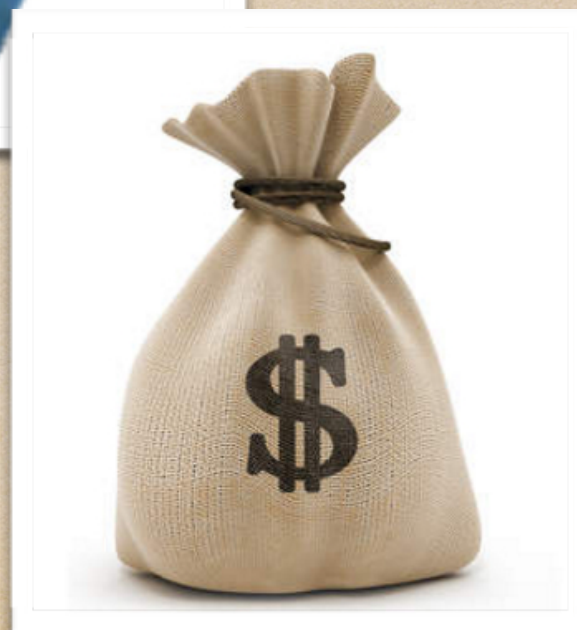
What you need next, if you want to fix it...

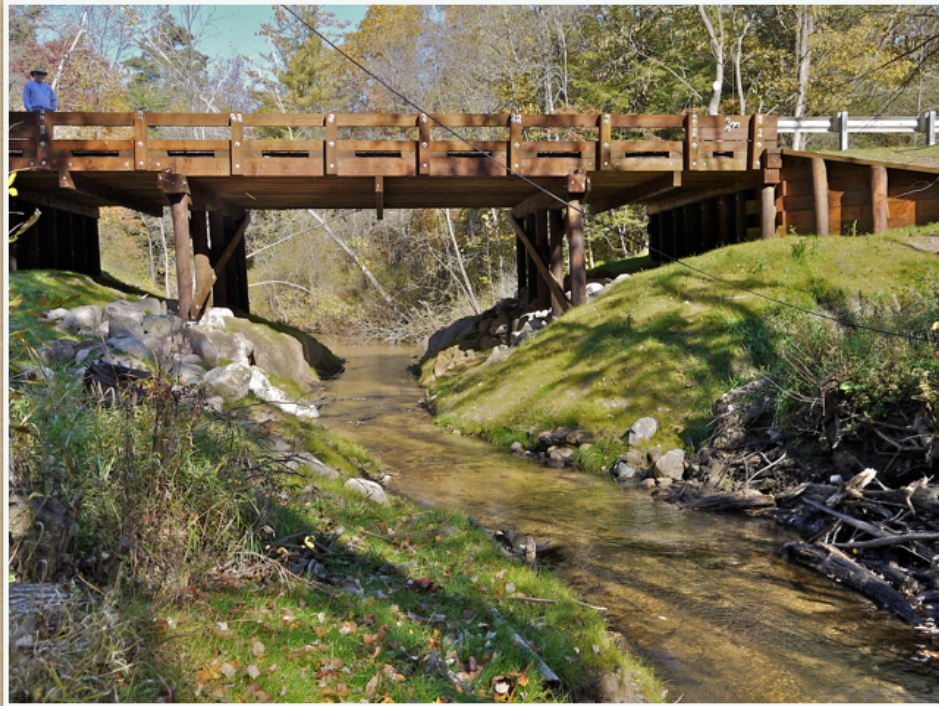
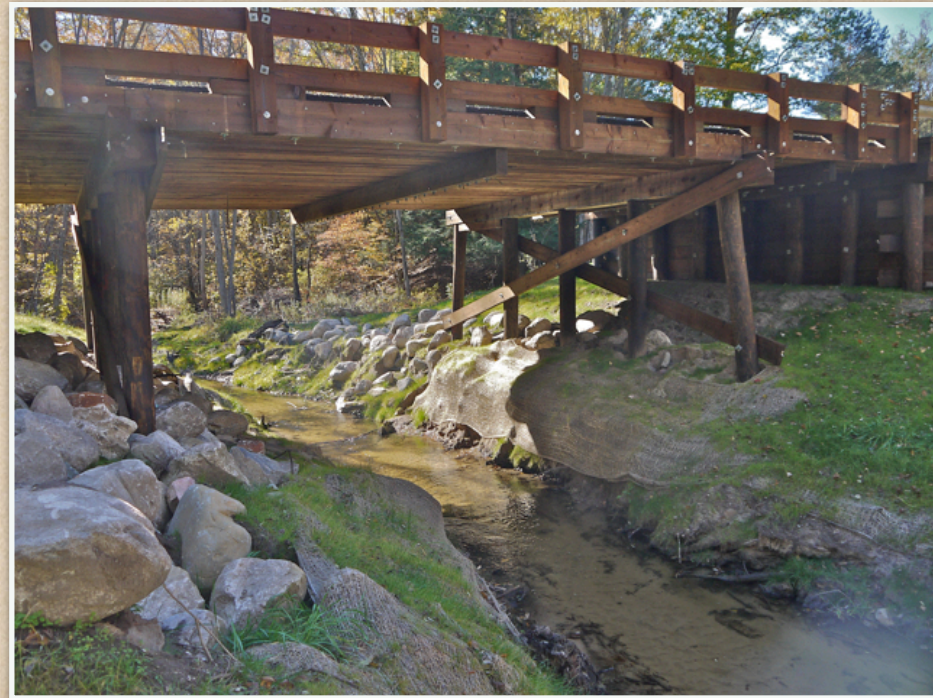
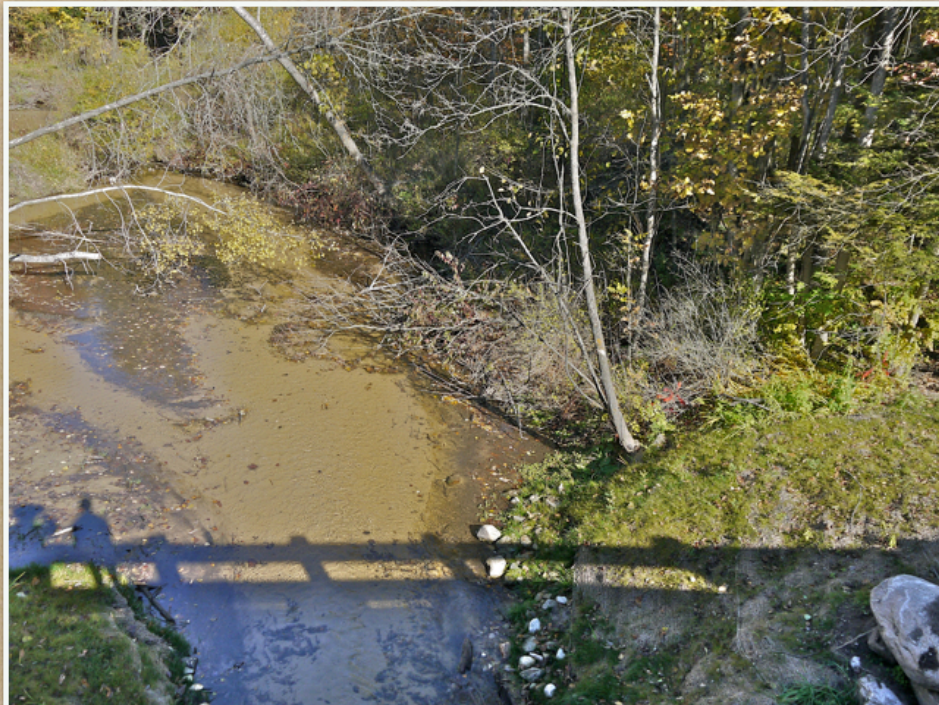
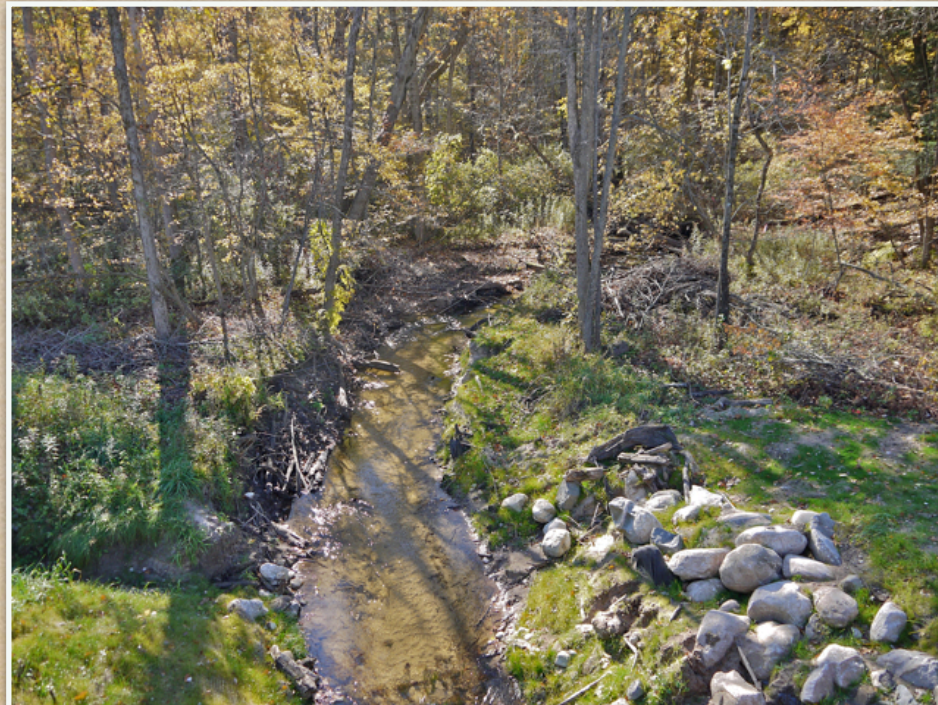
Lisa Dutcher waves her magic wand, and...

Presto!

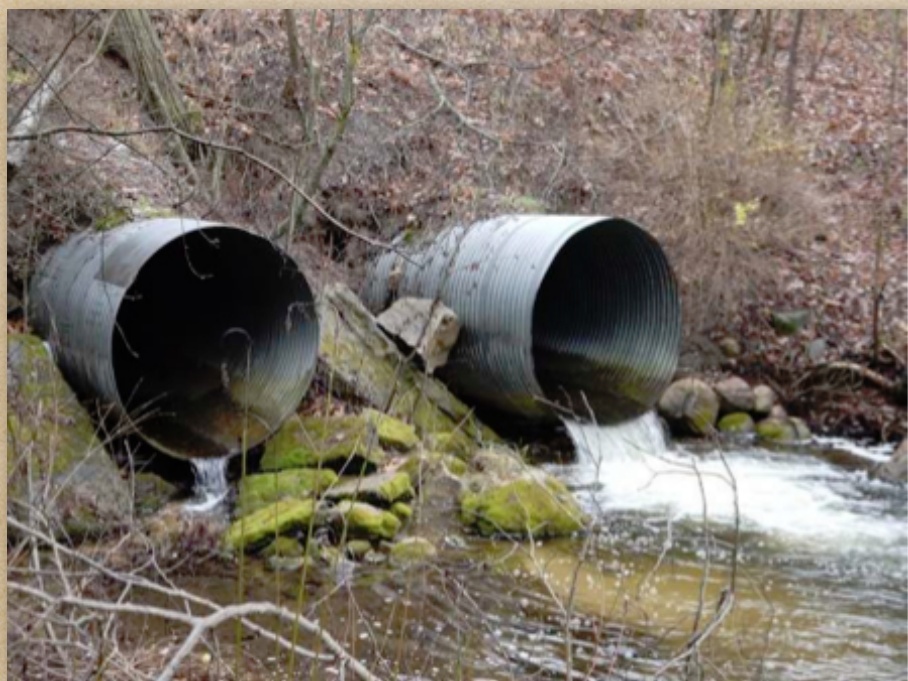
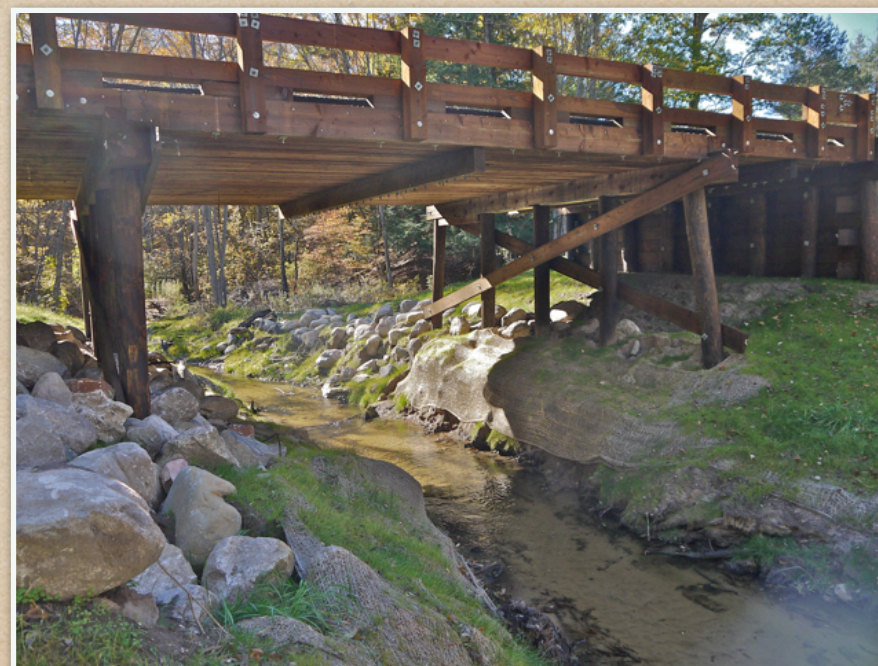
- ◆ Project cost: \$335 K
- ◆ Management: Oceana County Road Commission/Lisa Dutcher
- ◆ Competitive bids, local contractor
- ◆ Donors
  - ◆ Great Lakes Fisheries Trust
  - ◆ National Forest Foundation
  - ◆ Coca-Cola Company
  - ◆ DoI -U. S. Fish & Wildlife Service
  - ◆ USDA - Forest Service

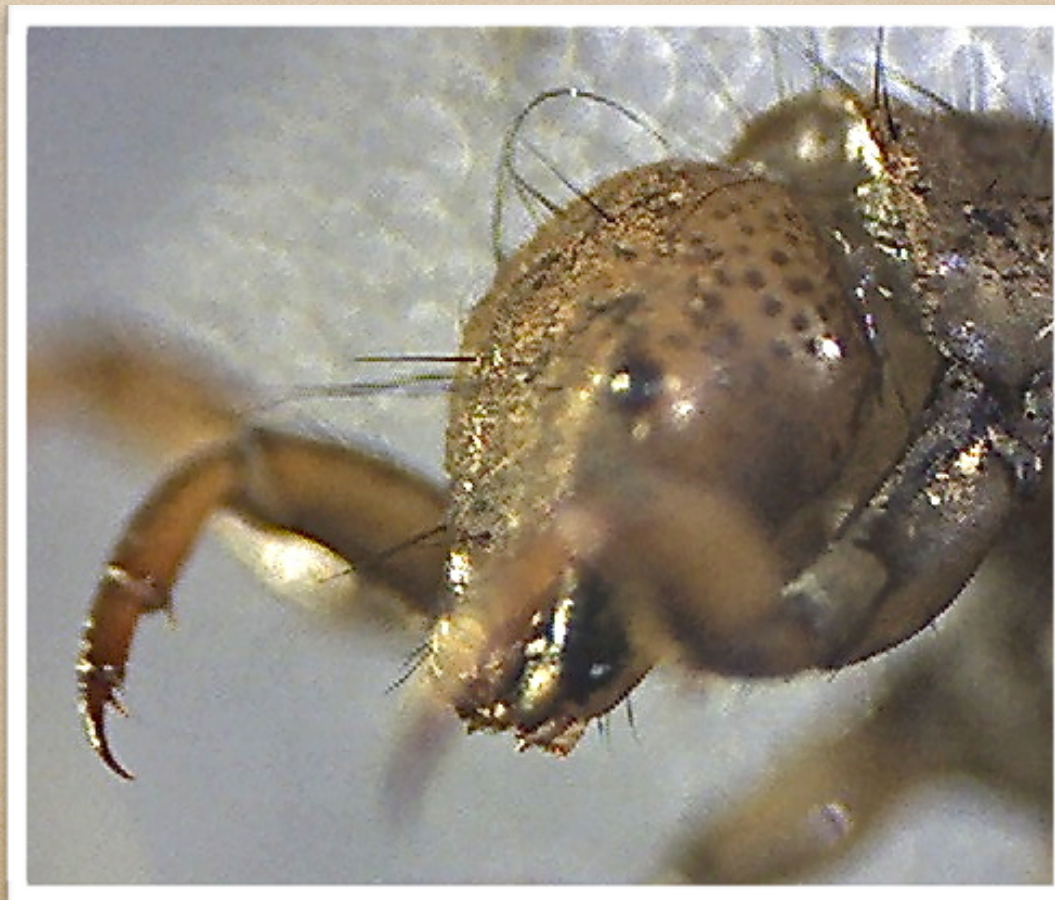
Caddis fly larva

Using standard MiCorps protocols for benthic invertebrates

Will monitor recovery over several years after improvements

Encouraging preliminary results from a couple of earlier replacement sites

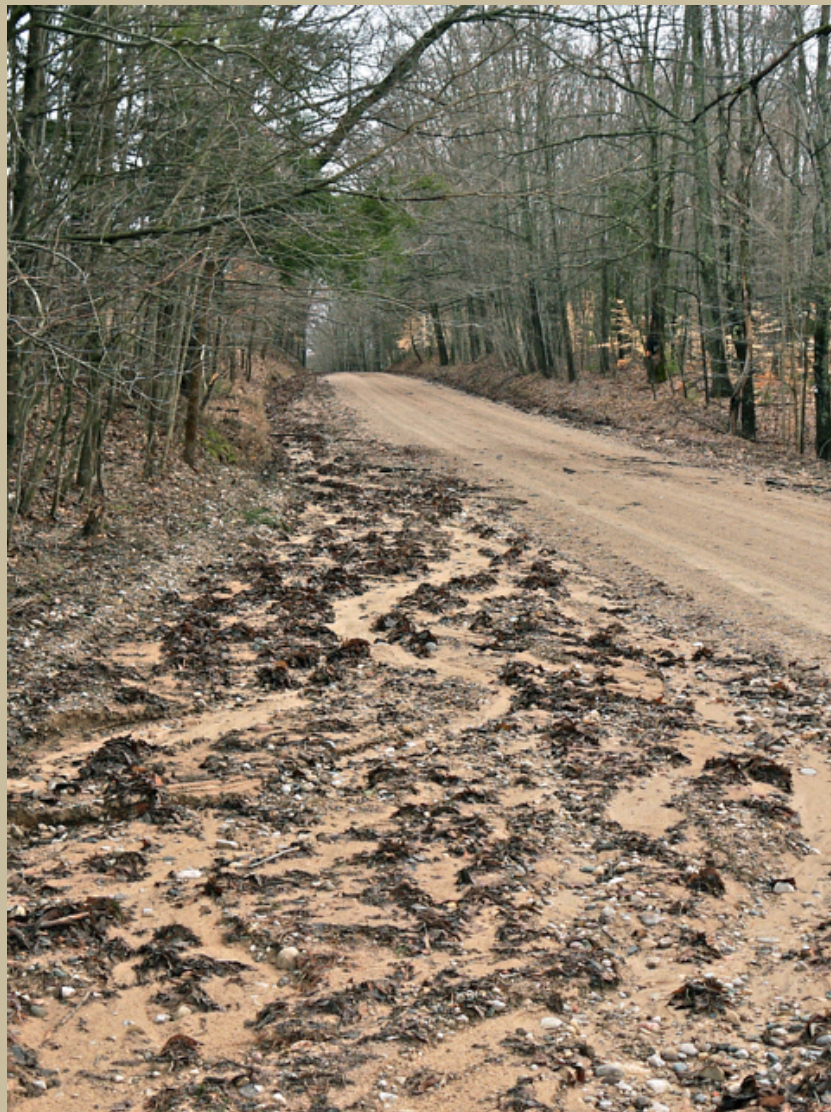
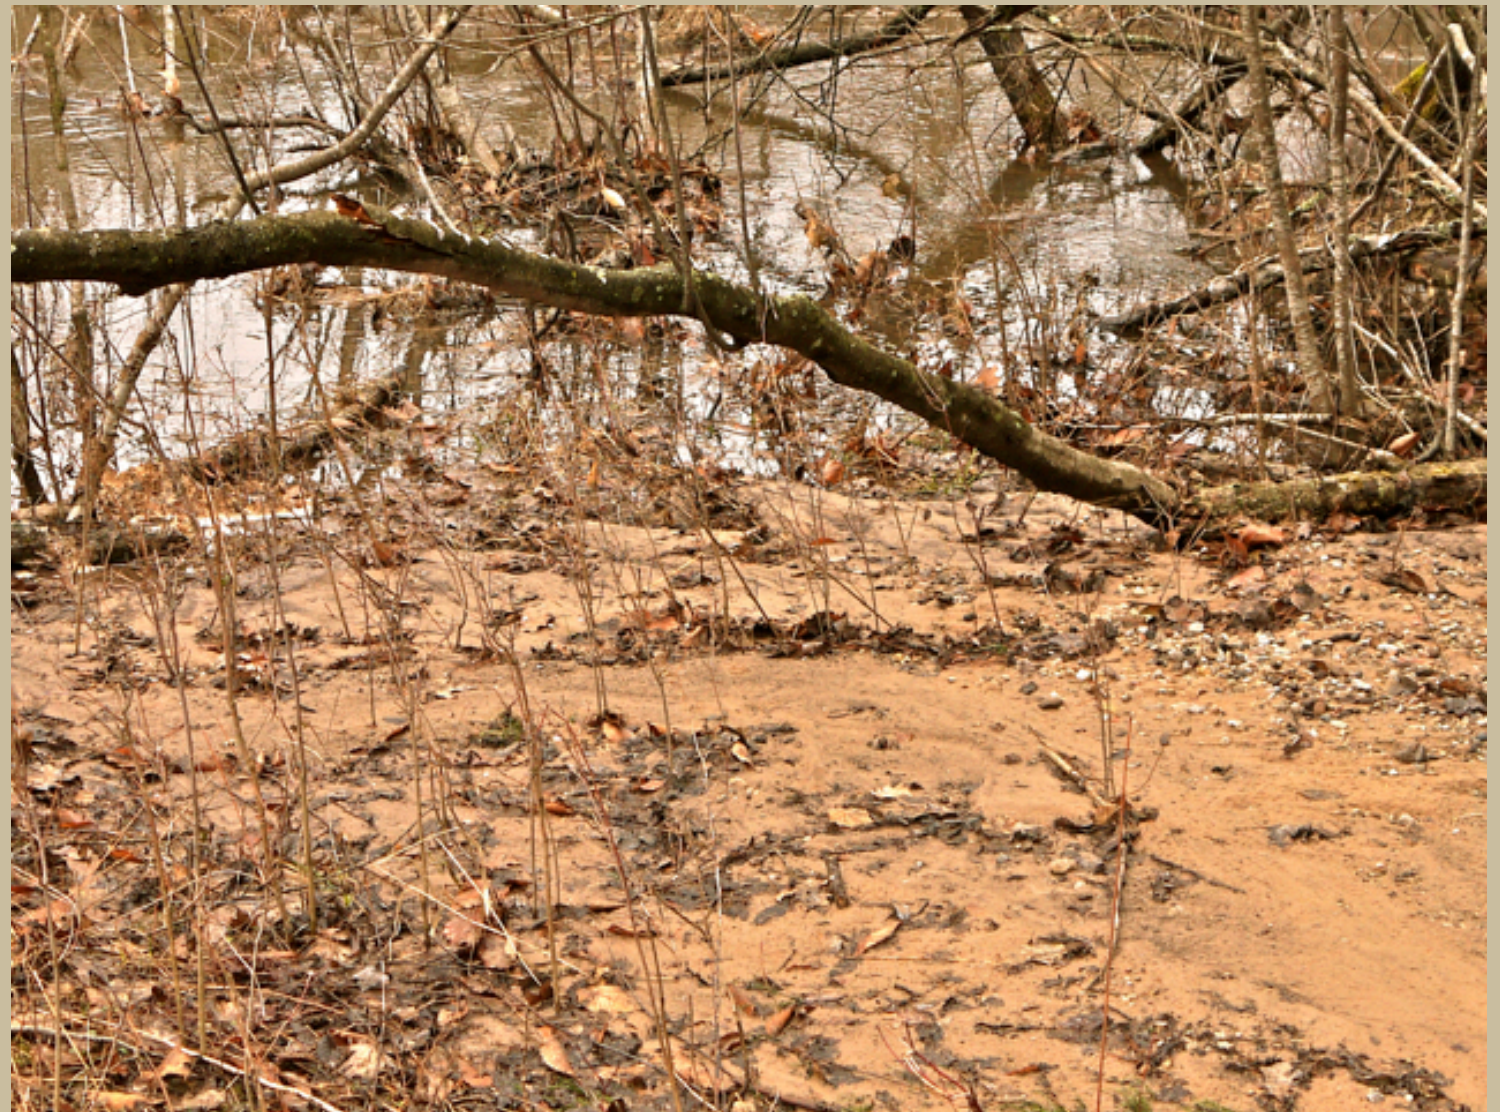
Left approach, 176th Ave. x N. Branch White River

Importance of erosion along approaches, which in our rural upper watersheds are frequently unpaved and in glacial terrain where coarse, easily erodible soils predominate

3 - 4% of the total annual erosion  
in the entire N. Branch sub-watershed (!),  
much of which is in the Natl. Forest

Erosion Factors:	R = 90 K = 0.15 LS = 3.3 C = 1.0 P = 1
Tolerable Soil Loss:	T = 5 (tons/acre/year)
Calculated Soil Loss:	A = 44.55 (tons/acre/year)
Potential soil loss (total):	44.55 (tons/year)

\* Note: Erosion from this site appears higher than the tolerable soil loss.
