USING COOPERATIVE LAKES DATA IN A REAL WORLD SITUATION

Deer Lake

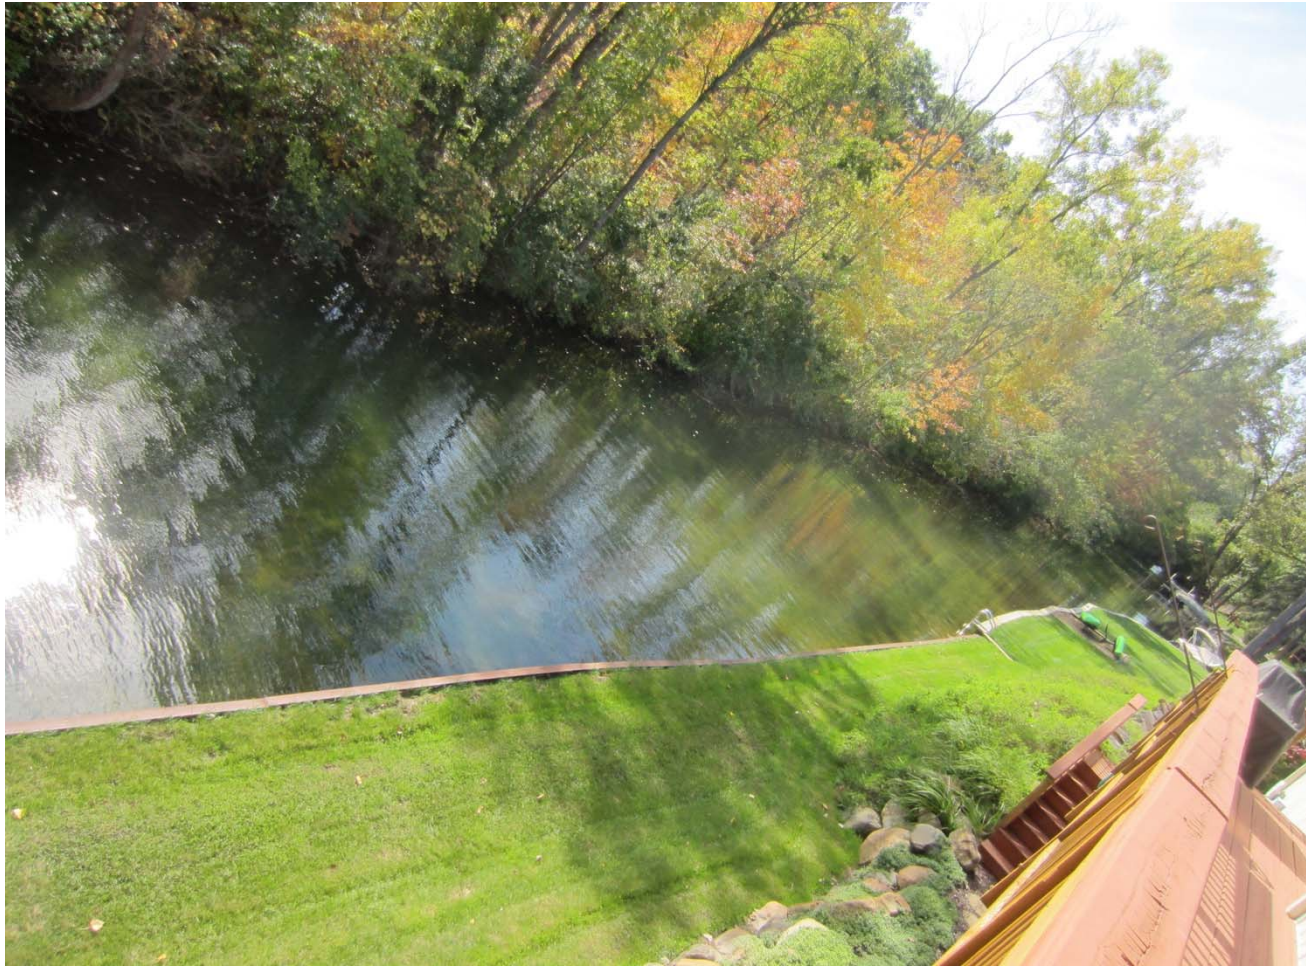
WEST INLET 1,200' LONG WITH A 4' DEPTH

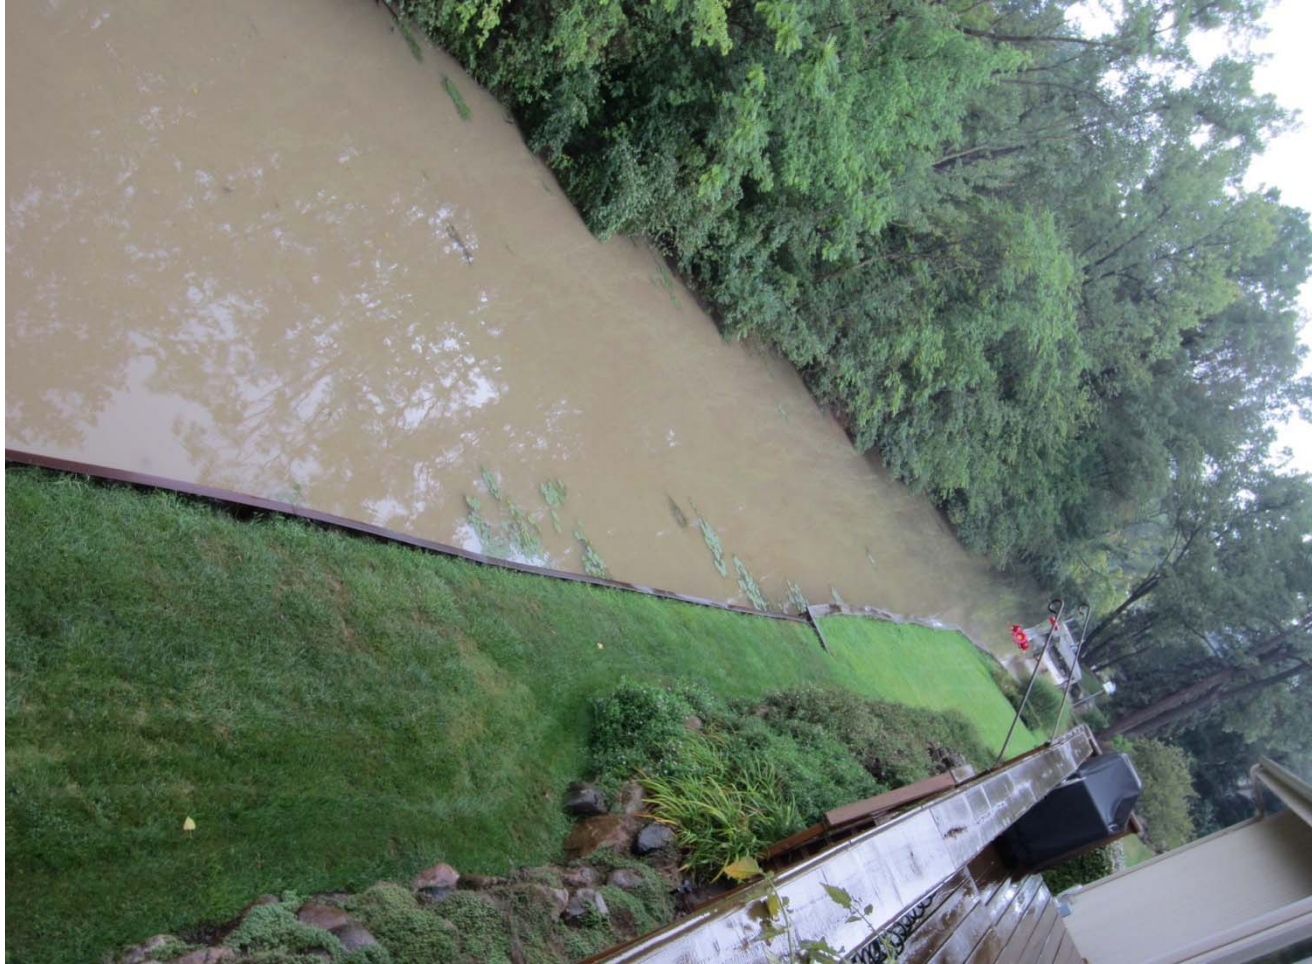
WEST INLET AFTER A
MEDIUM TO HARD RAIN

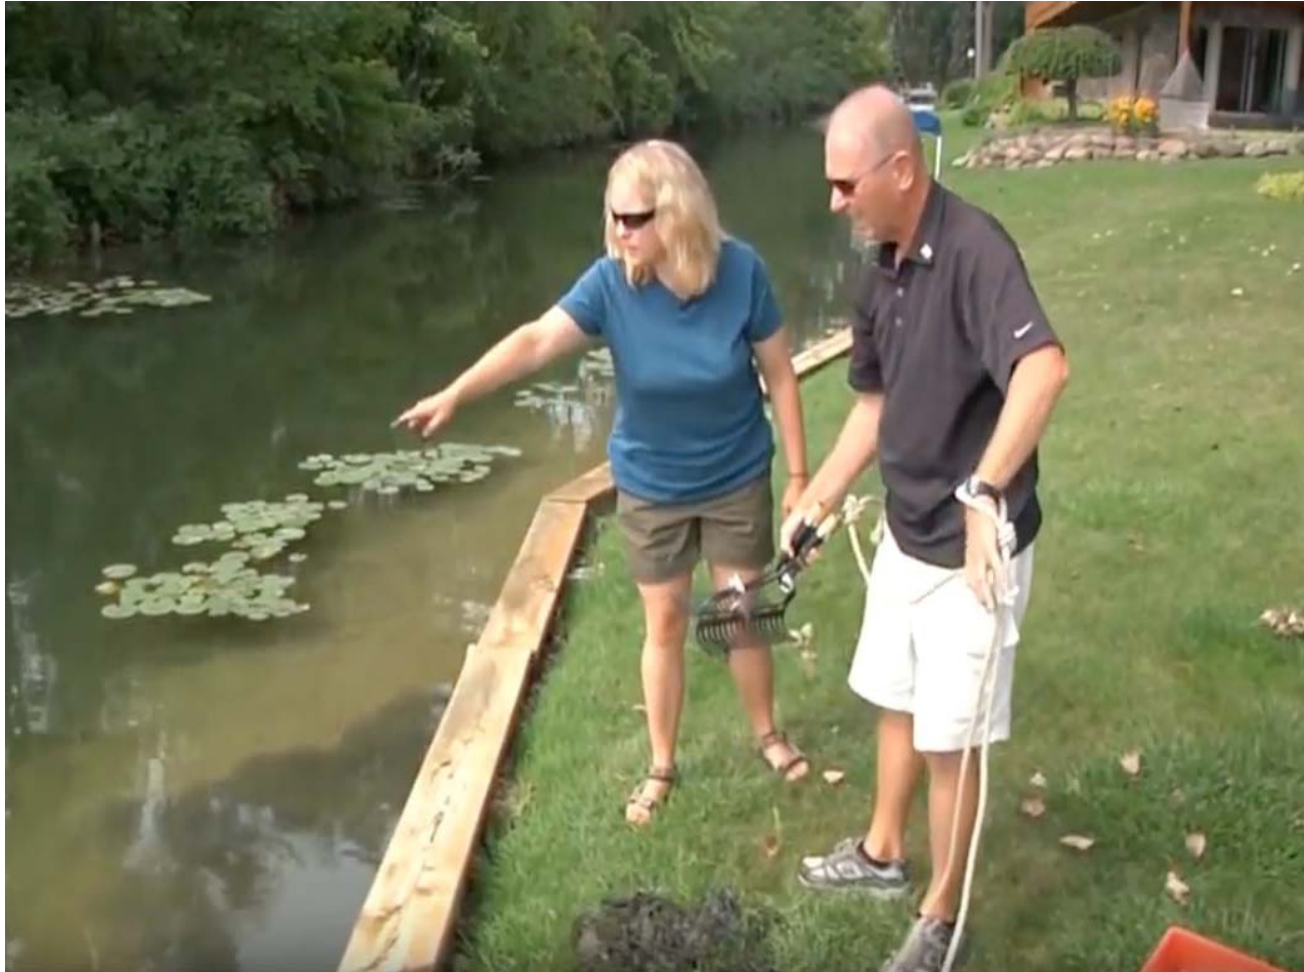
WEST INLET HAS TWO INVASIVES

1. CURLY LEAF PONDWEED
2. STARRY STONEWART (UNDER CONTROL)

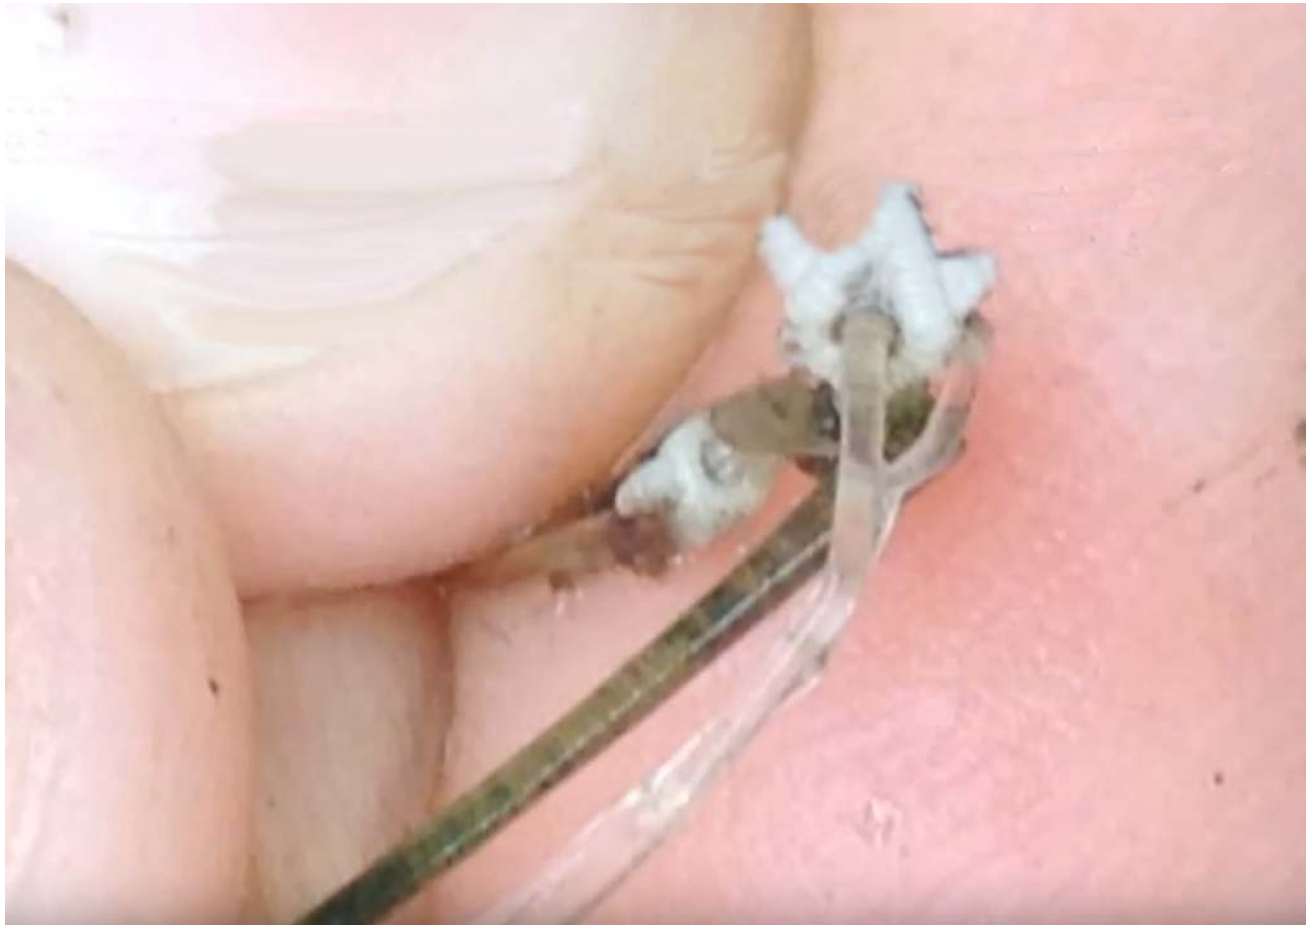
THE PRESENCE OF STARRY STONE
WART WAS CONFIRMED IN THE CANAL

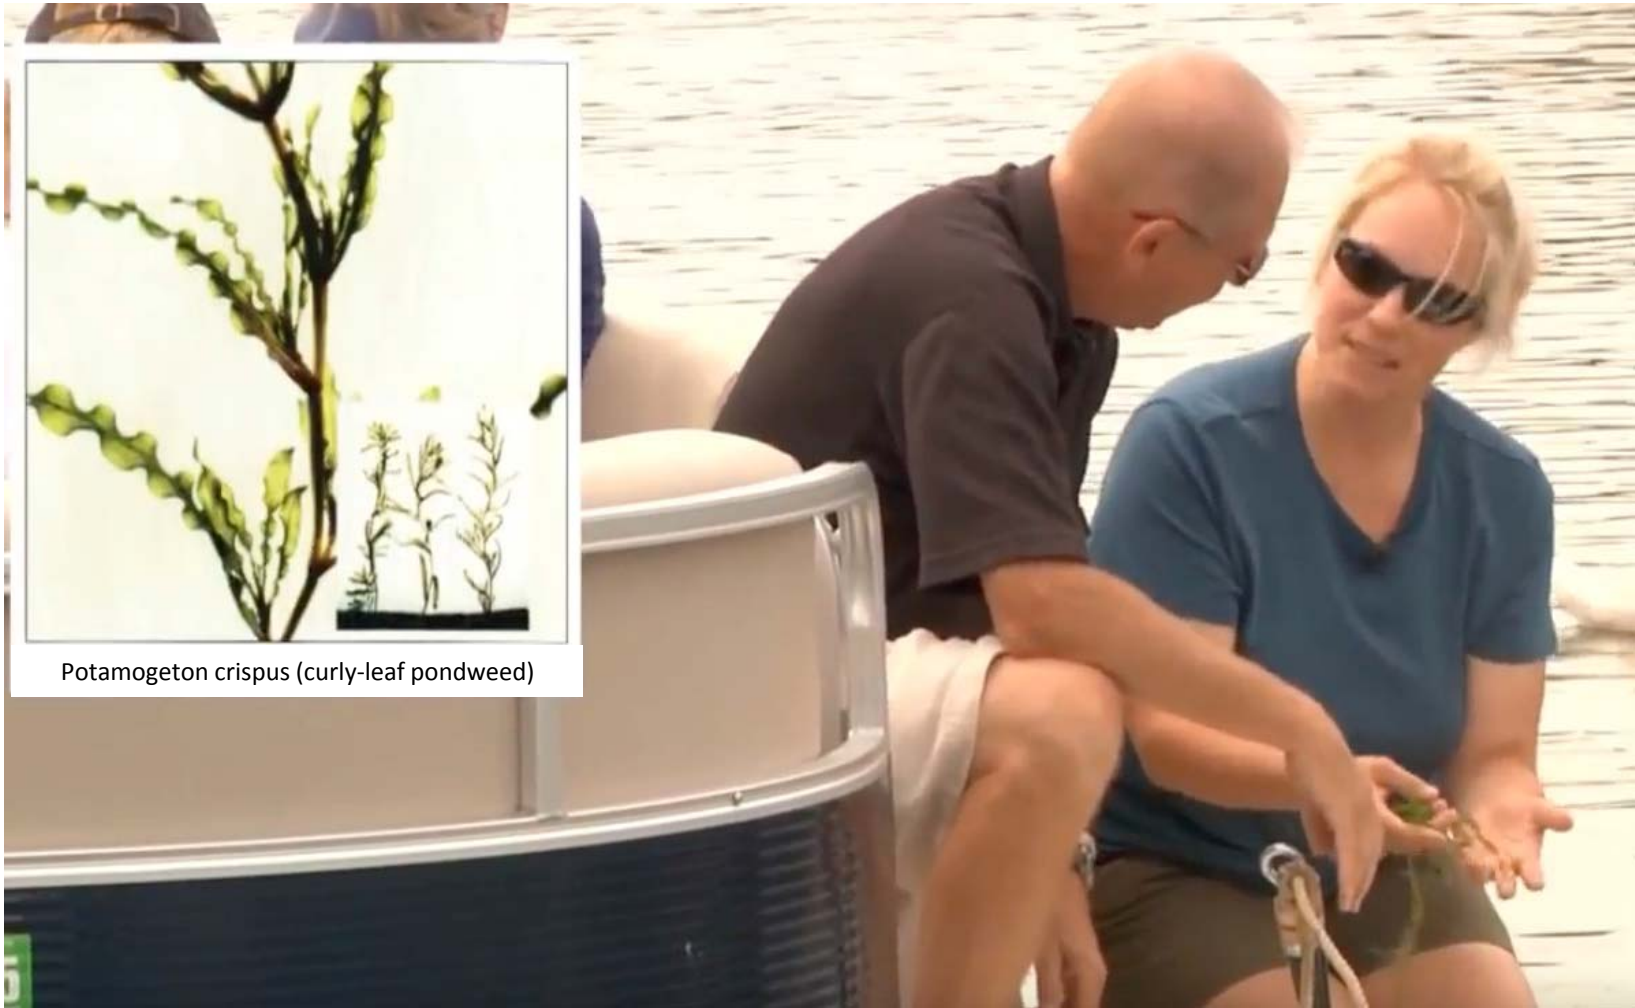
Potamogeton crispus (curly-leaf pondweed)

DR. LATIMORE IDENTIFIES CURLY-LEAF PONDWEED

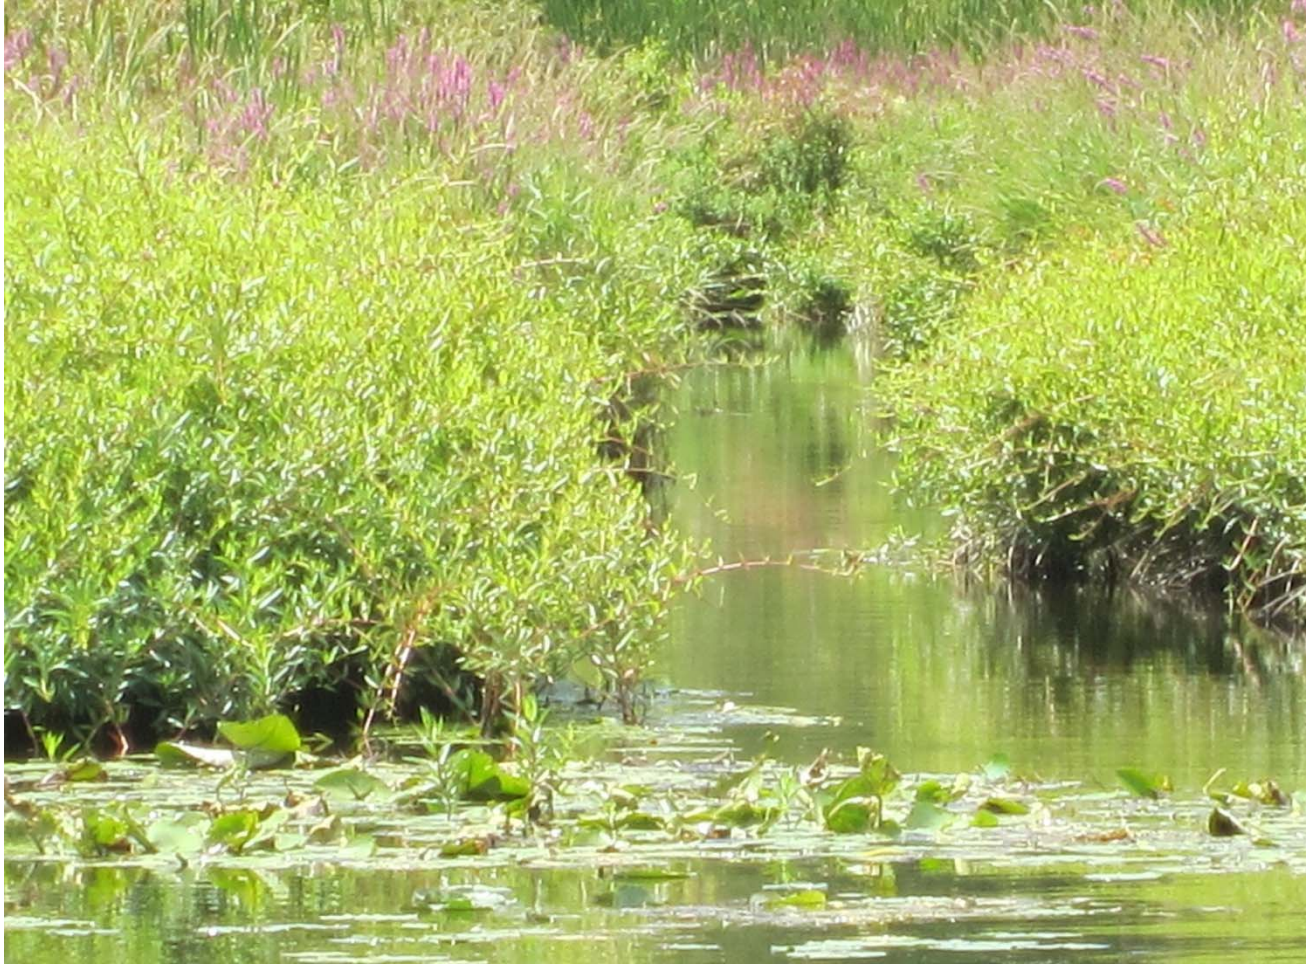
NORTH INLET CLINTON RIVER WATER SHED
SMALL AMOUNT OF CURLY LEAF PONDWEED AND
EURASIAN MILLFOIL
NOT PROBLEMATIC

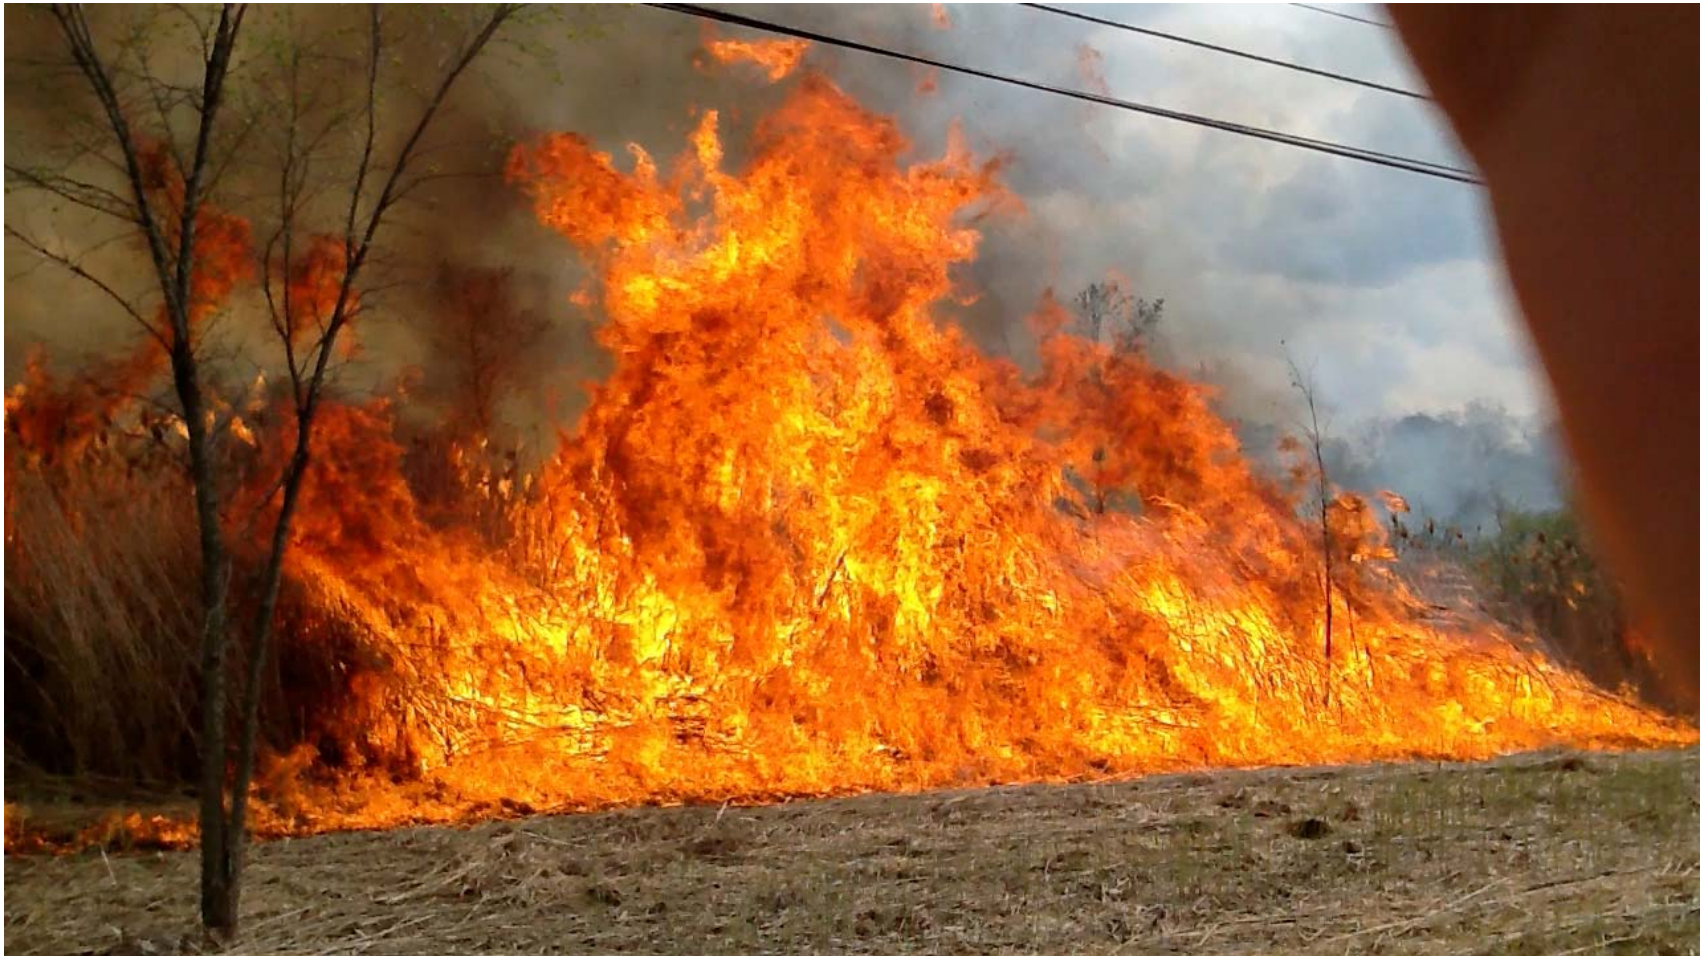
CONTROL PHRAGMITE TREATMENT

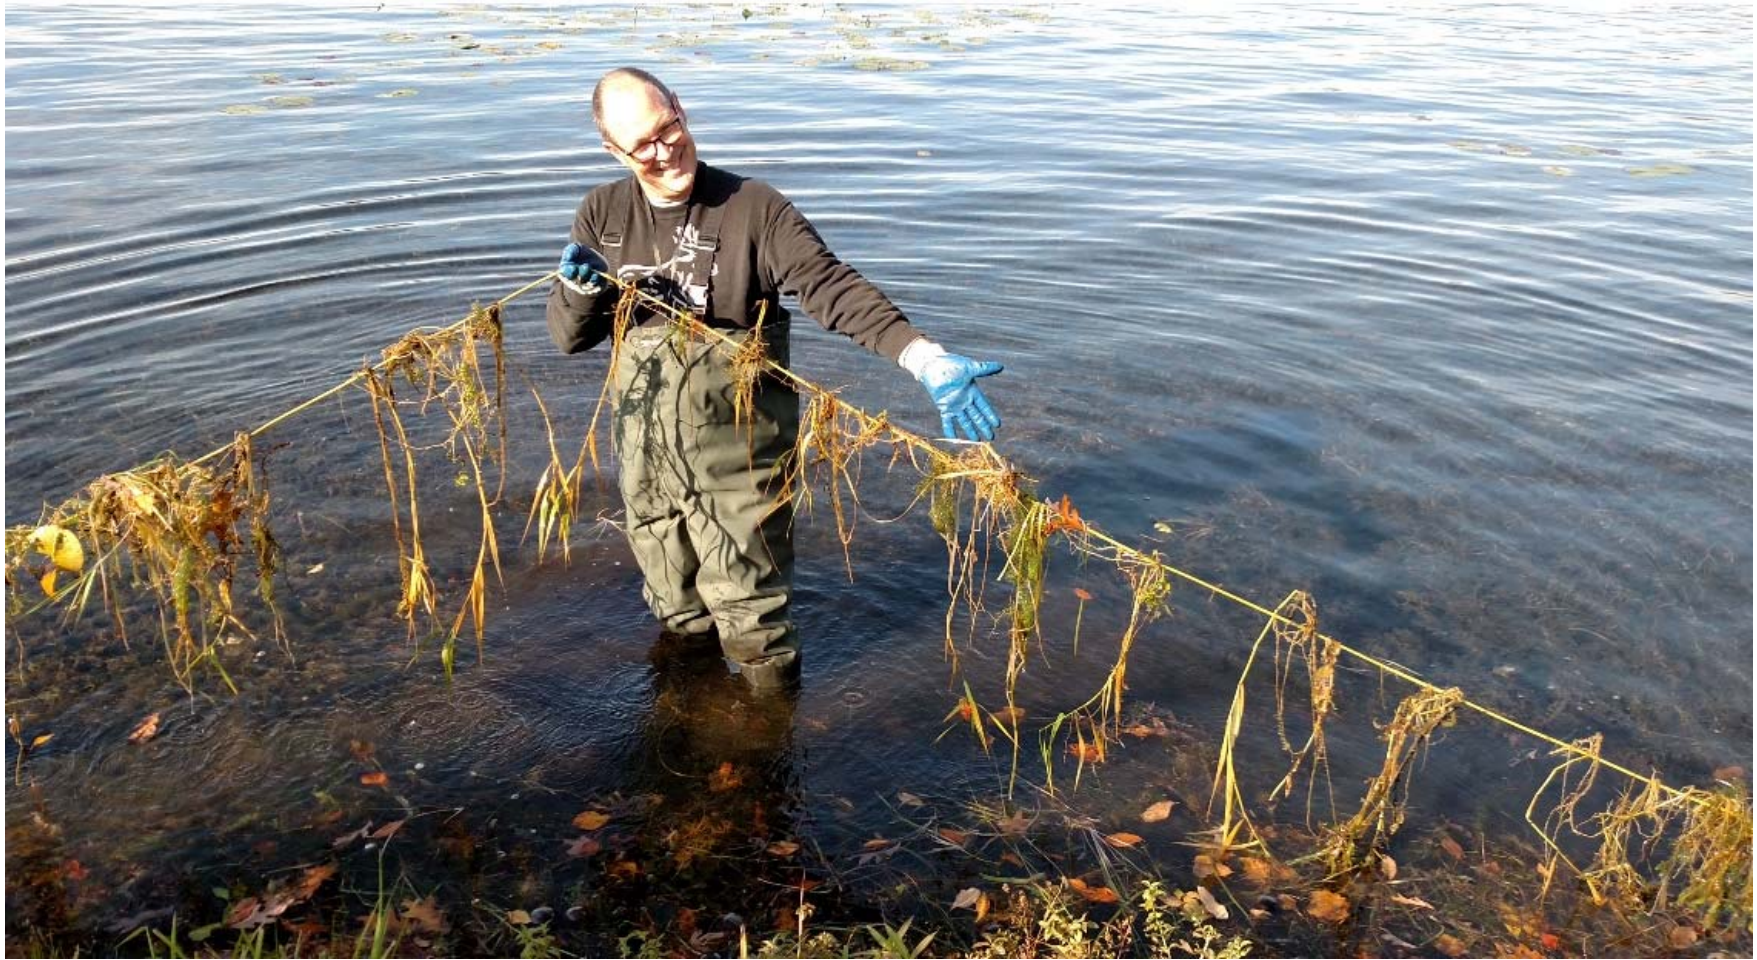
40' PHRAGMITE ROOT

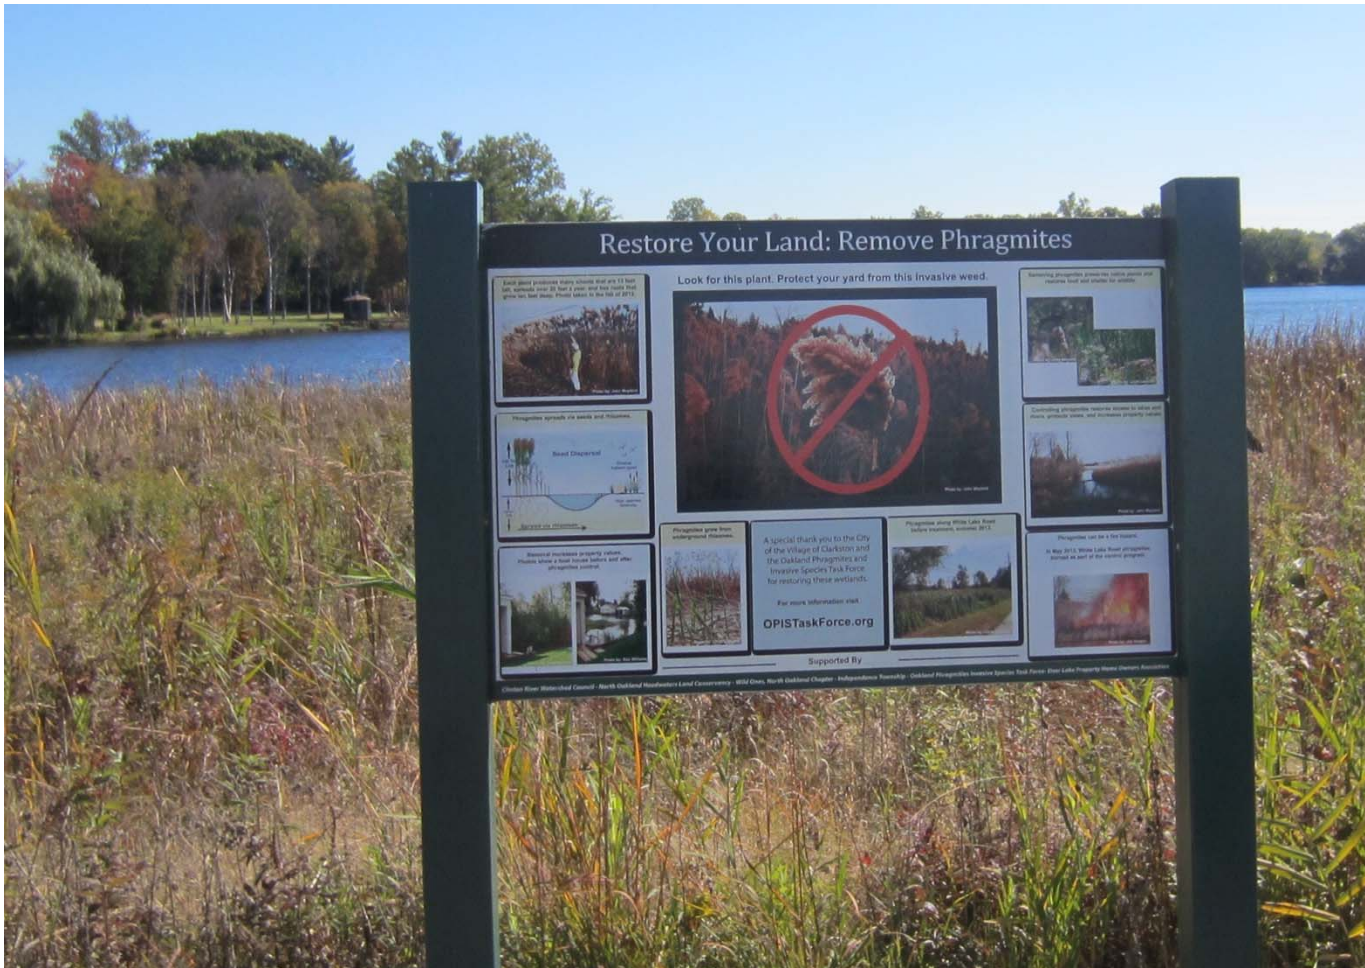
YOU COULD NOT SEE MIDDLE LAKE BEFORE THE PHRAGMITES TREATMENT

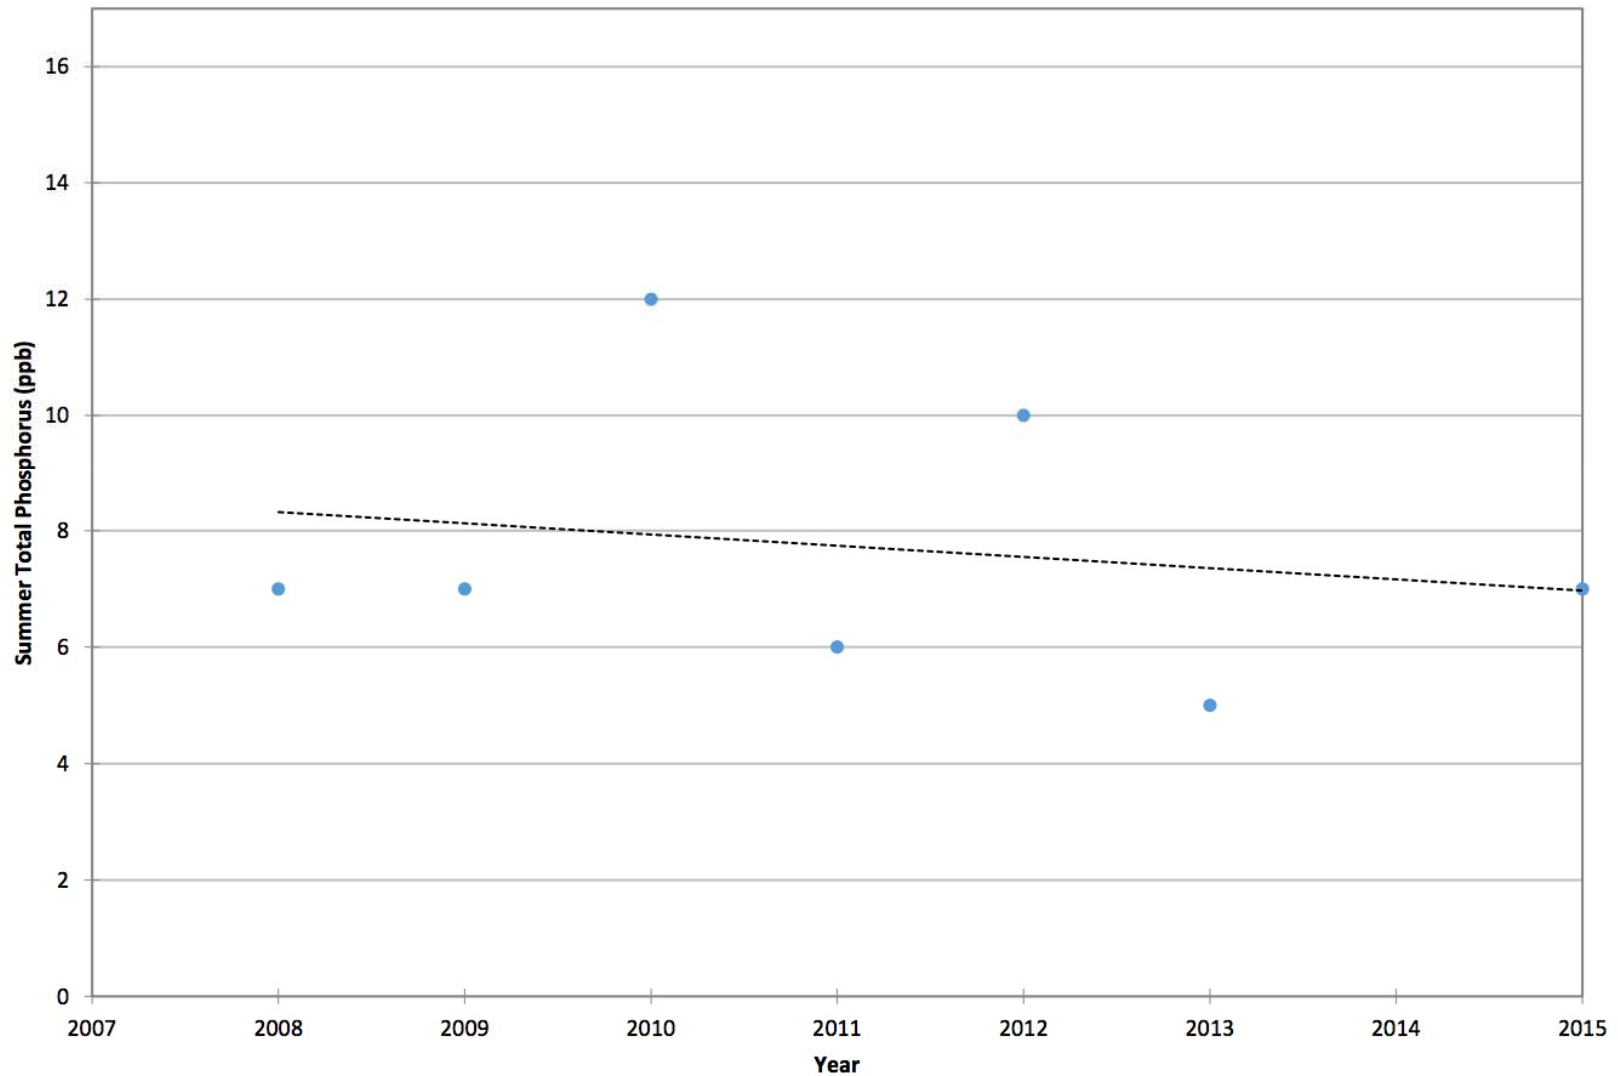
Deer Lake (Oakland Co.), 631128

COOPERATIVE LAKES MONITORING PROGRAM
SUMMER TOTAL PHOSPHORUS

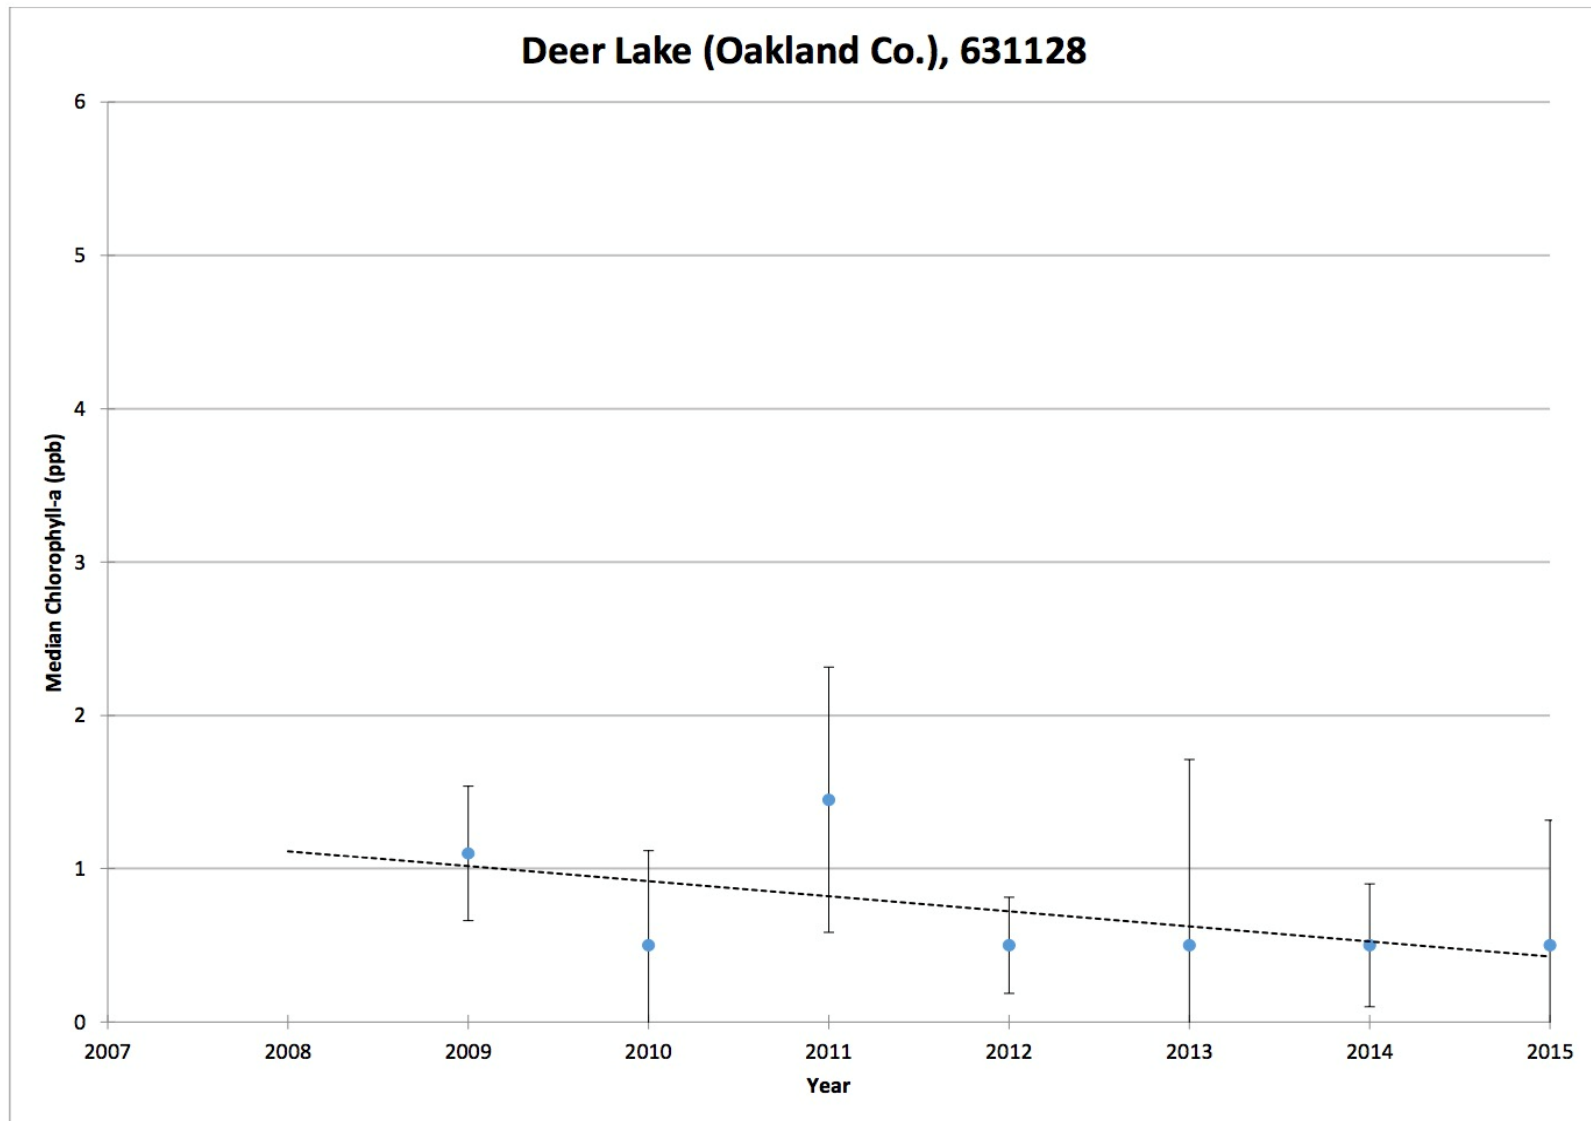
COOPERATIVE LAKES MONITORING PROGRAM
SUMMER MEDIAN CHLOROPHYLL-A

Vertical bars indicate standard deviation

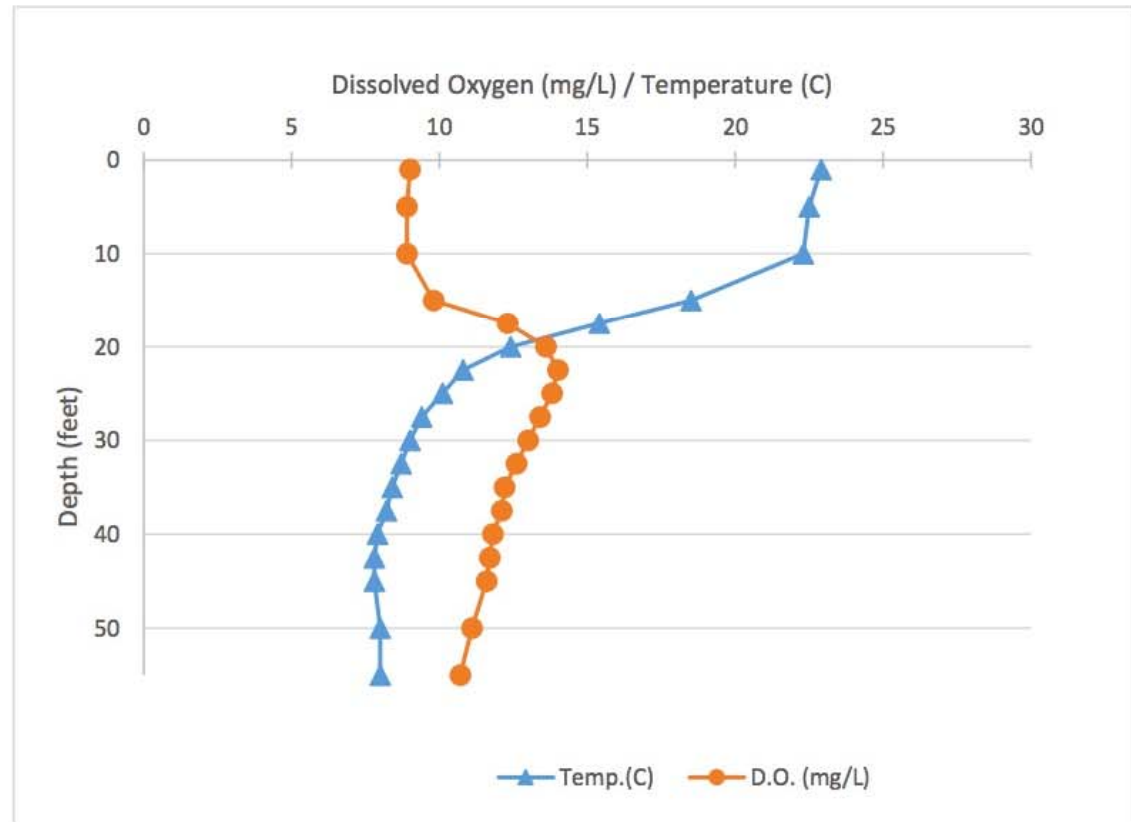
Lake: Deer (Oakland Co.)

Dissolved Oxygen and Temperature Profile

Depth (ft)	Temp.(C)	D.O. (mg/L)
1	22.9	9
5	22.5	8.9
10	22.3	8.9
15	18.5	9.8
17.5	15.4	12.3
20	12.4	13.6
22.5	10.8	14
25	10.1	13.8
27.5	9.4	13.4
30	9	13
32.5	8.7	12.6
35	8.4	12.2
37.5	8.2	12.1
40	7.9	11.8
42.5	7.8	11.7
45	7.8	11.6
50	8	11.1
55	8	10.7

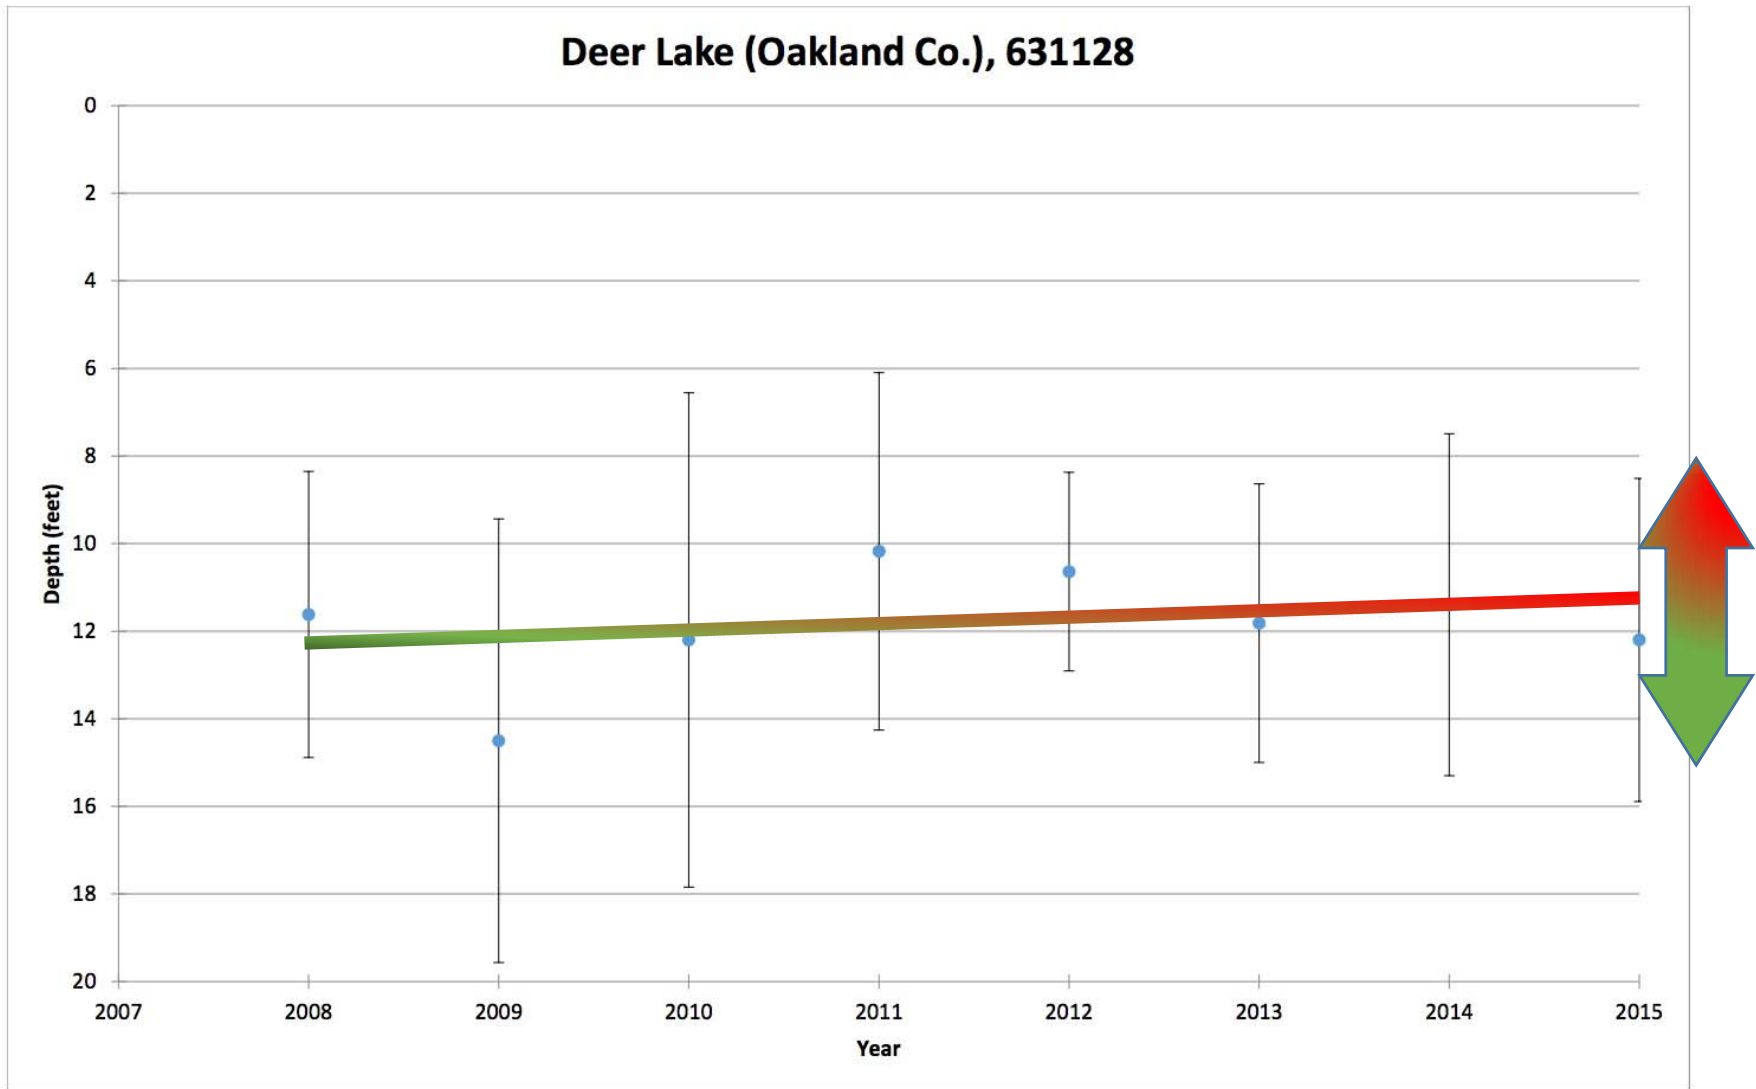
Deer Lake (Oakland Co.), 631128

COOPERATIVE LAKES MONITORING PROGRAM
SUMMER MEAN TRANSPARENCY

Vertical bars indicate standard deviation

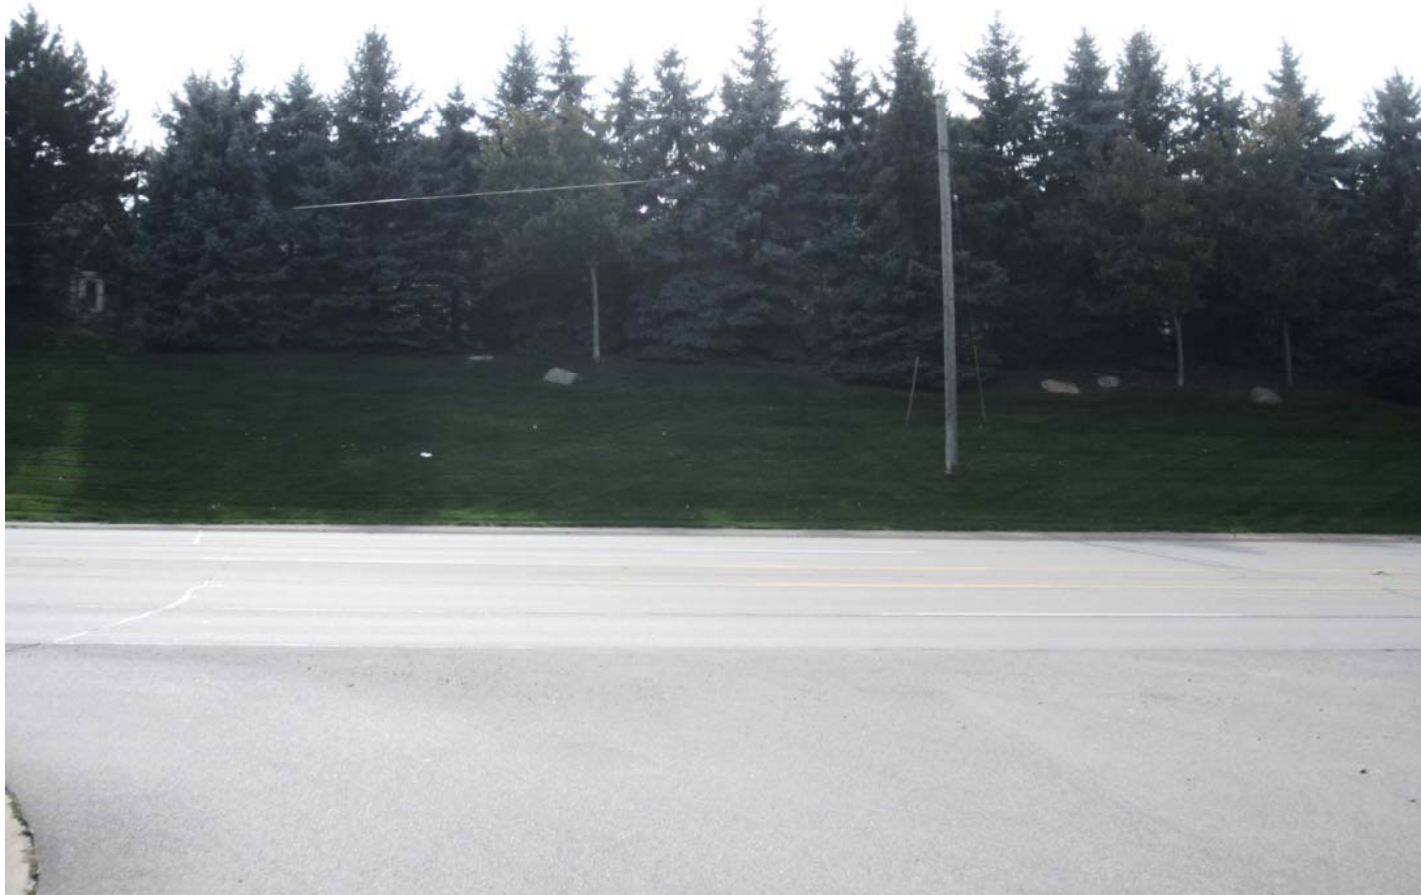
STREET ENTRANCE TO WEST INLET
ELEVATION 1000'
DEER LAKE ELEVATION 968'

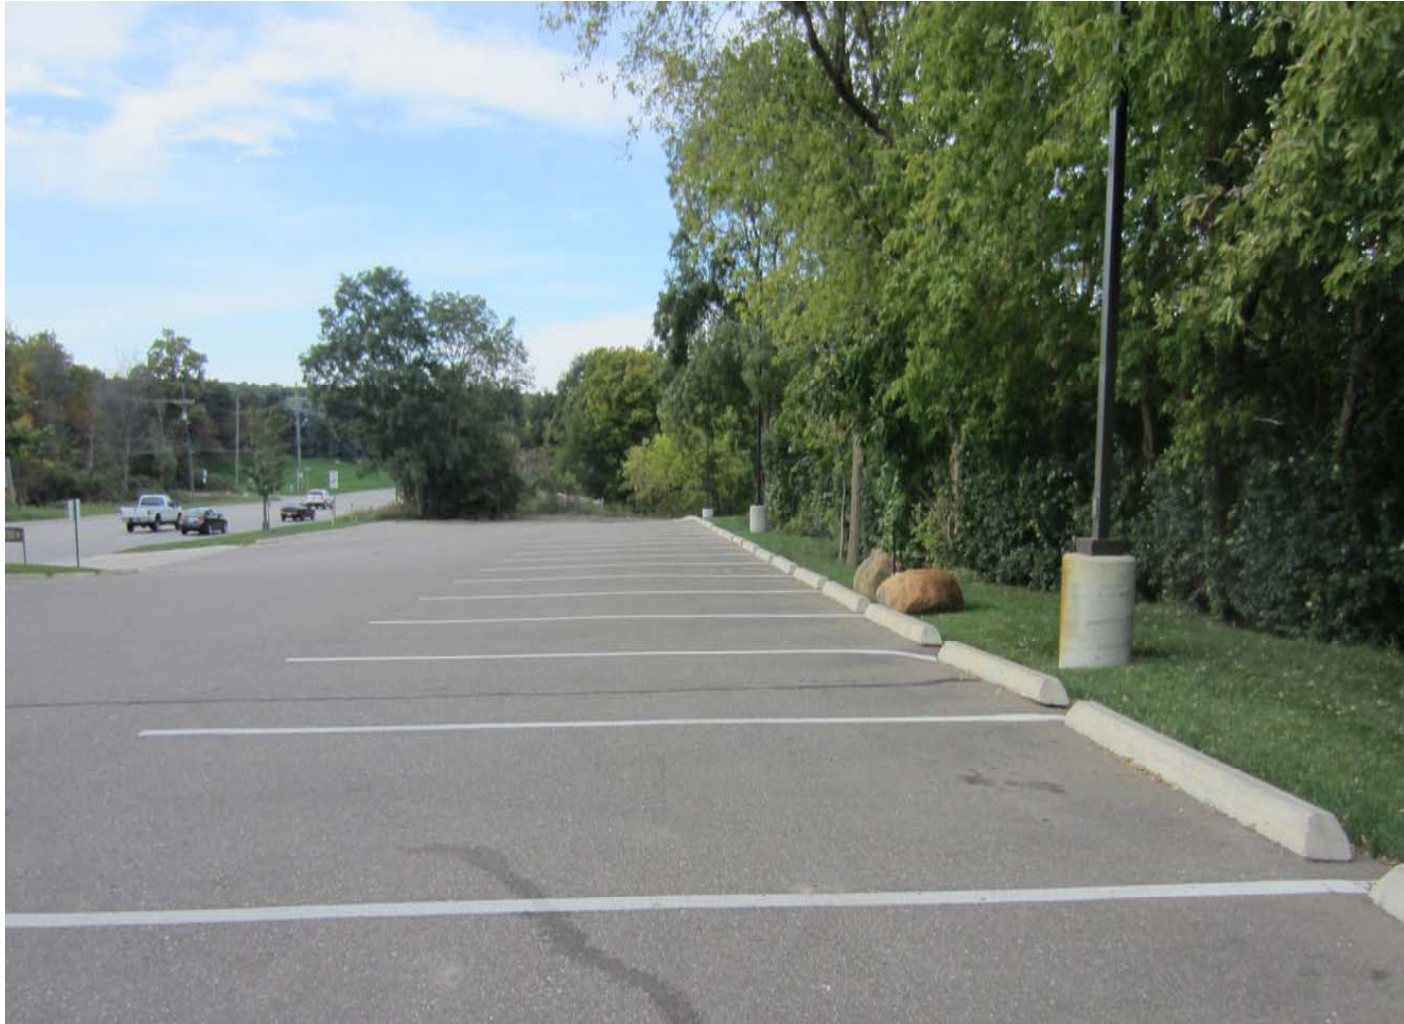
THREE YEARS AGO THIS WAS FIELD & WOODS
ELEVATION 1013'
DEER LAKE ELEVATION 968'
