USING COOPERATIVE LAKES DATA IN A REAL WORLD SITUATION

Deer Lake

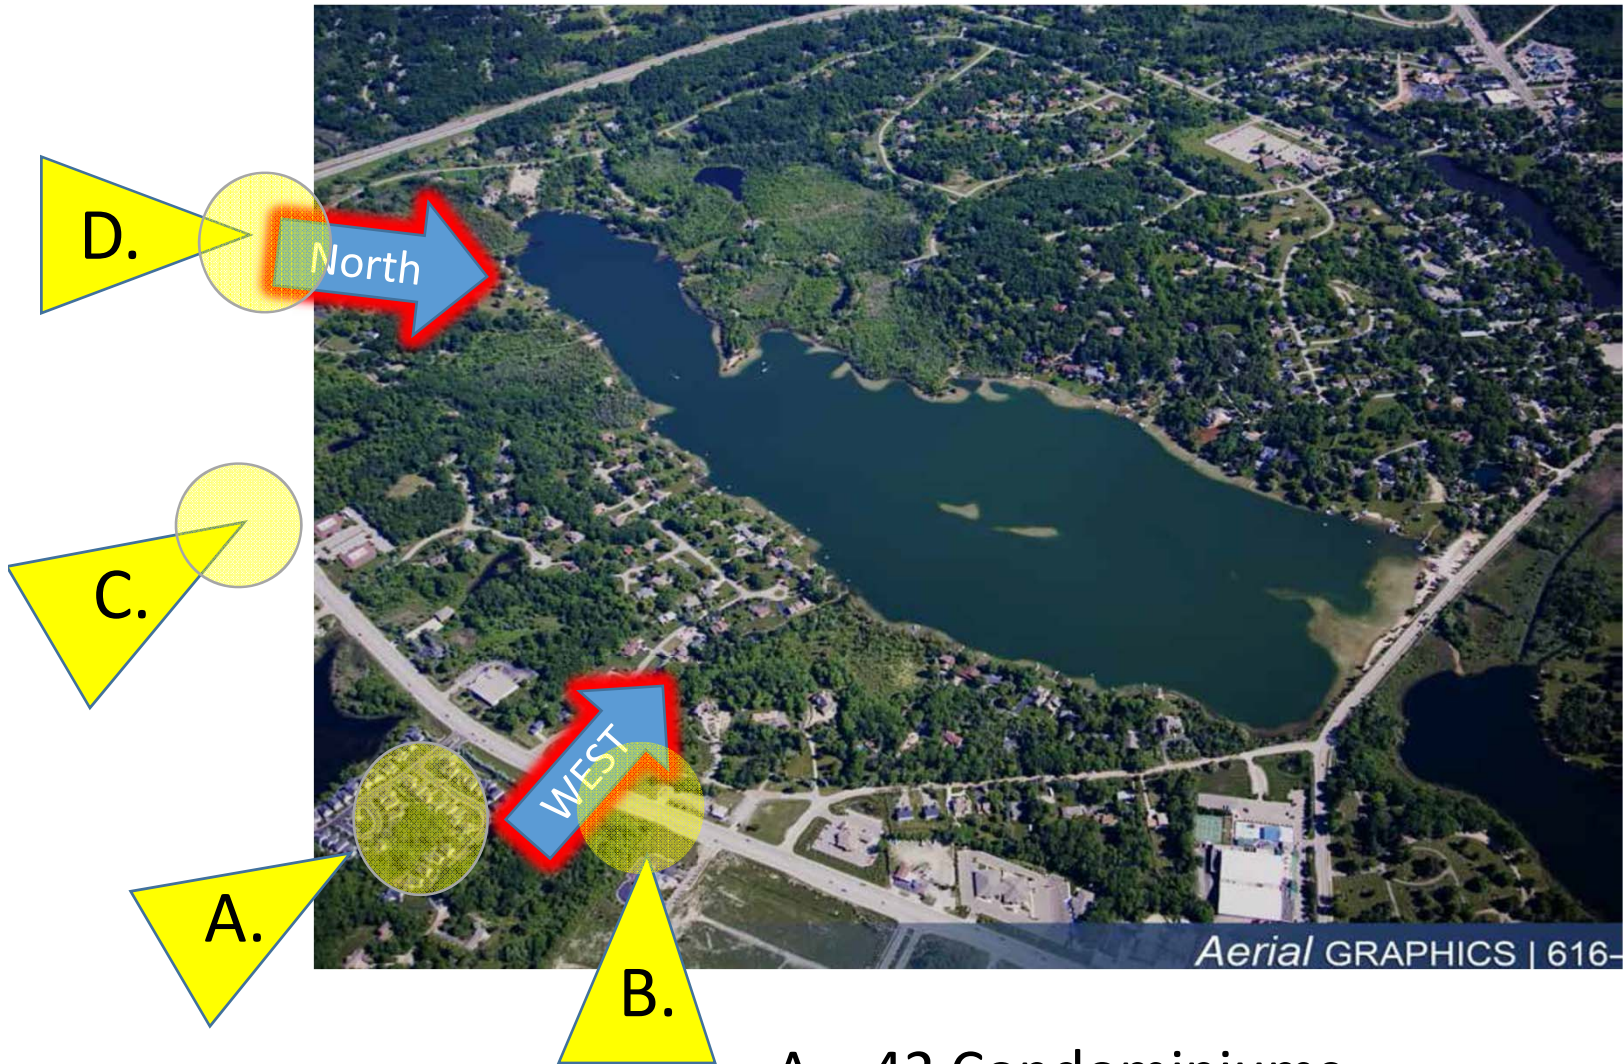
- A. 42 Condominiums
- B. Restaurant parking lot
- C. Future Clarkston Courthouse
- D. 92 Condominiums approved

INDEPENDENCE TWP. PLANNING TO DEVELOP DIXIE HIGHWAY CORRIDOR WITH BUSINESSES & LARGE HOUSING PROJECTS

- PLANNING
- WATER COMMISSION
- DPW
- PARKS
- TO INSURE BEST PRACTICES DETAINING AND FILTERING RUNOFF, ETC.
