**GRANTEE NAME:** Calhoun Conservation District (CCD)

**PROJECT NAME:** Road/Stream Crossing Inventory 2016

**PERIOD COVERED:** 06/01/16 – 12/31/16    **DATE SUBMITTED:** 01/04/17

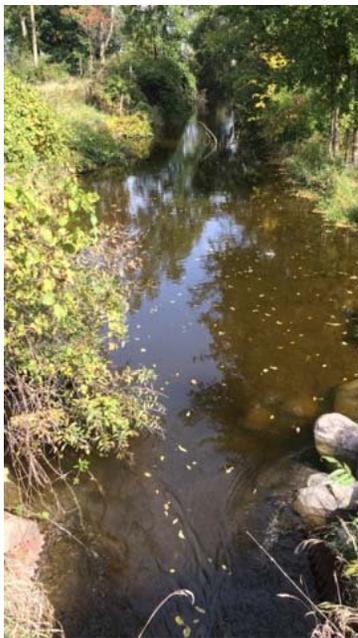
Pictured to the left, is a road/stream crossing located on Rice Creek. This particular crossing is severely undersized. The high velocity shown at the inlet and the restrictive size in relation to bankfull width upstream makes this site a priority for replacement. Pictured to the right, are two of our volunteers. Logan Kreiger (left) and Cullen Hielser (right). Both were being trained on correctly recording data and taking measurements.
