# 2019 Data Report for

# West Maggie Lake, Iron County

Site ID: 360172

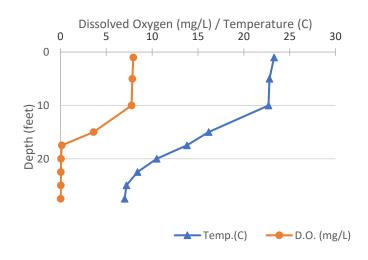
## **Dissolved Oxygen and Temperature Profile**

Due to the high nutrient level, the lake loses dissolved oxygen in the bottom waters in the spring and this condition persists through the whole monitoring season.

If you enrolled in Dissolved Oxygen/Temperature, the summary page will have a graph of one of the profiles taken during the late summer (typically August or September). If your lake stratifies, we will use a graph showing the earliest time of stratification, because identifying the timing of this condition and the depth at which it occurs is typically the most important use of dissolved oxygen measurements.

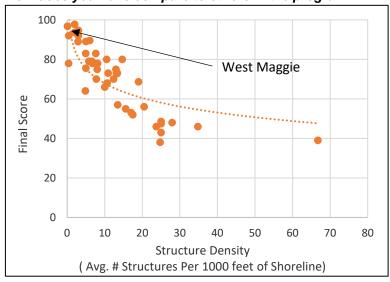
#### How does your lake compare to others in the program?

West Maggie Lake:	
Number of Sections:	8
Number of Structures:	25
Structure Density:	3.1
Final Score:	95

All 42 Participating Lakes from 2015-2018:		
Avg. Number of Sections:	16.3	
Avg. Number of Structures:	248.5	
Avg. Structure Density:	15.2	
Avg. Final Score:	70.5

Overall, the lakeshore habitat of West Maggie Lake is doing excellent and scored much higher than average when compared to other lakes in the program. All of the 1000 foot sections scored Good. Several had perfect scores (sections 2,7,8)

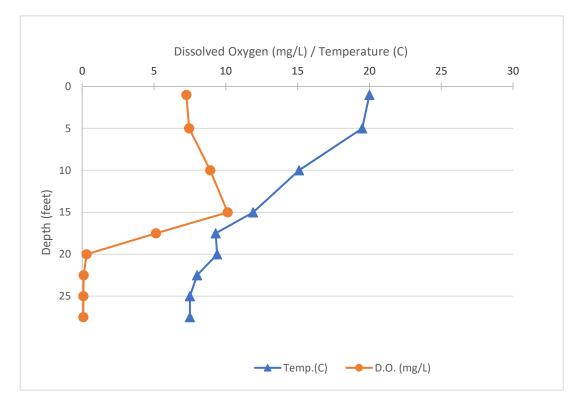
County: Iron
Site ID: 360172
Date: 5/26/2016

Temp.(C)	D.O. (mg/L)
20	7.26
19.5	7.45
15.1	8.92
11.9	10.13
9.3	5.14
9.4	0.3
8	0.1
7.5	0.08
7.5	0.08
	20 19.5 15.1 11.9 9.3 9.4 8 7.5

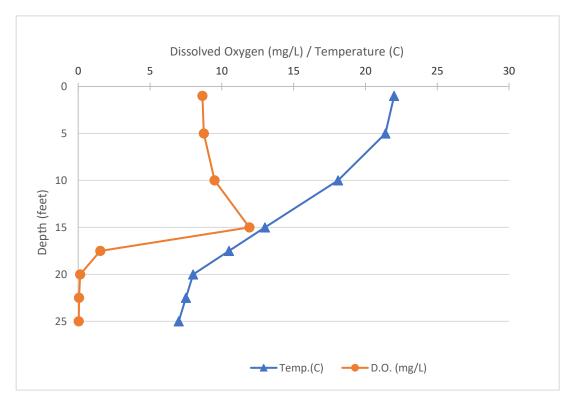
County: Iron
Site ID: 360172
Date: 6/12/2016

Depth (ft)	Temp.(C)	D.O. (mg/L)
1	22	8.65
5	21.4	8.75
10	18.1	9.5
15	13	11.92
17.5	10.5	1.54
20	8	0.14
22.5	7.5	0.06
25	7	0.04

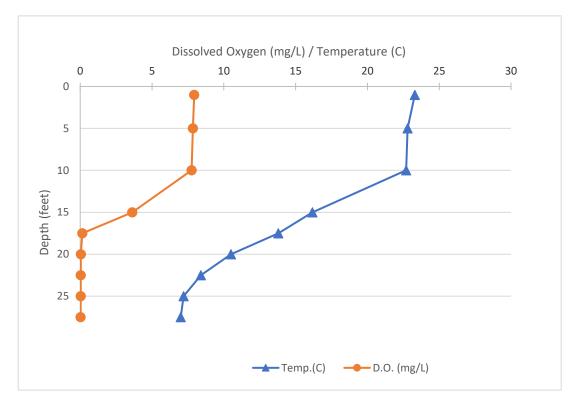
County: Iron
Site ID: 360172
Date: 7/16/2016

Depth (ft)	Temp.(C)	D.O. (mg/L)
1	23.3	7.94
5	22.8	7.85
10	22.7	7.76
15	16.17	3.62
17.5	13.8	0.15
20	10.5	0.05
22.5	8.4	0.04
25	7.2	0.04
27.5	7	0.03

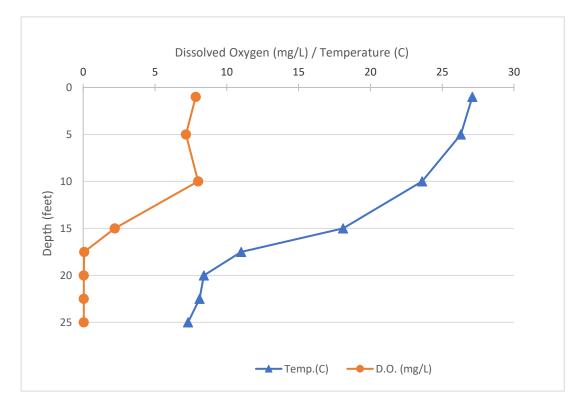
County: Iron
Site ID: 360172
Date: 7/23/2016

Depth (ft)	Temp.(C)	D.O. (mg/L)
1	27.1	7.83
5	26.3	7.15
10	23.6	8
15	18.1	2.2
17.5	11	0.07
20	8.4	0.04
22.5	8.1	0.04
25	7.3	0.04

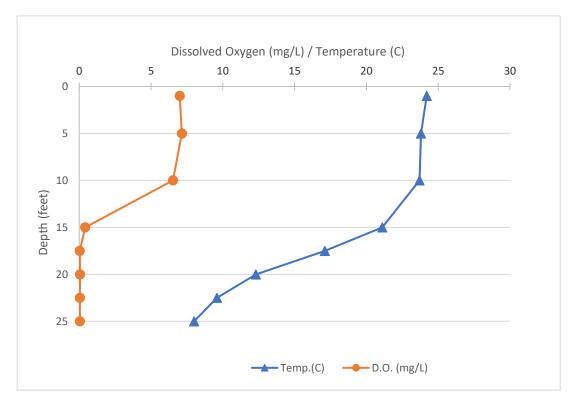
County: Iron
Site ID: 360172
Date: 8/14/2016

Temp.(C)	D.O. (mg/L)
24.2	7
23.8	7.15
23.7	6.53
21.1	0.42
17.1	0.04
12.3	0.06
9.6	0.05
8	0.05
	24.2 23.8 23.7 21.1 17.1 12.3 9.6

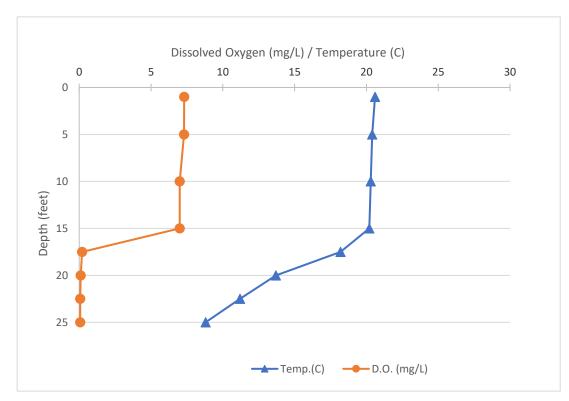
Lake: West Maggie Lake (Iron Co.) 9/11/2016

Depth (ft)	Temp.(C)	D.O. (mg/L)
1	20.6	7.31
5	20.4	7.3
10	20.3	7
15	20.2	7
17.5	18.2	0.2
20	13.7	0.1
22.5	11.2	0.07
25	8.8	0.07
