2019 Data Report for Painter Lake, Cass County

Site ID: 140108

Painter Lake, Cass County 2019 CLMP Results

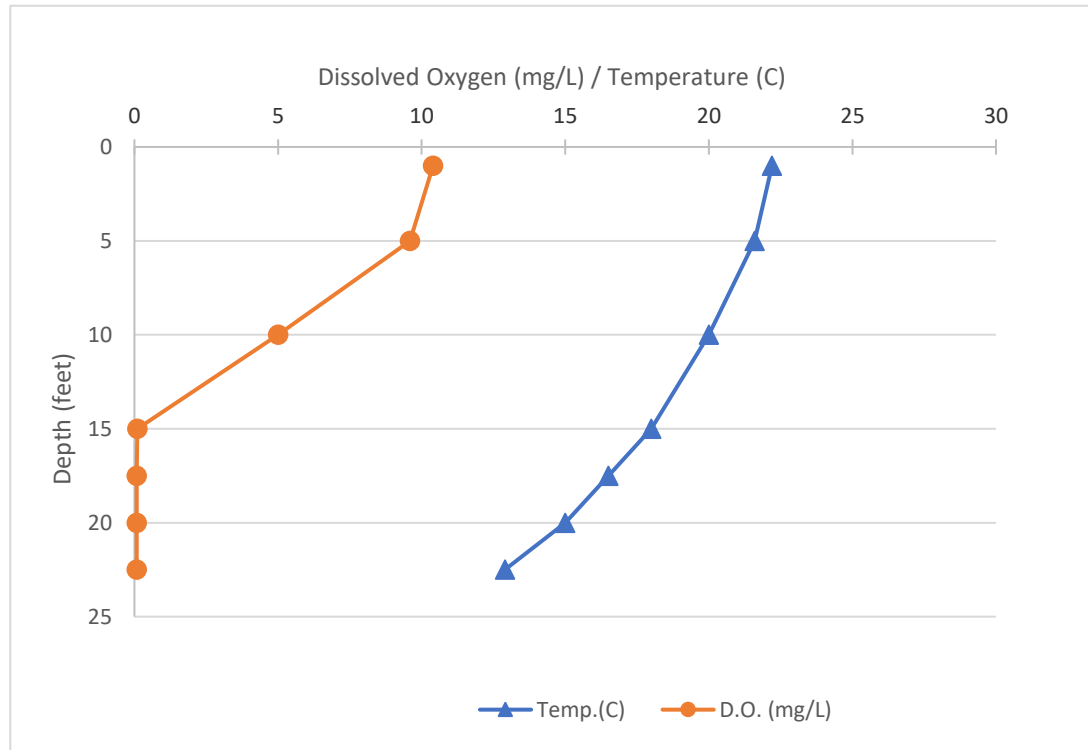
9/21/2019

Dissolved Oxygen and Temperature Profile

Depth (ft)	Temp.(C)	D.O. (mg/L)
1	22.2	10.4
5	21.6	9.6
10	20	5
15	18	0.1
17.5	16.5	0.08
20	15	0.08
22.5	12.9	0.08
