2019 Data Report for

Spider Lake, Grand Traverse County

Site ID: 280395

Spider Lake, Grand Traverse County 2019 CLMP Results

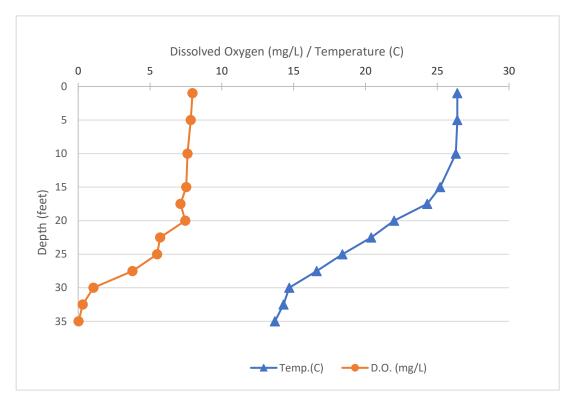
Site ID: 280395 Date: 7/18/2019

Depth (ft)	Temp.(C)	D.O. (mg/L)
1	26.4	7.96
5	26.4	7.83
10	26.3	7.61
15	25.2	7.52
17.5	24.3	7.12
20	22	7.46
22.5	20.4	5.71
25	18.4	5.5
27.5	16.6	3.78
30	14.7	1.06
32.5	14.3	0.31
35	13.7	0.03

The lake keeps some dissolved oxygen in the bottom waters through early summer, but by midsummer the lake has stratified and the bottom water is devoid of oxygen.
