2019 Data Report for

Big Star Lake, Lake County

Site ID: 430022

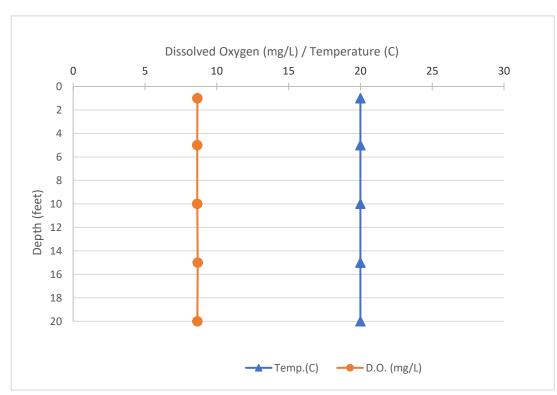
County: Lake Site ID: 430022 Date: 9/7/2017

Depth (ft) Temp.(C) D.O. (mg/L) 20 8.65 20 8.65 20 8.65 8.65 20 20 8.64 5 5 20 8.64 5 20 8.64 5 20 8.64 20 8.64 10 10 8.64 20 10 20 8.64 10 20 8.64 15 20 8.67 15 20 8.67 15 20 8.67 15 20 8.67 20 20 8.65 20 20 8.65 20 20 8.65 20 20 8.65
