**2019 Data Report
for
Betsie Lake, Benzie County**

Site ID: 100113

Betsie Lake, Benzie County 2019 CLMP Results

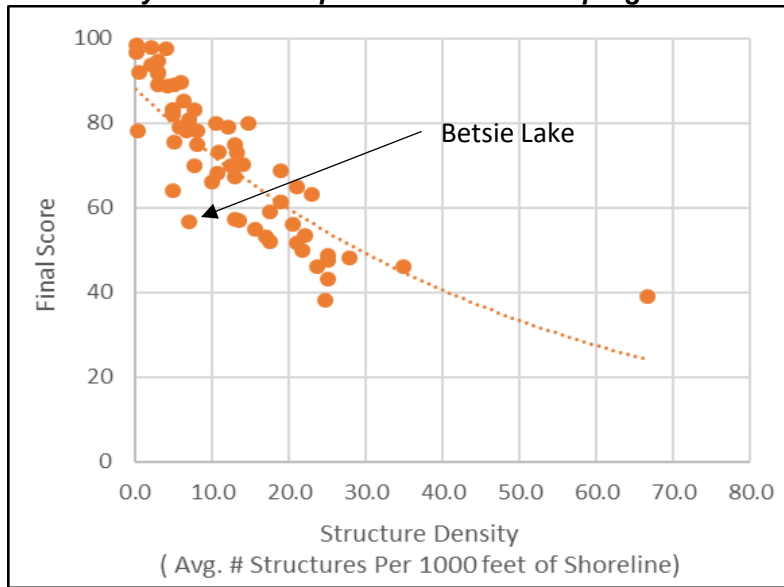
How does your lake compare to others in the program?

Betsie Lake:	
Number of Sections:	19
Number of Structures:	135
Structure Density:	7
Final Score:	57

All 63 Participating Lakes from 2015-2019:	
Avg. Number of Sections:	15.9
Avg. Number of Structures:	226
Avg. Structure Density:	12.5
Avg. Final Score:	71.1

Overall, the lakeshore habitat of Betsie Lake is below average when compared to the other lakes in the program. About 50% percent of the lake sections score poor or worse (1 highly impacted, 9 poor, 2 fair, 7 good). Other lakes with a same amount of development as Betsie Lake typically have higher scores, indicating that Betsie could be much better than it is.

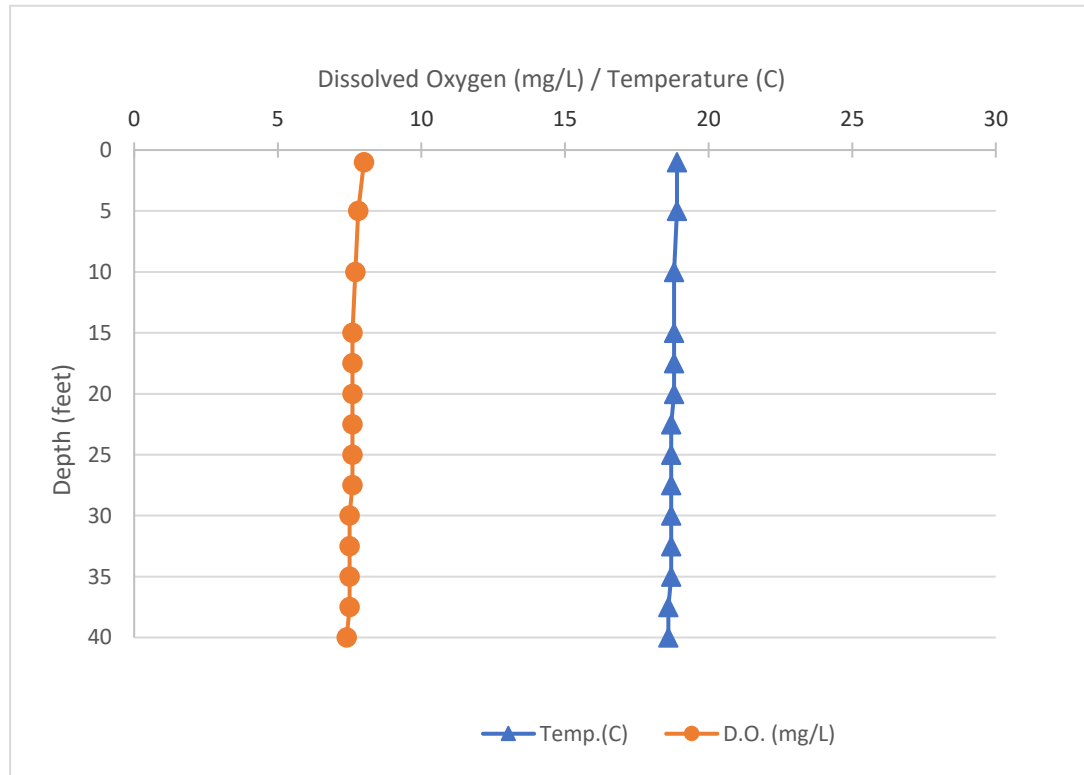
9/5/2019

Dissolved Oxygen and Temperature Profile

Depth (ft)	Temp.(C)	D.O. (mg/L)
1	18.9	8
5	18.9	7.8
10	18.8	7.7
15	18.8	7.6
17.5	18.8	7.6
20	18.8	7.6
22.5	18.7	7.6
25	18.7	7.6
27.5	18.7	7.6
30	18.7	7.5
32.5	18.7	7.5
35	18.7	7.5
37.5	18.6	7.5
40	18.6	7.4
