# 2019 Data Report for Chippewa Lake, Mecosta County

Site ID: 540050

# Chippewa Lake, Mecosta County 2019 CLMP Results

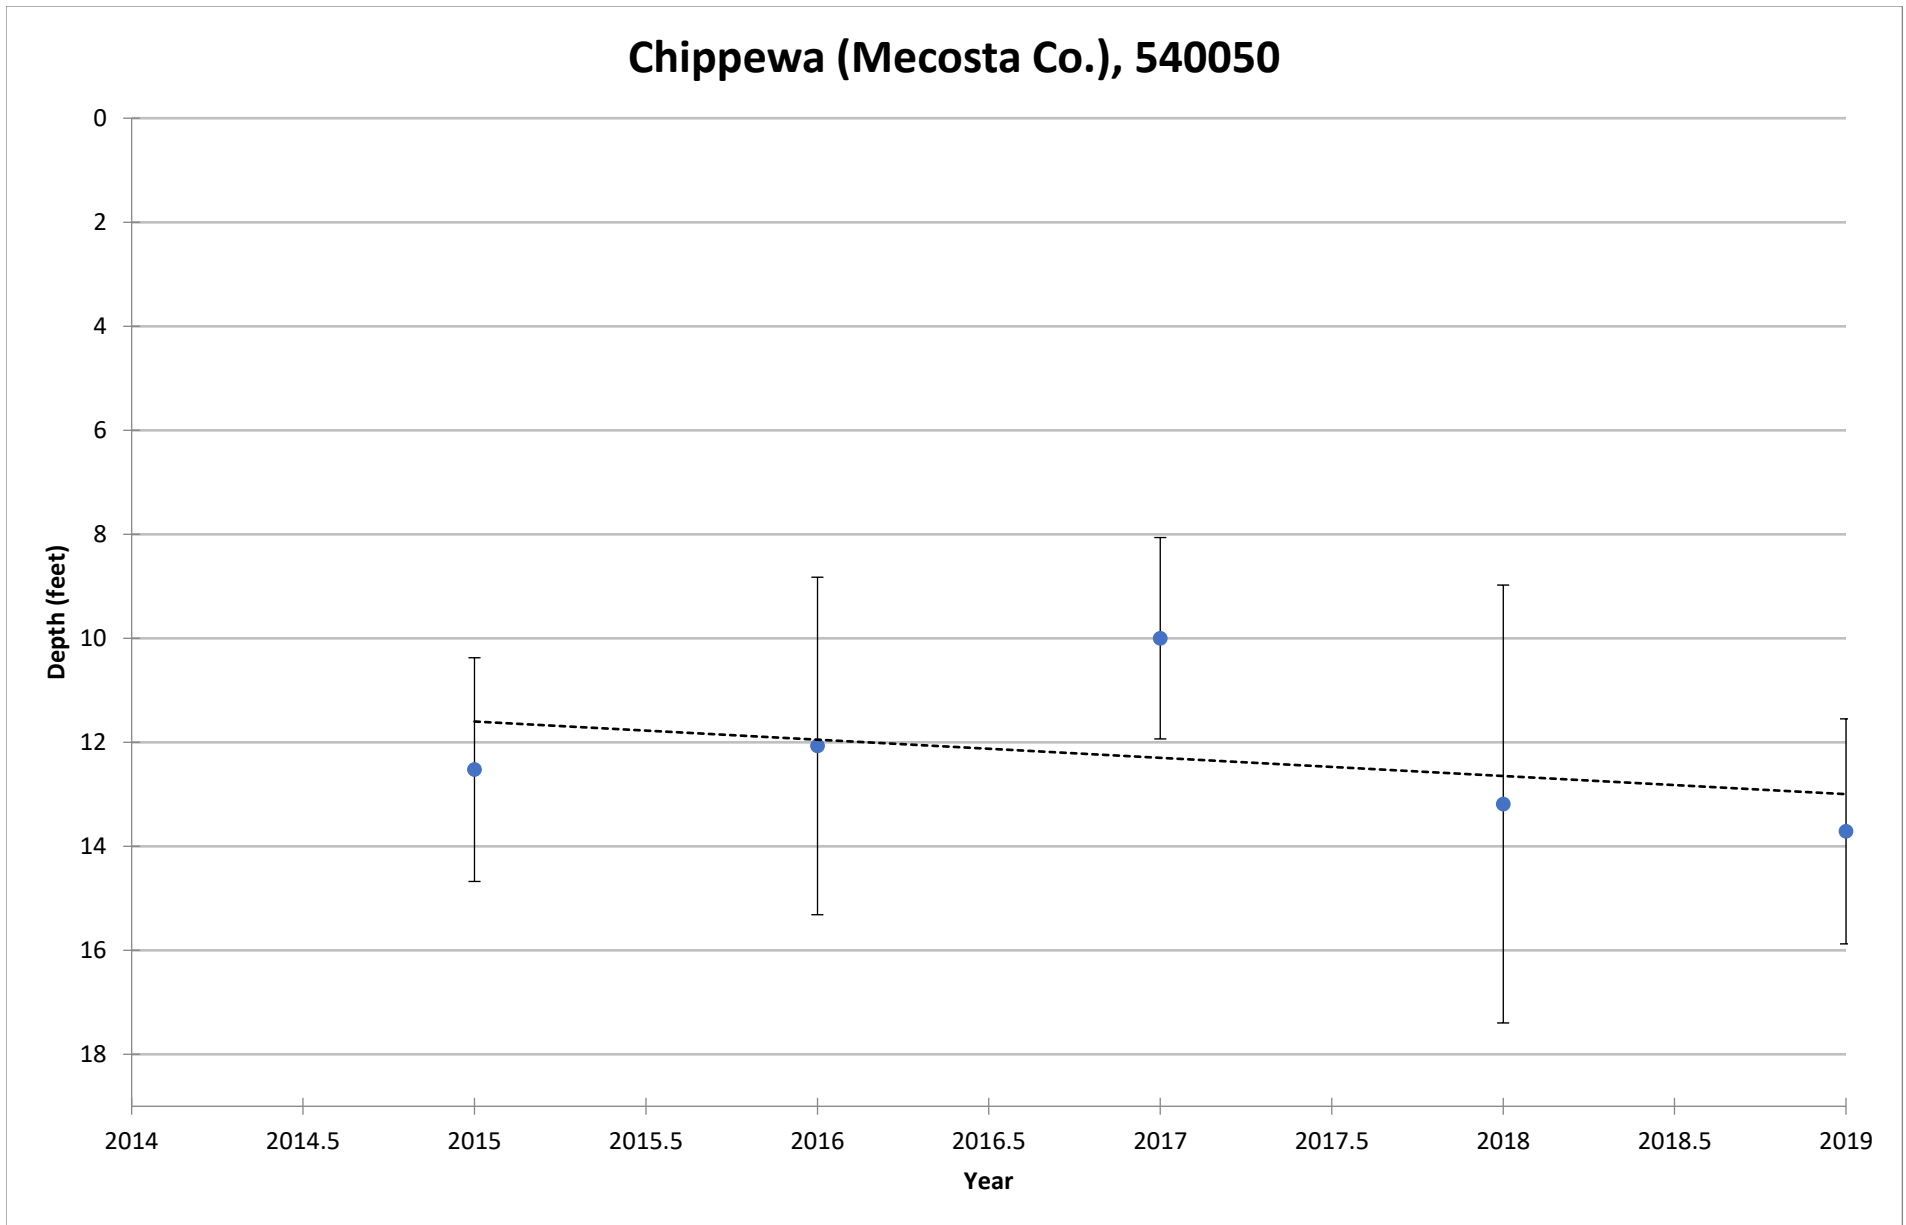
COOPERATIVE LAKES MONITORING PROGRAM  
SUMMER MEAN TRANSPARENCY

Vertical bars indicate standard deviation

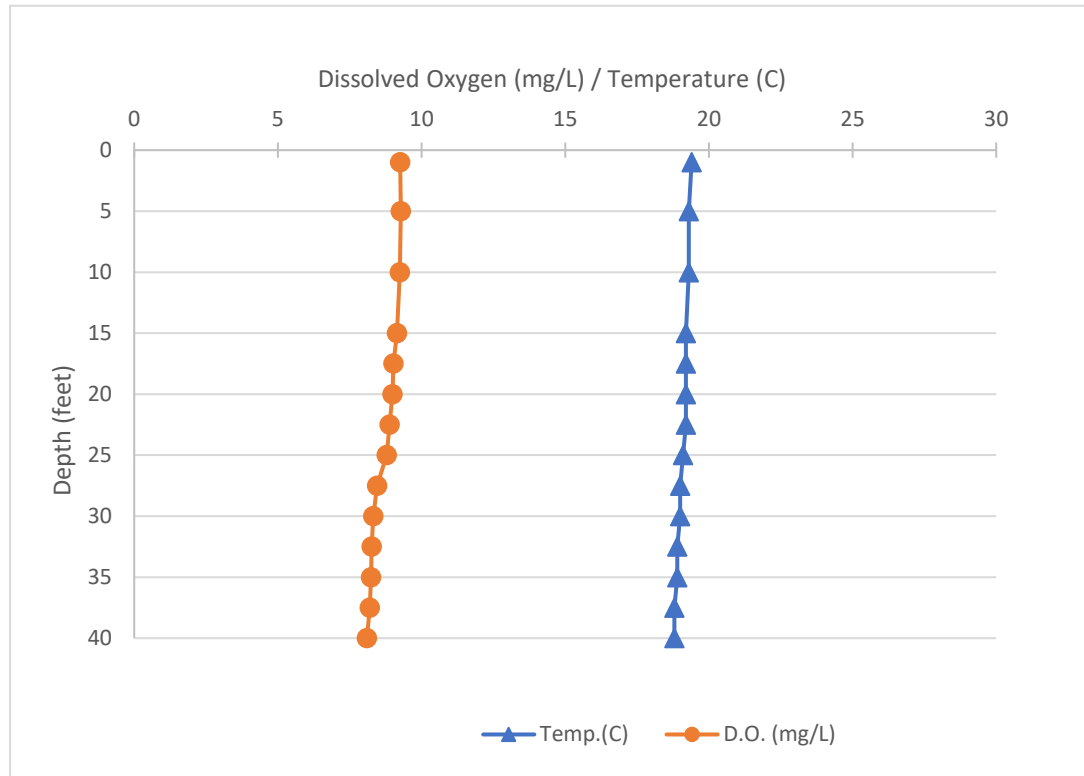
9/15/2019

Depth (ft)	Temp.(C)	D.O. (mg/L)
1	19.4	9.26
5	19.3	9.28
10	19.3	9.25
15	19.2	9.14
17.5	19.2	9.02
20	19.2	8.99
22.5	19.2	8.89
25	19.1	8.79
27.5	19	8.45
30	19	8.32
32.5	18.9	8.26
35	18.9	8.24
37.5	18.8	8.2
40	18.8	8.1
