# 2019 Data Report for Lake Christiana, Cass County

Site ID: 140055

# Lake Christiana, Cass County 2019 CLMP Results

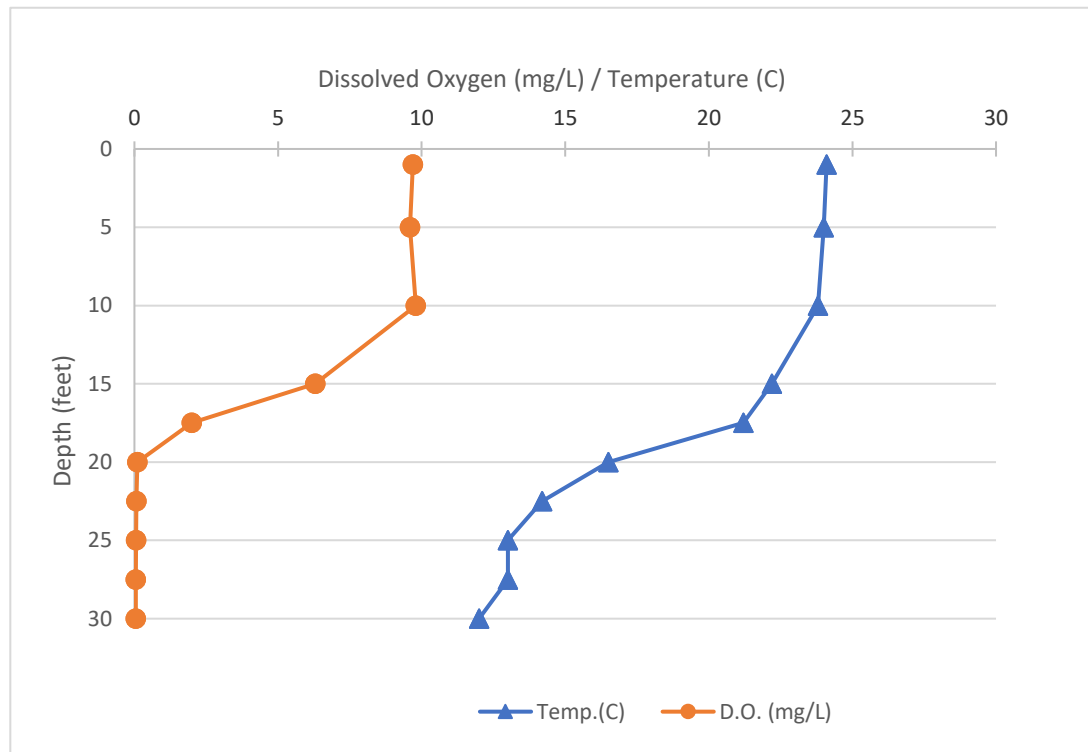
9/21/2019

### Dissolved Oxygen and Temperature Profile

Depth (ft)	Temp.(C)	D.O. (mg/L)
1	24.1	9.7
1	24.1	9.7
5	24	9.6
5	24	9.6
10	23.8	9.8
10	23.8	9.8
15	22.2	6.3
15	22.2	6.3
17.5	21.2	2
17.5	21.2	2
20	16.5	0.1
20	16.5	0.1
22.5	14.2	0.07
22.5	14.2	0.07
25	13	0.06
25	13	0.06
27.5	13	0.05
27.5	13	0.05
30	12	0.05
30	12	0.05
