2019 Data Report for Crockery Lake, Ottawa County

Site ID: 700422

Crockery Lake, Ottawa County 2019 CLMP Results

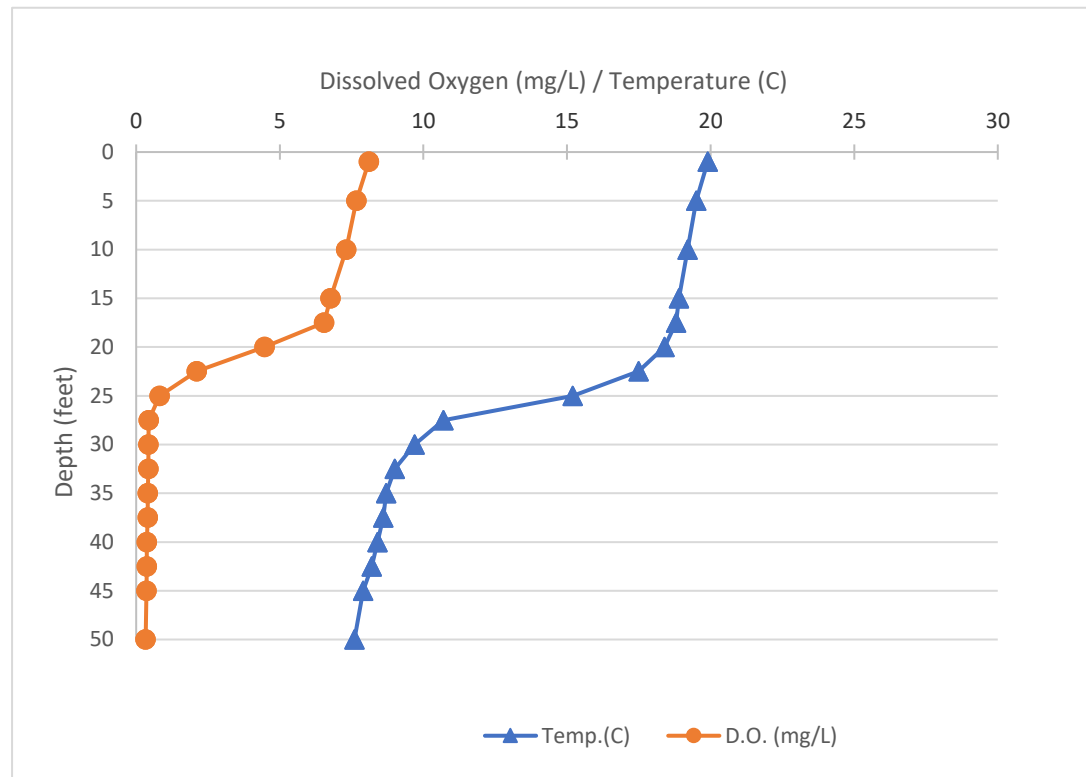
Name: Crockery Lake
 County: Ottawa
 Site ID: 700422
 Date: 10/1/2019

Dissolved Oxygen and Temperature Profile

Depth (ft)	Temp.(C)	D.O. (mg/L)
1	19.9	8.1
1	19.9	8.1
5	19.5	7.67
5	19.5	7.67
10	19.2	7.31
10	19.2	7.31
15	18.9	6.76
15	18.9	6.76
17.5	18.8	6.54
17.5	18.8	6.54
20	18.4	4.47
20	18.4	4.47
22.5	17.5	2.11
22.5	17.5	2.11
25	15.2	0.82
25	15.2	0.82
27.5	10.7	0.44
27.5	10.7	0.44
30	9.7	0.43
30	9.7	0.43
32.5	9	0.43
32.5	9	0.43
35	8.7	0.4
35	8.7	0.4
37.5	8.6	0.4
37.5	8.6	0.4
40	8.4	0.37
40	8.4	0.37
42.5	8.2	0.37
42.5	8.2	0.37
45	7.9	0.36
45	7.9	0.36
50	7.6	0.33
50	7.6	0.33
