2019 Data Report for Deer Lake, Oakland County

Site ID: 631128

Deer Lake, Oakland County 2019 CLMP Results

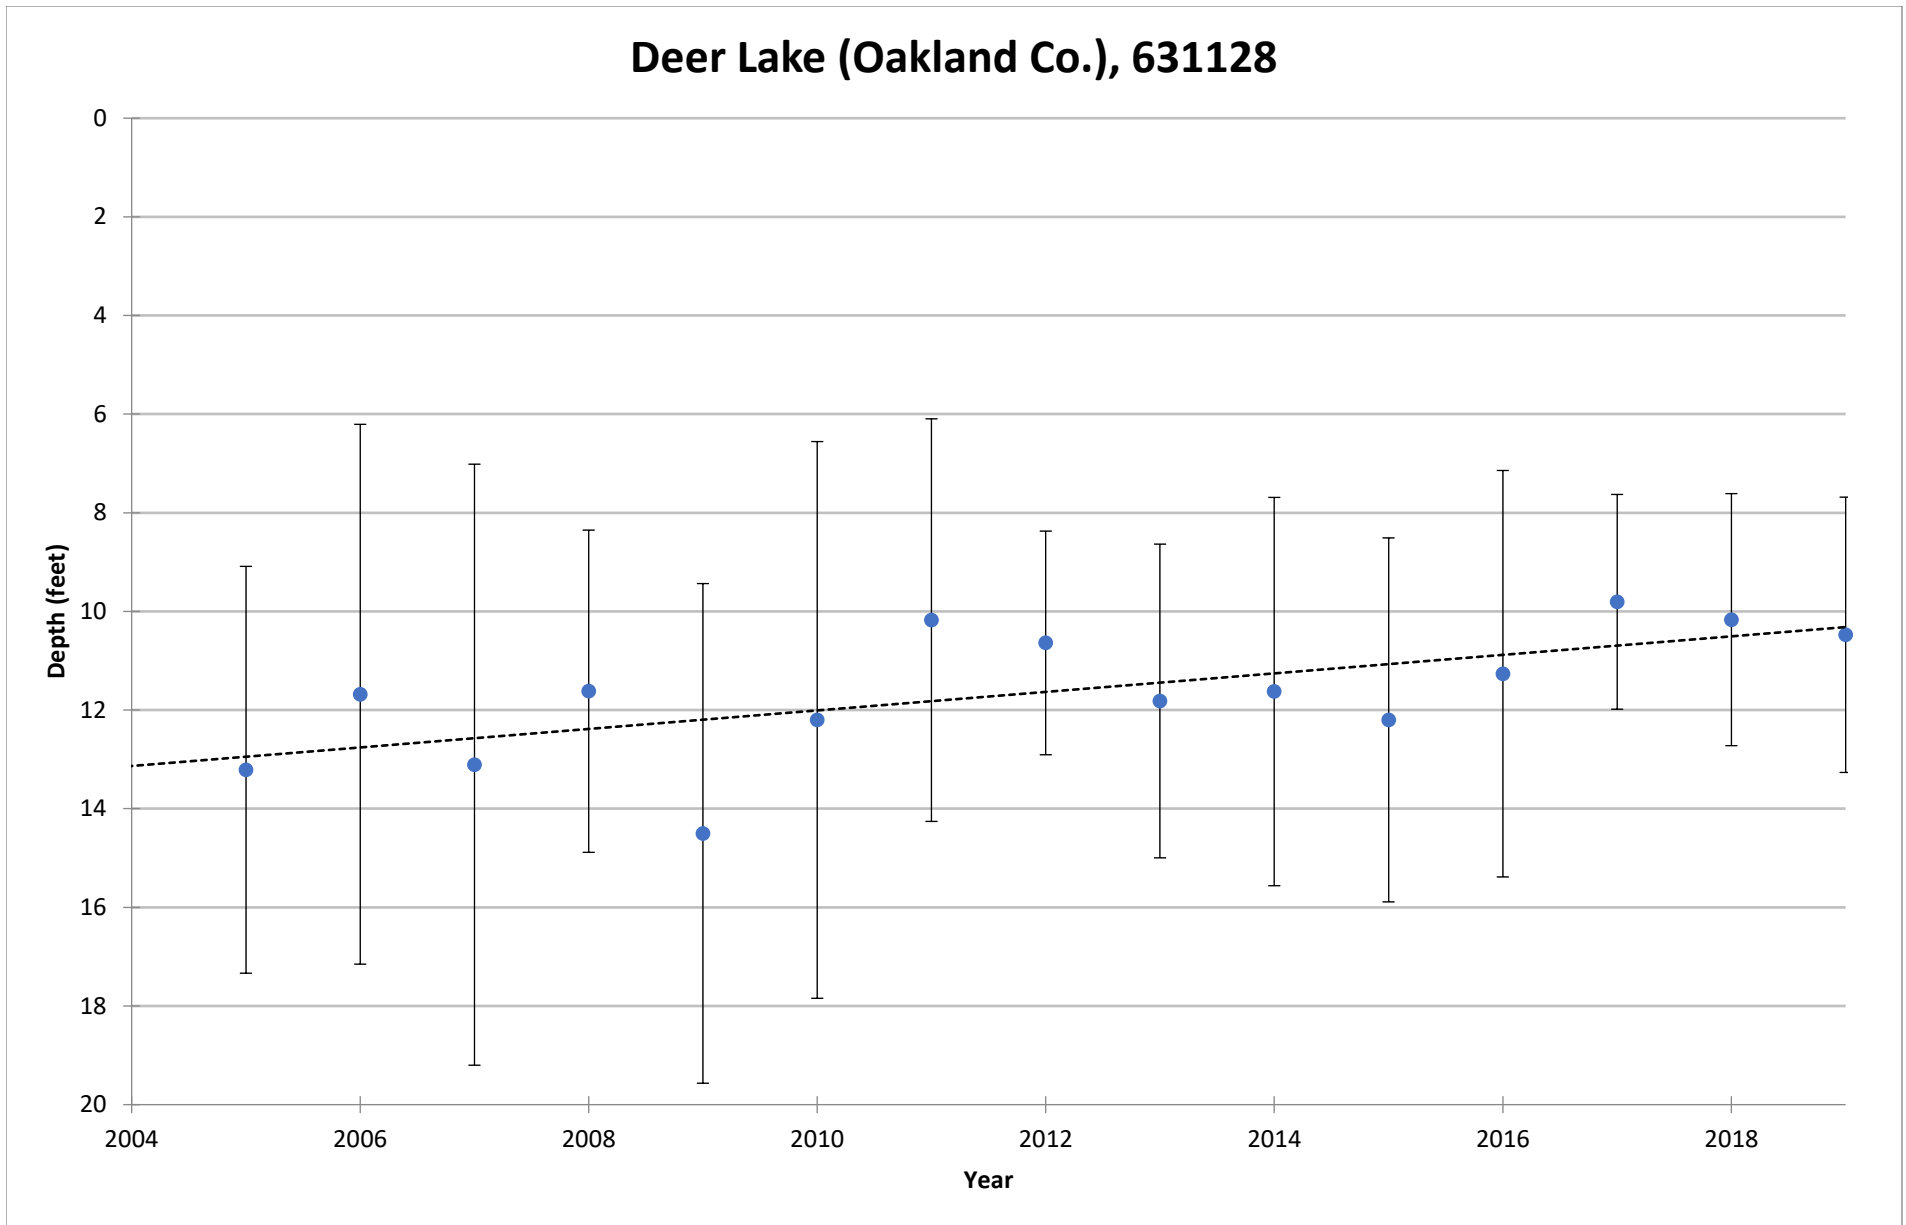
COOPERATIVE LAKES MONITORING PROGRAM
SUMMER MEAN TRANSPARENCY

Deer Lake (Oakland Co.), 631128

Vertical bars indicate standard deviation

Long term monitoring shows slight upward slopes on all of the parameters, indicating a very slow movement toward higher nutrient levels in the lake. This shift in trends is largely due to 2019 results, which were quite a bit higher than normal.

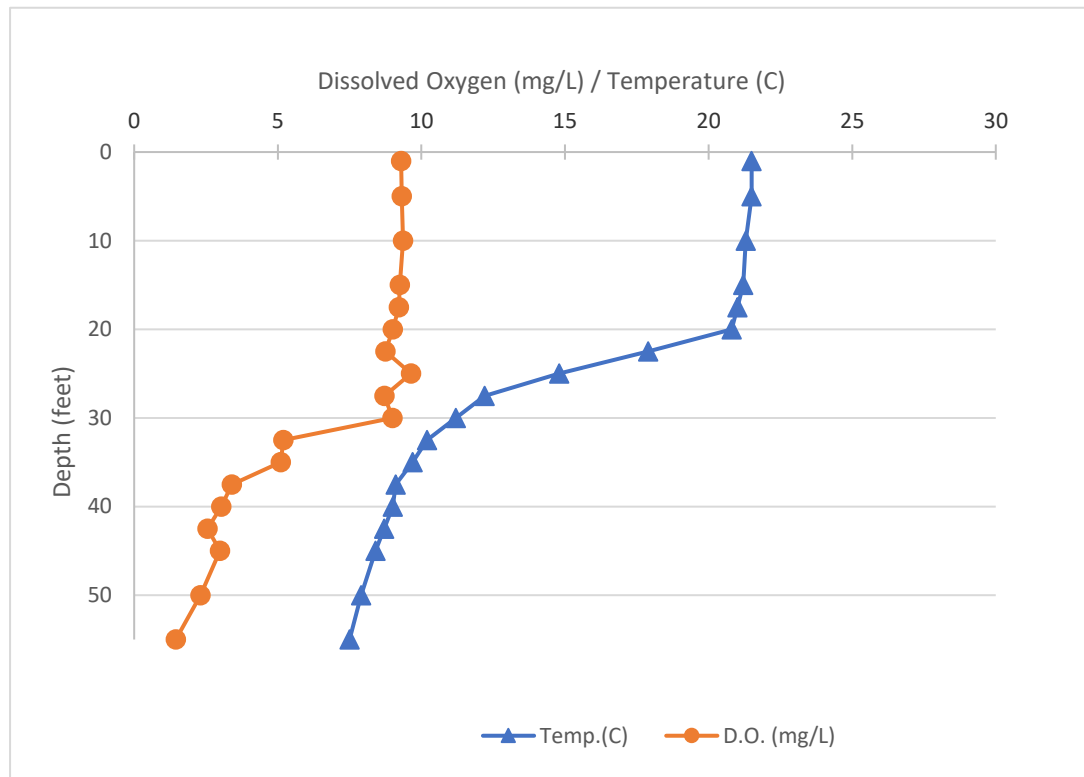
Dissolved Oxygen and Temperature Profile

Name: Deer Lake
 County: Oakland
 Site ID: 631128
 Date: 9/14/2019

Depth (ft)	Temp.(C)	D.O. (mg/L)
1	21.5	9.3
5	21.5	9.32
10	21.3	9.36
15	21.2	9.25
17.5	21	9.22
20	20.8	9
22.5	17.9	8.75
25	14.8	9.64
27.5	12.2	8.72
30	11.2	8.99
32.5	10.2	5.19
35	9.7	5.11
37.5	9.1	3.4
40	9	3.03
42.5	8.7	2.55
45	8.4	2.99
50	7.9	2.31
55	7.5	1.45

The lake is able to maintain dissolved oxygen throughout the most of the water column for the entire summer, though dissolved oxygen gets low or anoxic on the very bottom waters.
