2019 Data Report for Lake Lancer, Gladwin County

Site ID: 260116

Lake Lancer, Gladwin County 2019 CLMP Results

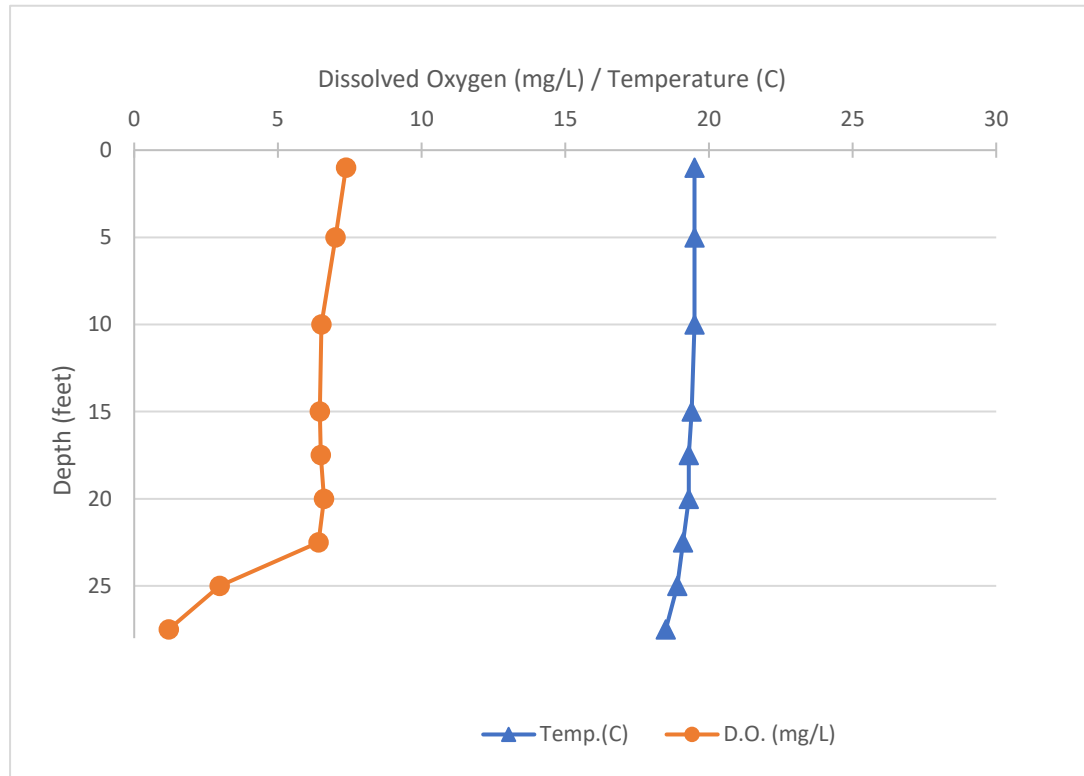
Name: Lake Lancer
County: Gladwin
Site ID: 260116
Date: 9/9/2019

Dissolved Oxygen and Temperature Profile

| Depth (ft) | Temp.(C) | D.O. (mg/L) |
