2019 Data Report for Oneida Lake, Livingston County

Site ID: 470573

Oneida Lake, Livingston County 2019 CLMP Results

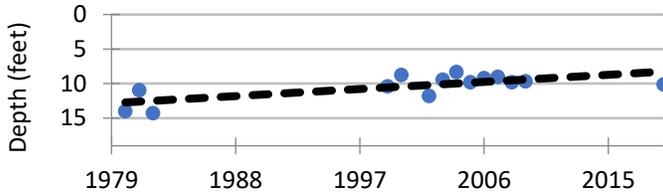
Secchi Disk Transparency (feet)

Year	# Readings	Min	Max	Average	Std. Dev	Carlson TSI
2019	14	7.5	32.0	10.1	6.3	44
1980-2009	228	4.0	20.5	10.4	2.2	44
2019 All CLMP Lakes	3392	1.5	50.0	12.8	5.8	42

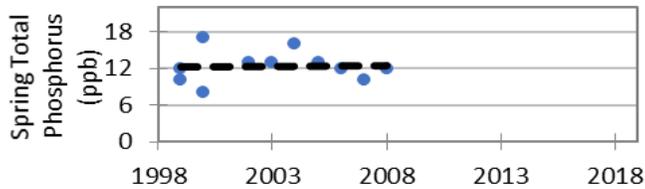
Spring Phosphorus (parts per billion)

Year	# Samples	Min	Max	Average	Std. Dev
2008	1	12.0	12.0	12.0	NA
2003-2007	5	10.0	16.0	12.8	2.2
1999-2002	5	8.0	17.0	12.0	3.4
2019 All CLMP Lakes	220	<= 3	100.0	14.9	11.0

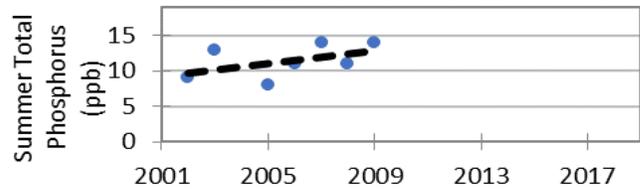
Summer Phosphorus (parts per billion)

Year	# Samples	Min	Max	Average	Std. Dev	Carlson TSI
2009	1	14.0	14.0	14.0	NA	42
2004-2008	4	8.0	14.0	11.0	2.4	38
2002-2003	2	9.0	13.0	11.0	2.8	39
2019 All CLMP Lakes	281	<= 3	65.0	12.8	9.3	38

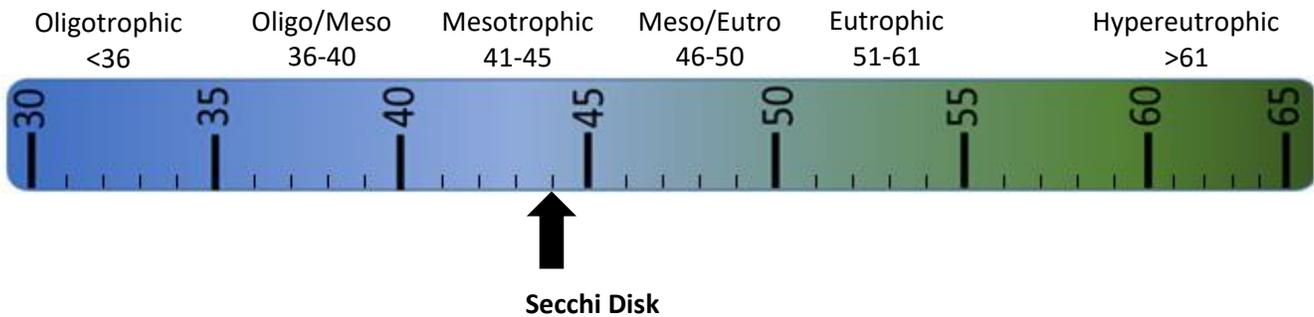
TSI for Oneida Lake in 2019	
Average	
Secchi Disk	44
Summer TP	
Chlorophyll-a

With a TSI score of 44 based on 2019 Secchi transparency, this lake is rated as a mesotrophic lake.

In 1977, limnologist Dr. Robert Carlson developed a numerical scale (0-100) where the numbers indicate the level of nutrient enrichment. Using the proper equations, we can convert results from Summer Total Phosphorus, Secchi Depth, and Chlorophyll-a to this Trophic Status Index (TSI). The TSI numbers are furthermore grouped into general categories (oligotrophic, mesotrophic, eutrophic, and hypereutrophic), to quickly give us a way to understand the general nutrient level of any lake.

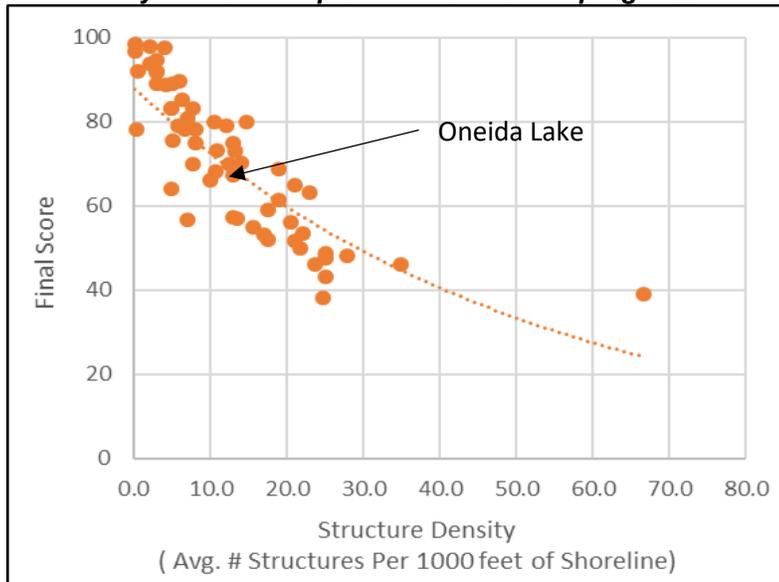
How does your lake compare to others in the program?

Oneida Lake:	
Number of Sections:	7
Number of Structures:	93
Structure Density:	13
Final Score:	67

All 62 Participating Lakes from 2015-2019:	
Avg. Number of Sections:	16
Avg. Number of Structures:	228
Avg. Structure Density:	12.6
Avg. Final Score:	71

Overall, the lakeshore habitat of Oneida Lake right around average when compared to other lakes in the program. All of the 1000 foot sections scored either Fair or Good: 6 fair, and 1 good.

The lake sections scored highest for erosion control, with an average of 91, meaning that there are a low amount of sea walls, rock rip-rap, and other shoreline erosion structures.

The littoral zone and riparian zone were the weak points in Oneida Lake's habitat (scoring an average of 57 and 56, respectively). To improve the littoral zone score, leave woody debris in place and allow native aquatic vegetation to grow in the shallow waters. Reduce the amount of mowed grass and increase the amount of unmowed native vegetation along the lakeshore to boost the riparian aspect of the shoreline habitat.

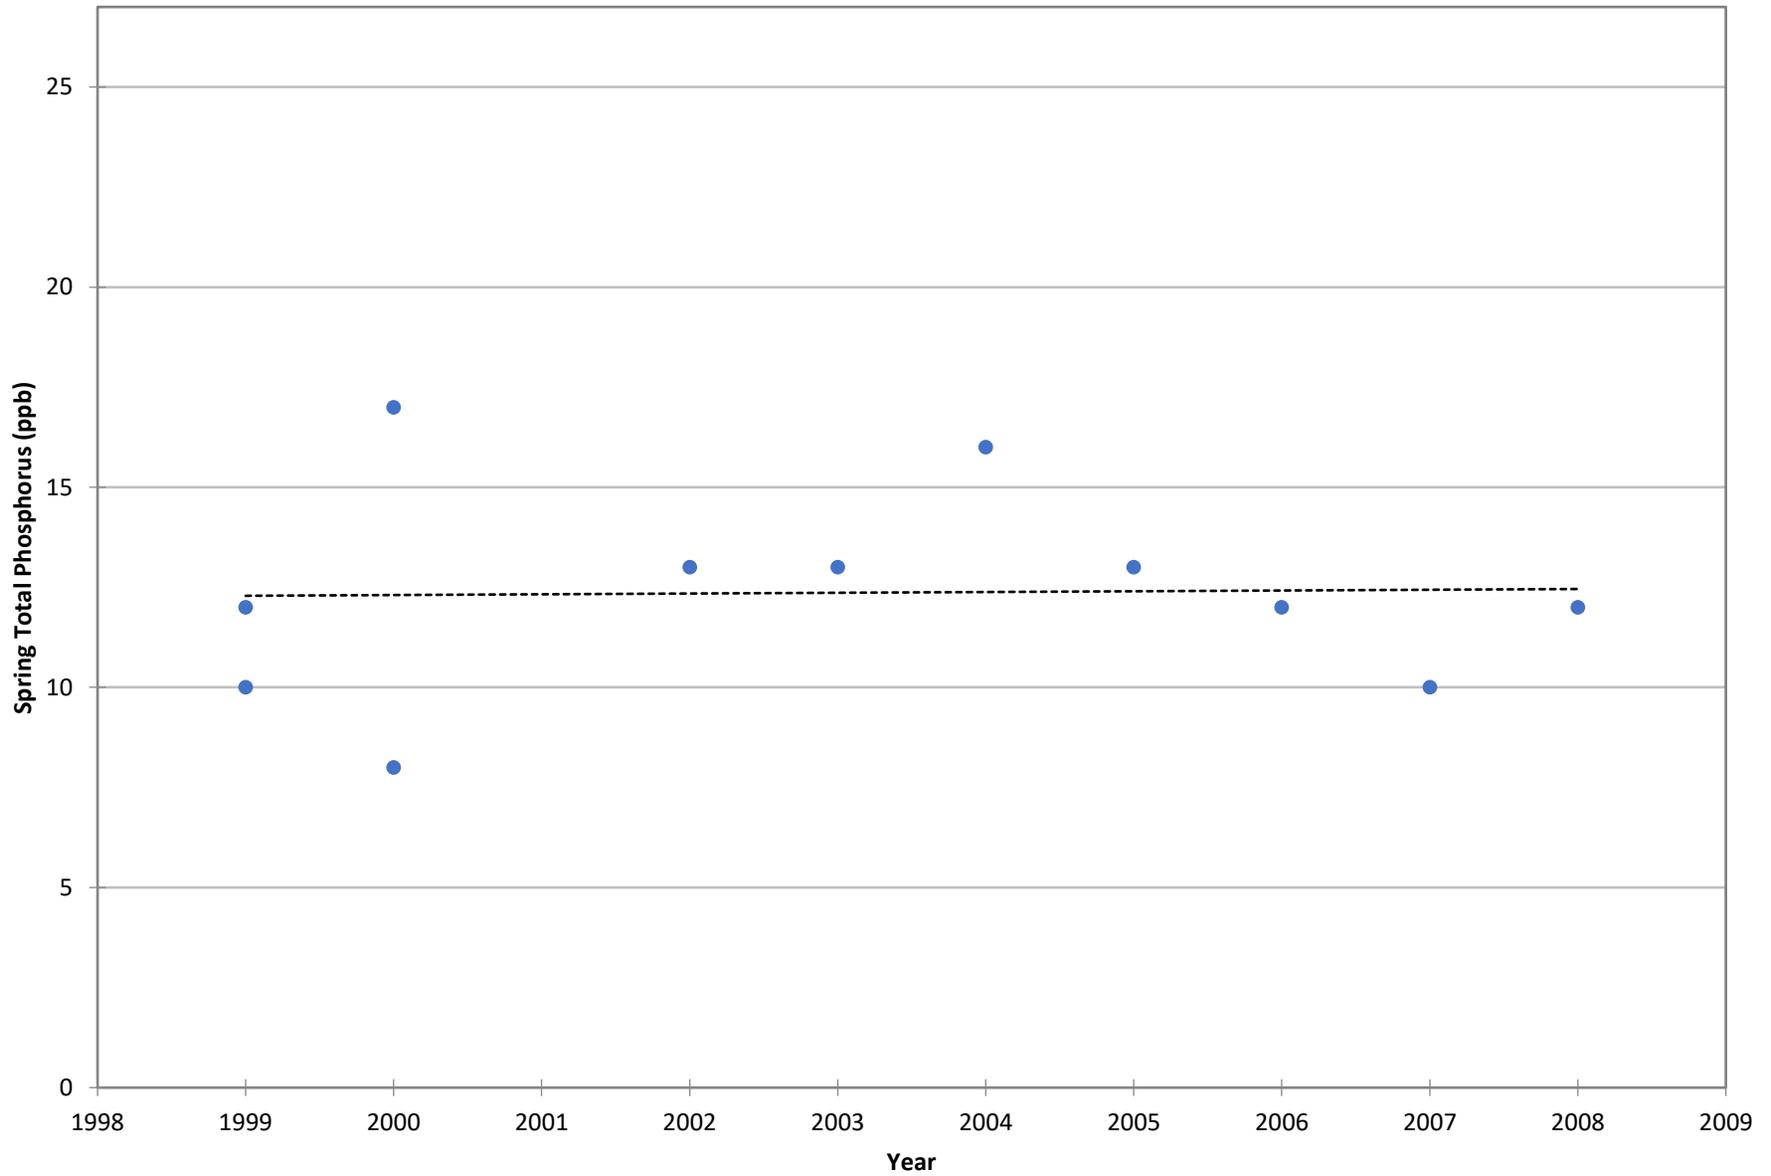
COOPERATIVE LAKES MONITORING PROGRAM
SPRING TOTAL PHOSPHORUS

While the data record is spotty, long term monitoring shows slight upward slopes on all of the parameters, indicating a very slow movement toward higher nutrient levels in the lake.

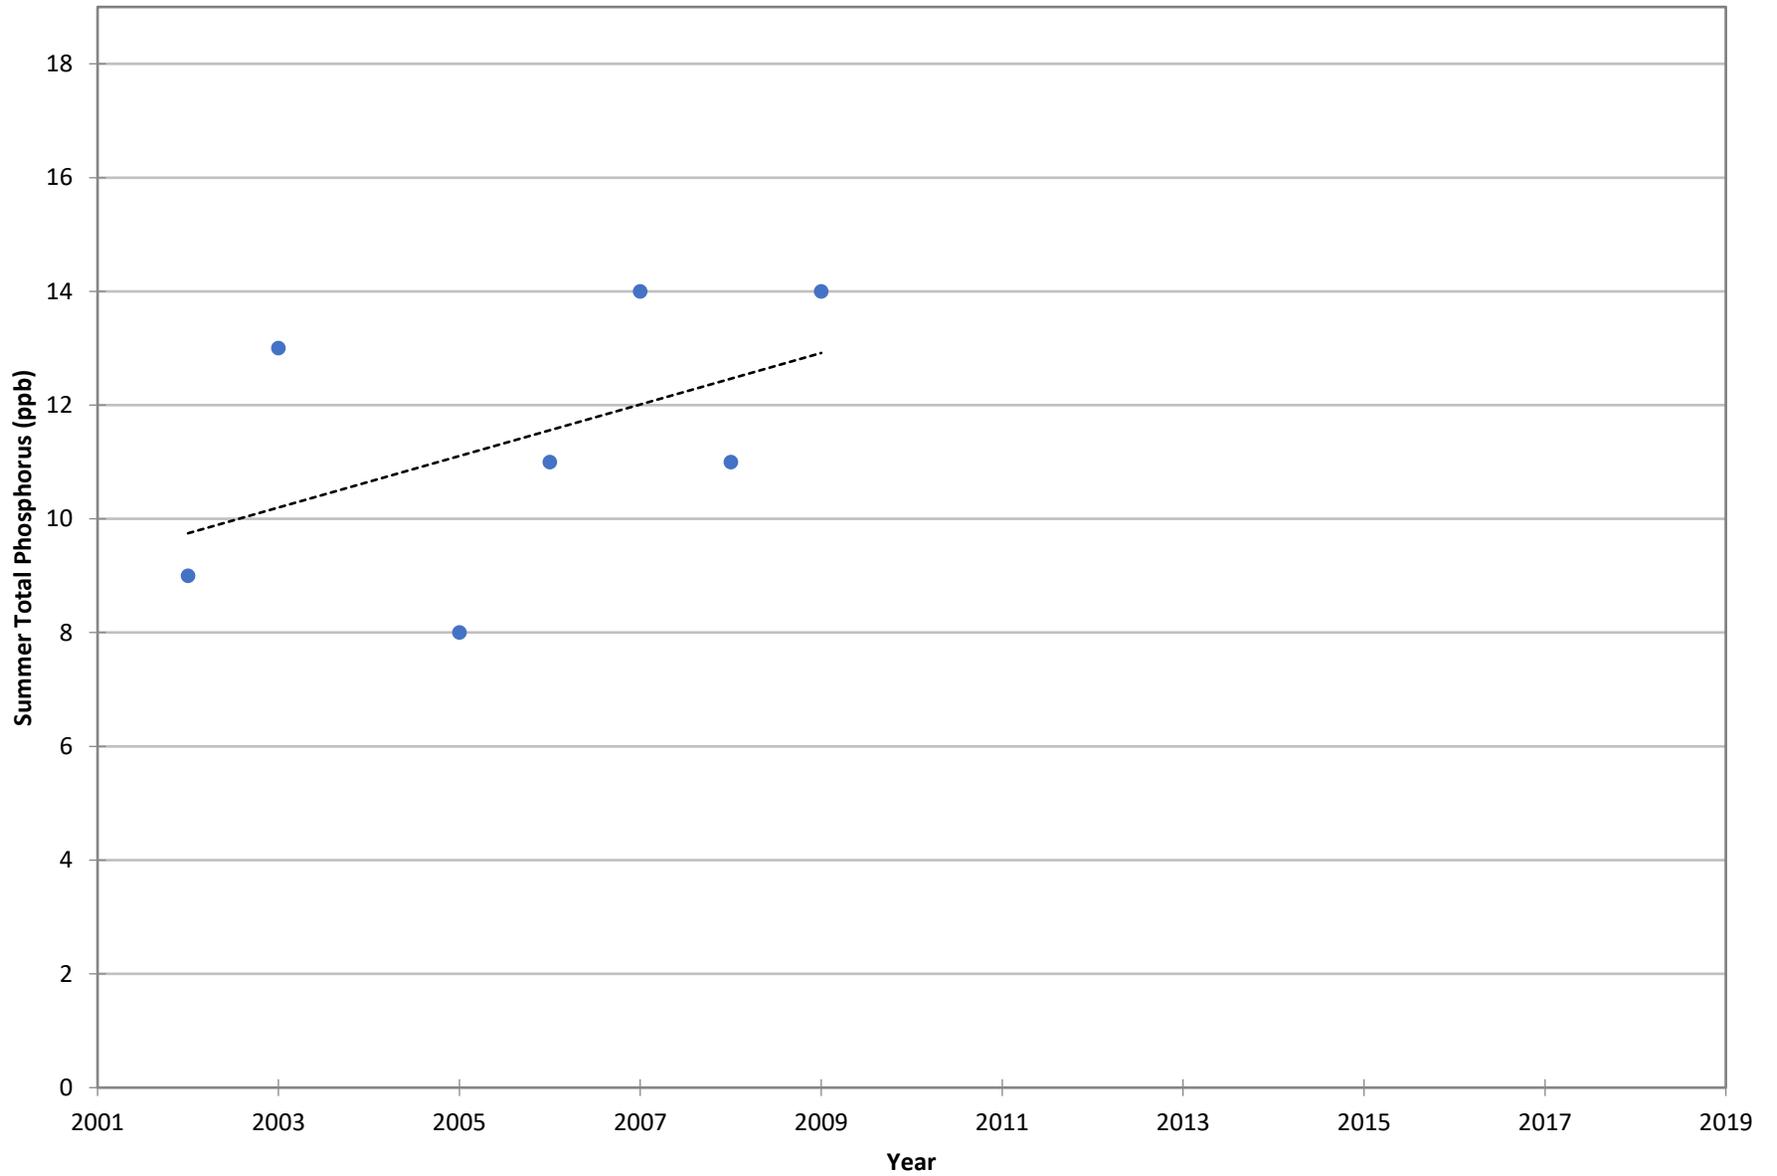
COOPERATIVE LAKES MONITORING PROGRAM
SUMMER TOTAL PHOSPHORUS

Vertical bars indicate standard deviation
