2019 Data Report for Otter Lake, Oakland County

Site ID: 631193

Otter Lake, Oakland County 2019 CLMP Results

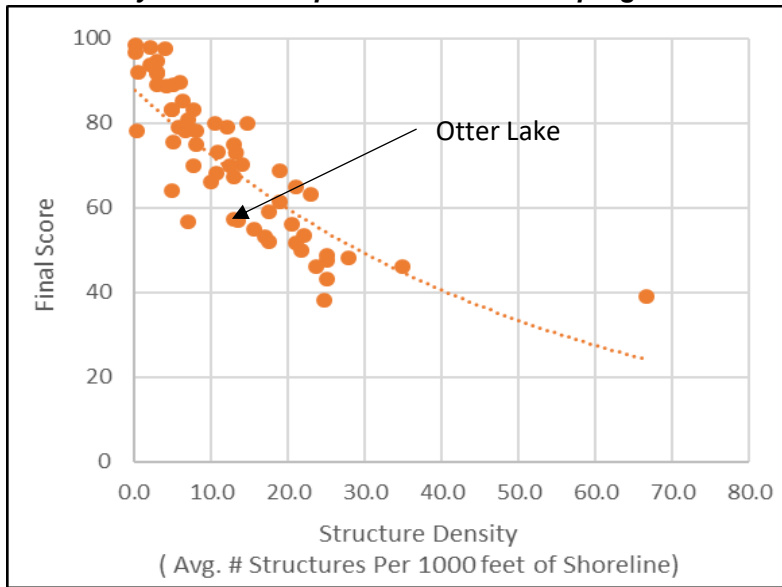
How does your lake compare to others in the program?

Otter Lake:	
Number of Sections:	26
Number of Structures:	57
Structure Density:	13
Final Score:	57

All 62 Participating Lakes from 2015-2019:	
Avg. Number of Sections:	16
Avg. Number of Structures:	228
Avg. Structure Density:	12.6
Avg. Final Score:	71

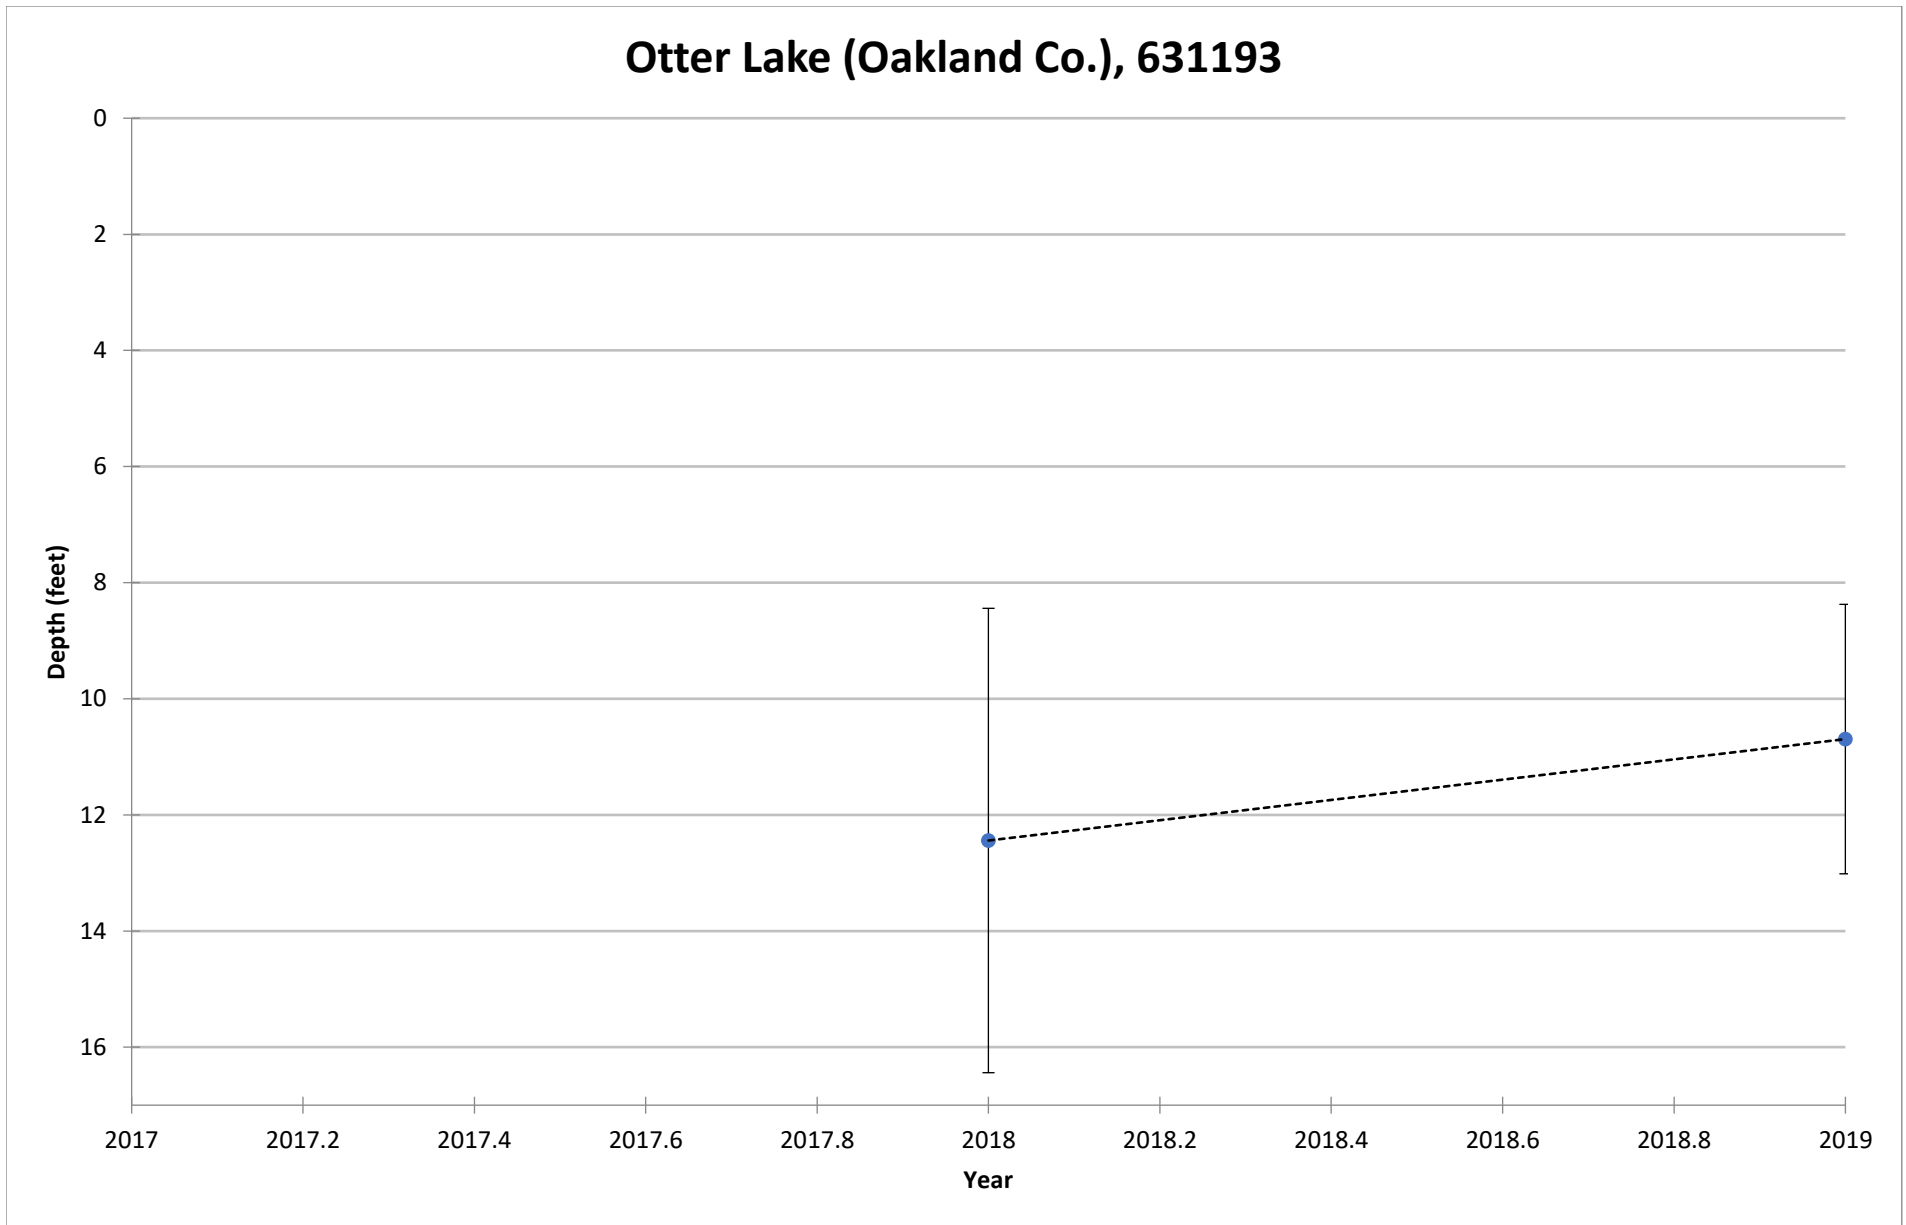
Otter Lake (Oakland Co.), 631193

COOPERATIVE LAKES MONITORING PROGRAM
SUMMER MEAN TRANSPARENCY

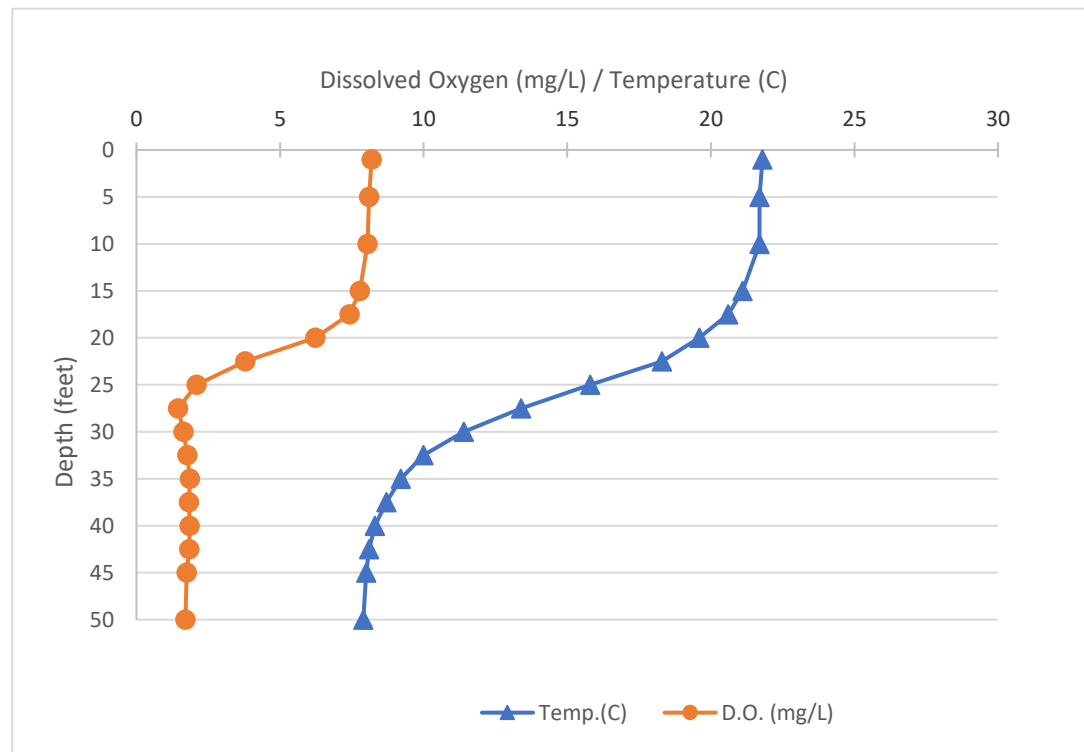
9/16/2019

Dissolved Oxygen and Temperature Profile

Depth (ft)	Temp.(C)	D.O. (mg/L)
1	21.8	8.19
5	21.7	8.1
10	21.7	8.05
15	21.1	7.78
17.5	20.6	7.42
20	19.6	6.23
22.5	18.3	3.79
25	15.8	2.1
27.5	13.4	1.45
30	11.4	1.64
32.5	10	1.77
35	9.2	1.86
37.5	8.7	1.83
40	8.3	1.85
42.5	8.1	1.84
45	8	1.75
50	7.9	1.71
