# 2019 Data Report for Platte Lake, Benzie County

Site ID: 100086

# Platte Lake, Benzie County 2019 CLMP Results

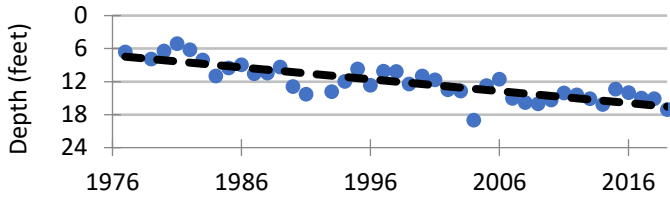
## Secchi Disk Transparency (feet)

Year	# Readings	Min	Max	Average	Std. Dev	Carlson TSI
2019	8	11.0	21.5	17.1	4.5	36
2014-2018	91	9.0	24.0	17.1	3.5	38
1977-2013	691	2.5	29.0	11.6	3.2	42
2019 All CLMP Lakes	3392	1.5	50.0	12.8	5.8	42

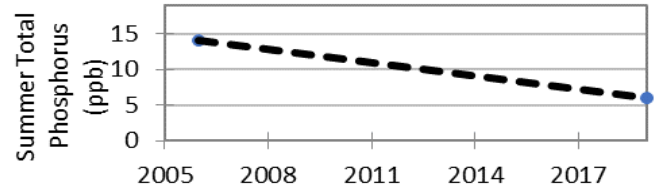
## Summer Phosphorus (parts per billion)

Year	# Samples	Min	Max	Average	Std. Dev	Carlson TSI
2019	1	6.0	6.0	6.0	NA	30
2006	1	14.0	14.0	14.0	NA	42
2019 All CLMP Lakes	281	<= 3	65.0	12.8	9.3	38

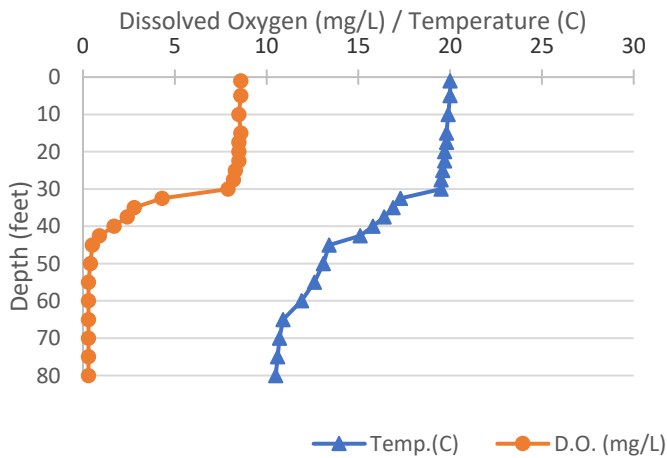
## Dissolved Oxygen and Temperature Profile 9/5/2019

The lake keeps some dissolved oxygen in the bottom waters through mid-summer, but by late summer the lake has stratified and the bottom water is devoid of oxygen.

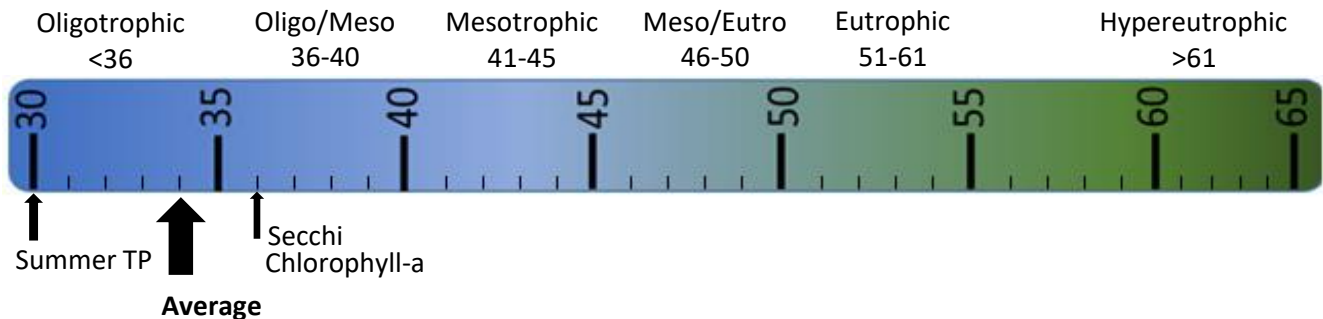
TSI for Platte Lake in 2019	
Average	34
Secchi Disk	36
Summer TP	30
Chlorophyll-a	36

In 1977, limnologist Dr. Robert Carlson developed a numerical scale (0-100) where the numbers indicate the level of nutrient enrichment. Using the proper equations, we can convert results from Summer Total Phosphorus, Secchi Depth, and Chlorophyll-a to this Trophic Status Index (TSI). The TSI numbers are furthermore grouped into general categories (oligotrophic, mesotrophic, eutrophic, and hypereutrophic), to quickly give us a way to understand the general nutrient level of any lake.

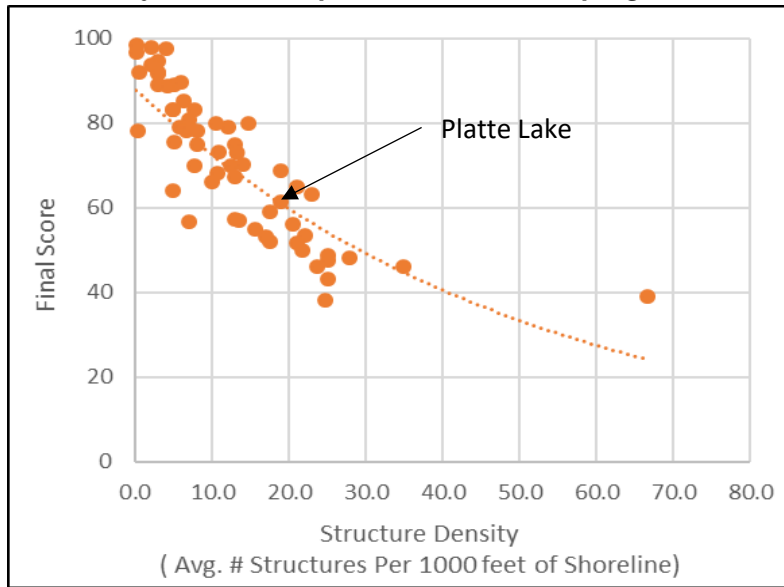
### How does your lake compare to others in the program?

Platte Lake:	
Number of Sections:	47
Number of Structures:	874
Structure Density:	19
Final Score:	61

All 62 Participating Lakes from 2015-2019:	
Avg. Number of Sections:	16
Avg. Number of Structures:	228
Avg. Structure Density:	12.6
Avg. Final Score:	71

Overall, the lakeshore habitat of Platte Lake is slightly below average when compared to the other lakes in the program. The shorelines reaches were rated between poor through good, with the vast majority rated as fair. (8 poor, 34 fair, 5 good).

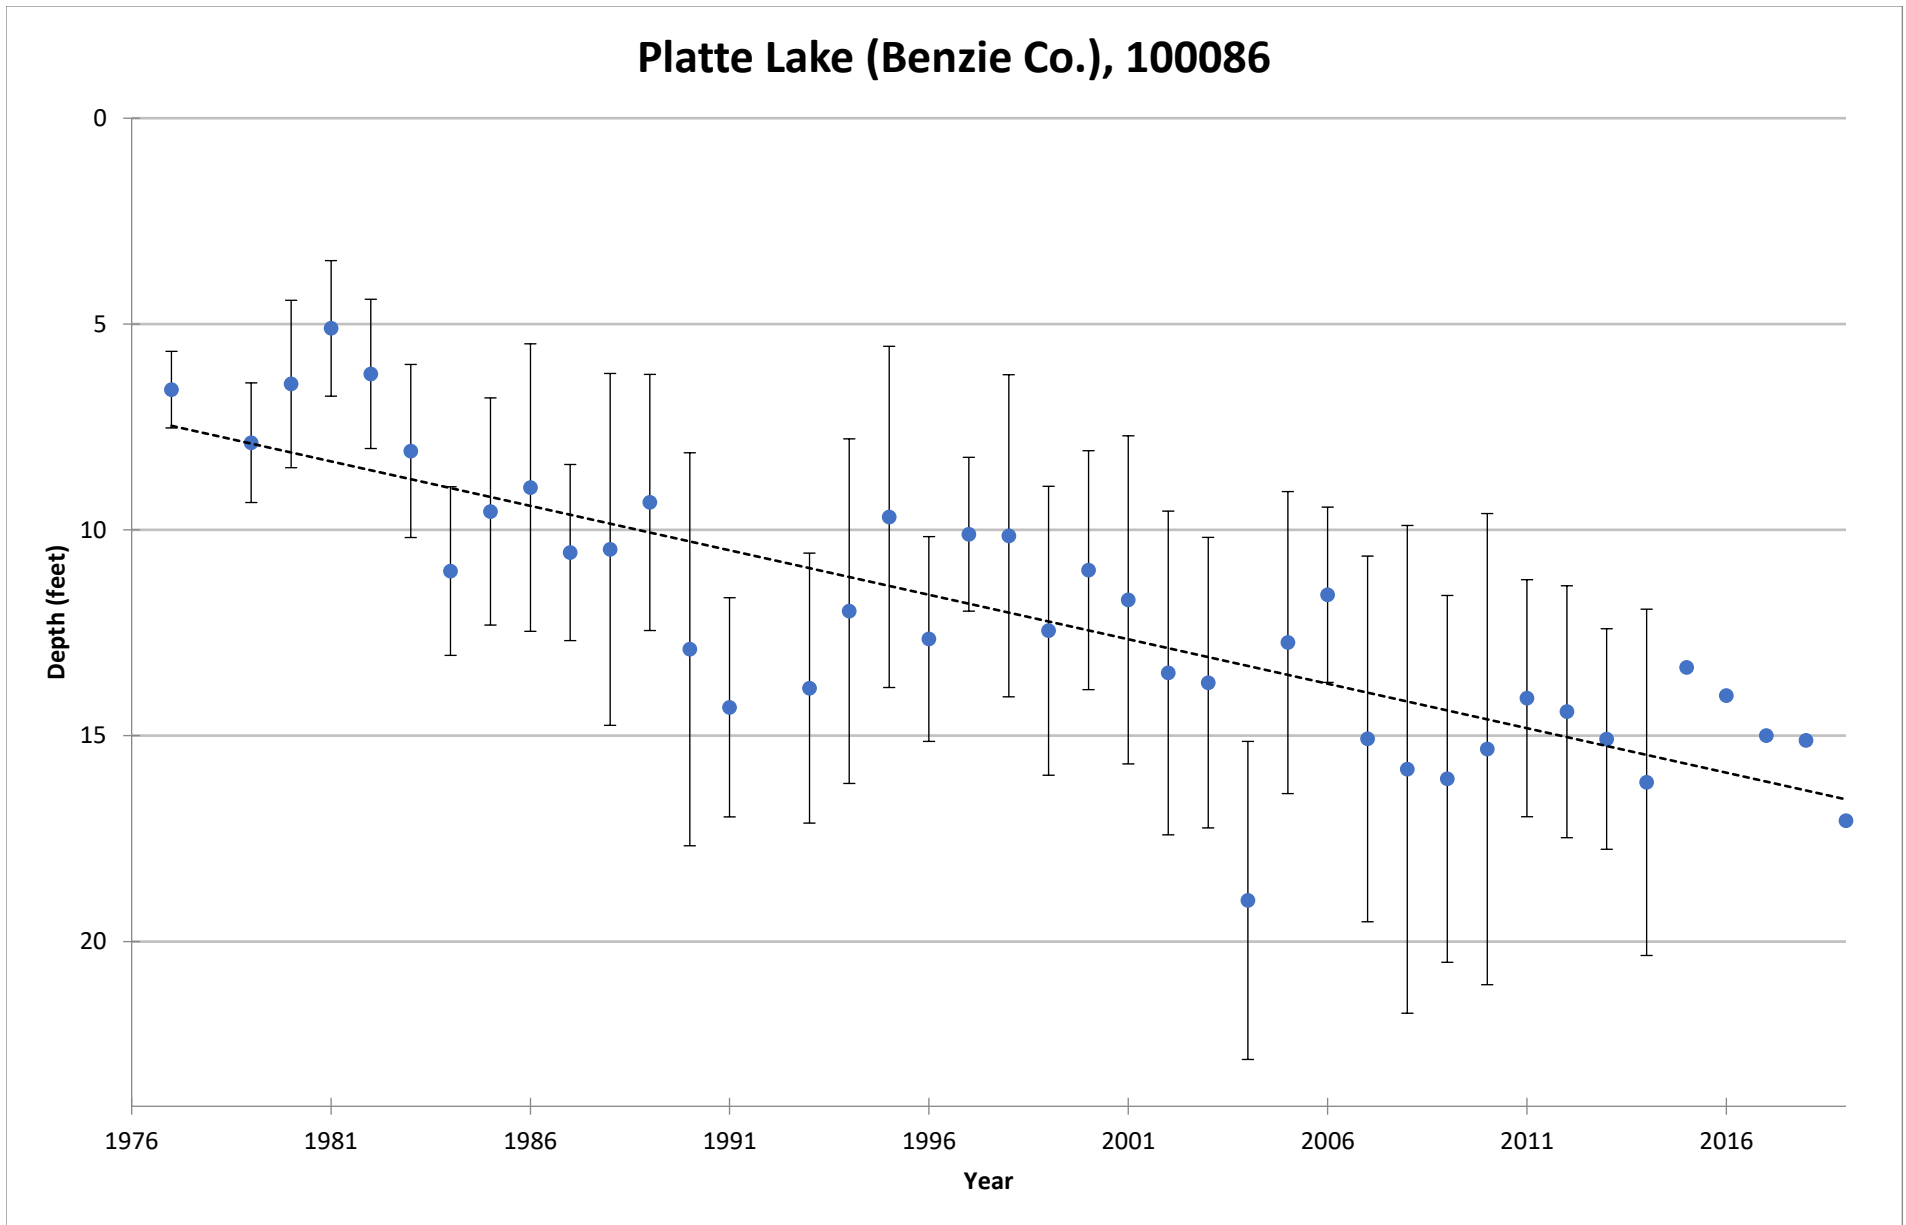
COOPERATIVE LAKES MONITORING PROGRAM  
SUMMER MEAN TRANSPARENCY

**Platte Lake (Benzie Co.), 100086**

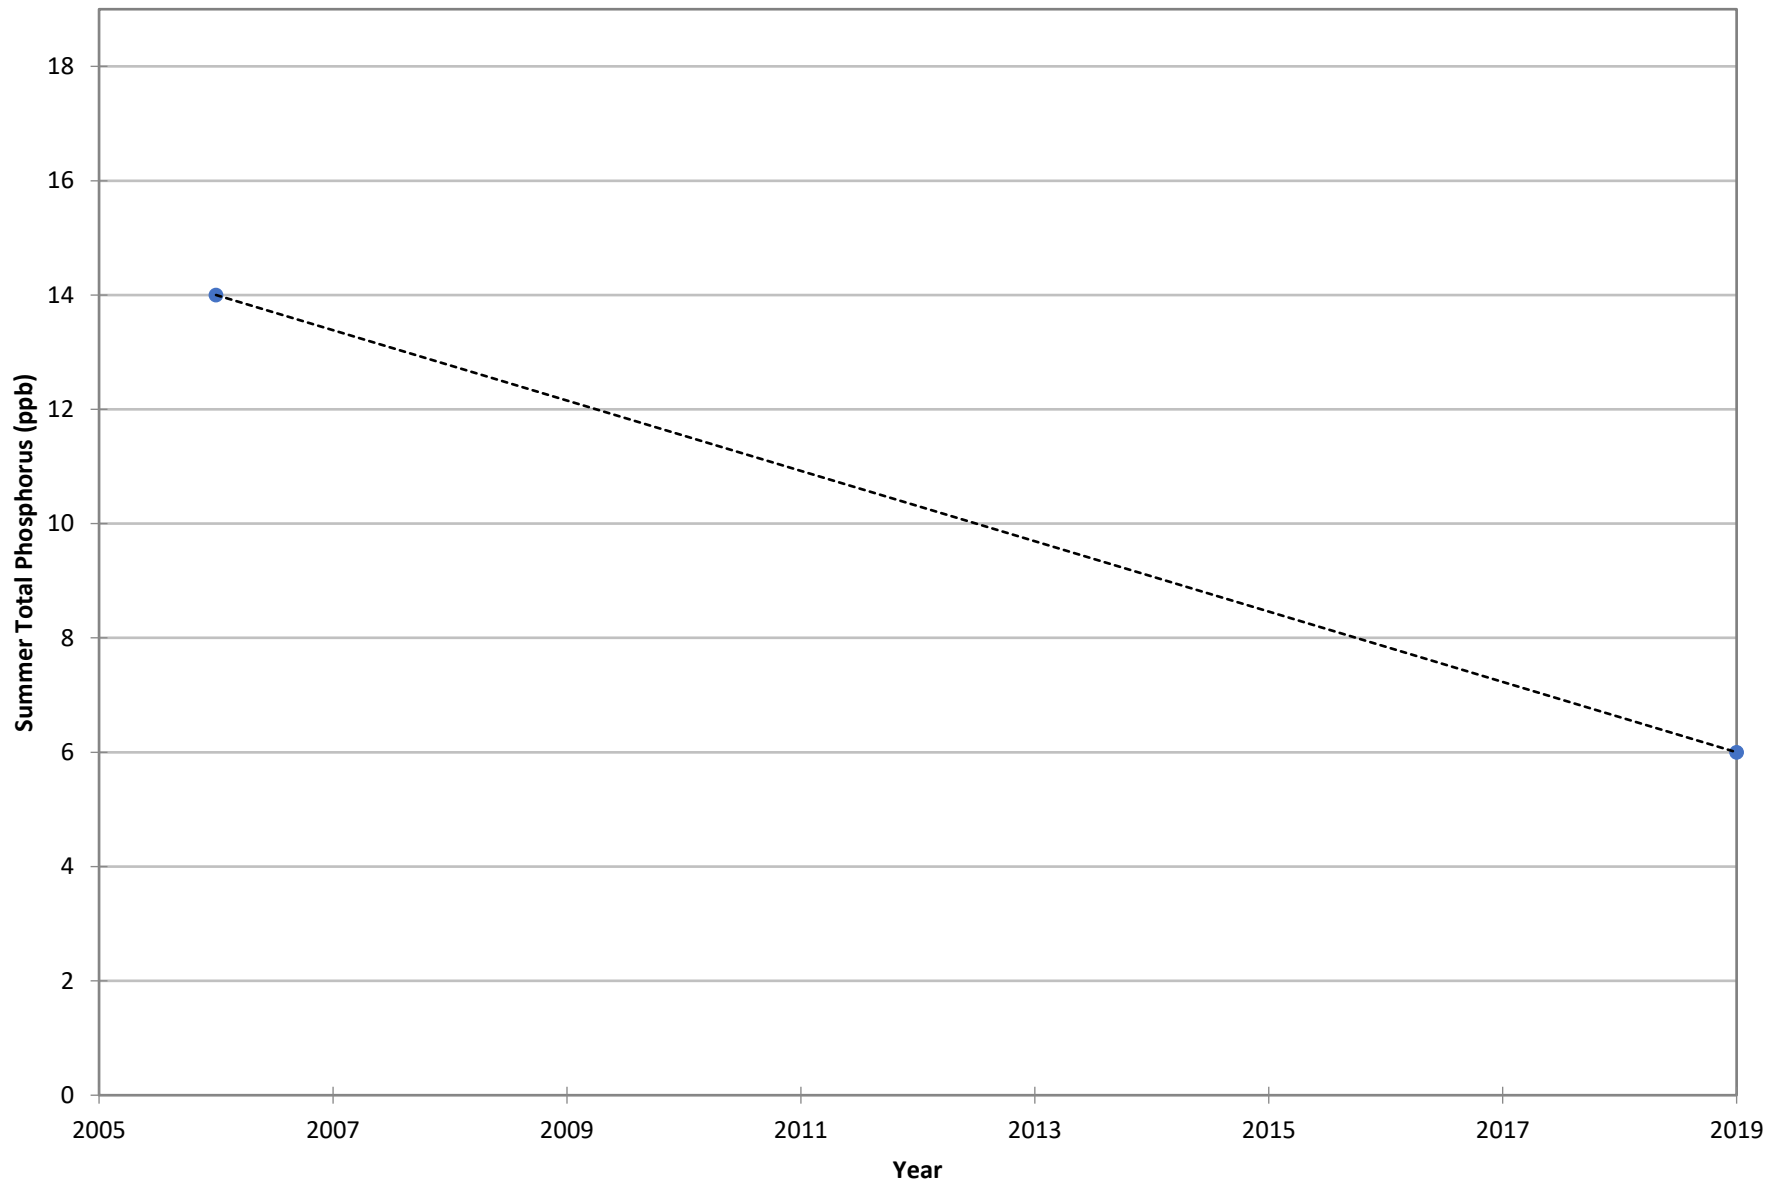
COOPERATIVE LAKES MONITORING PROGRAM  
SUMMER TOTAL PHOSPHORUS

Vertical bars indicate standard deviation

**Platte Lake (Benzie Co.), 100086**

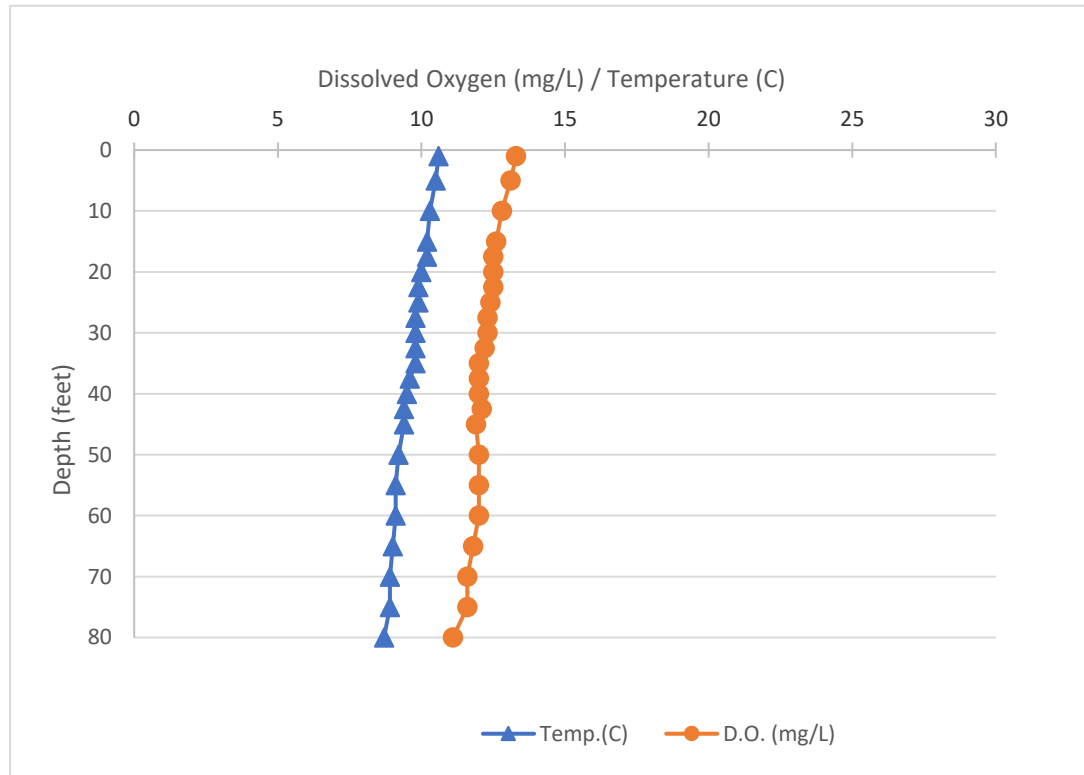
**5/14/2019**

Depth (ft)	Temp.(C)	D.O. (mg/L)
1	10.6	13.3
5	10.5	13.1
10	10.3	12.8
15	10.2	12.6
17.5	10.2	12.5
20	10	12.5
22.5	9.9	12.5
25	9.9	12.4
27.5	9.8	12.3
30	9.8	12.3
32.5	9.8	12.2
35	9.8	12
37.5	9.6	12
40	9.5	12
42.5	9.4	12.1
45	9.4	11.9
50	9.2	12
55	9.1	12
60	9.1	12
65	9	11.8
70	8.9	11.6
75	8.9	11.6
80	8.7	11.1

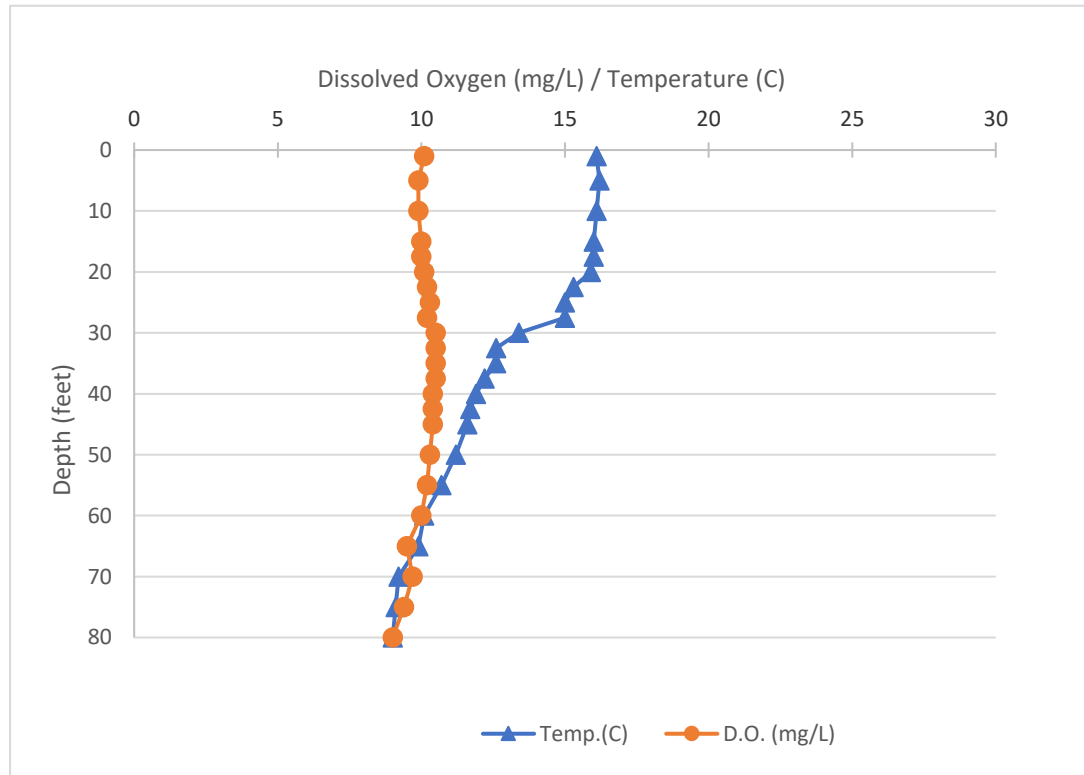
**5/31/2019**

Depth (ft)	Temp.(C)	D.O. (mg/L)
1	16.1	10.1
5	16.2	9.9
10	16.1	9.9
15	16	10
17.5	16	10
20	15.9	10.1
22.5	15.3	10.2
25	15	10.3
27.5	15	10.2
30	13.4	10.5
32.5	12.6	10.5
35	12.6	10.5
37.5	12.2	10.5
40	11.9	10.4
42.5	11.7	10.4
45	11.6	10.4
50	11.2	10.3
55	10.7	10.2
60	10.1	10
65	9.9	9.5
70	9.2	9.7
75	9.1	9.4
80	9	9

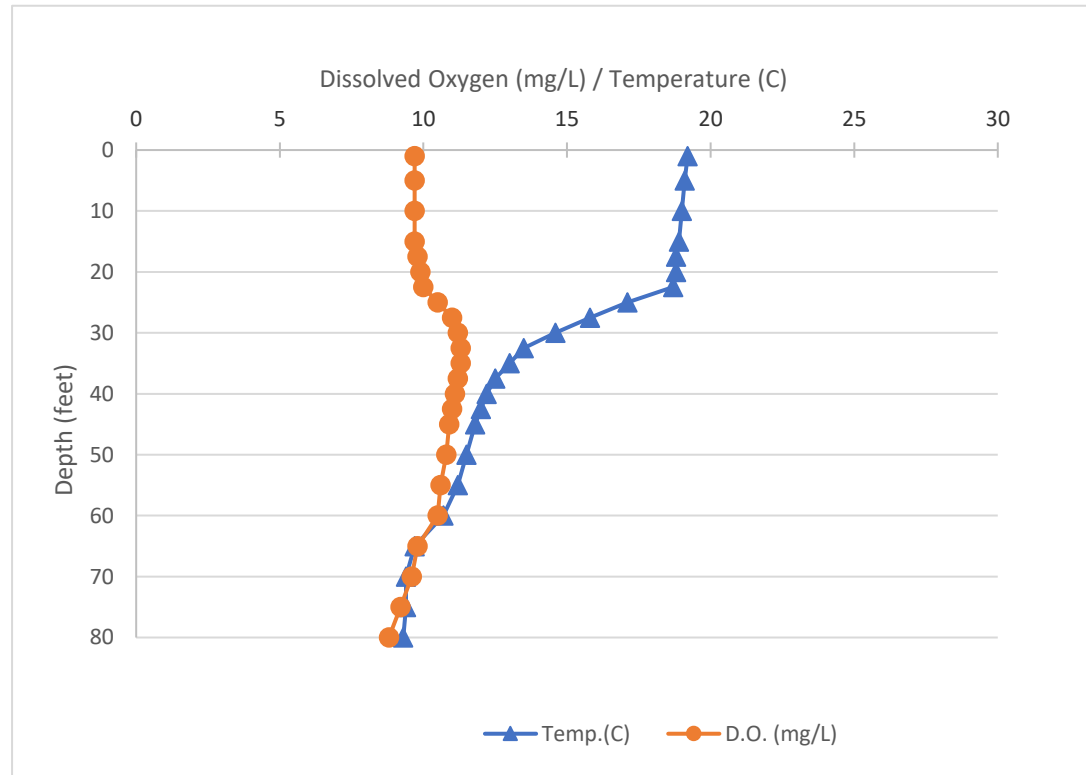
6/12/2019

Depth (ft)	Temp.(C)	D.O. (mg/L)
1	19.2	9.7
5	19.1	9.7
10	19	9.7
15	18.9	9.7
17.5	18.8	9.8
20	18.8	9.9
22.5	18.7	10
25	17.1	10.5
27.5	15.8	11
30	14.6	11.2
32.5	13.5	11.3
35	13	11.3
37.5	12.5	11.2
40	12.2	11.1
42.5	12	11
45	11.8	10.9
50	11.5	10.8
55	11.2	10.6
60	10.7	10.5
65	9.7	9.8
70	9.4	9.6
75	9.4	9.2
80	9.3	8.8

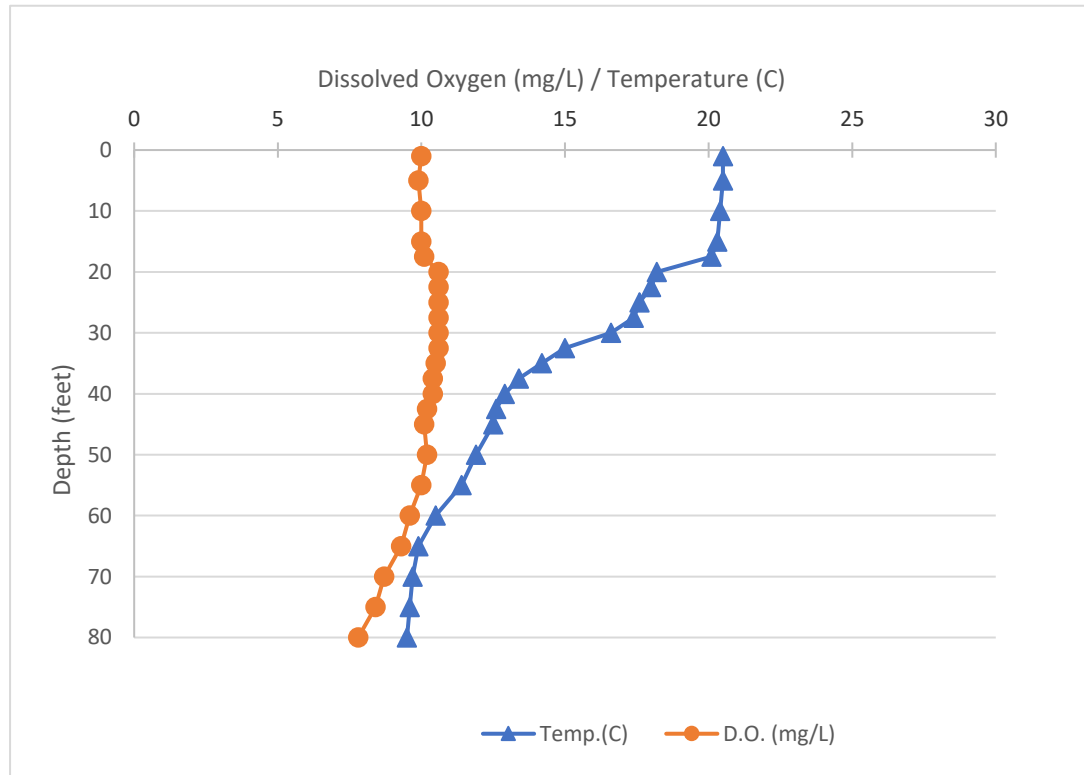
**6/25/2019**

Depth (ft)	Temp.(C)	D.O. (mg/L)
1	20.5	10
5	20.5	9.9
10	20.4	10
15	20.3	10
17.5	20.1	10.1
20	18.2	10.6
22.5	18	10.6
25	17.6	10.6
27.5	17.4	10.6
30	16.6	10.6
32.5	15	10.6
35	14.2	10.5
37.5	13.4	10.4
40	12.9	10.4
42.5	12.6	10.2
45	12.5	10.1
50	11.9	10.2
55	11.4	10
60	10.5	9.6
65	9.9	9.3
70	9.7	8.7
75	9.6	8.4
80	9.5	7.8

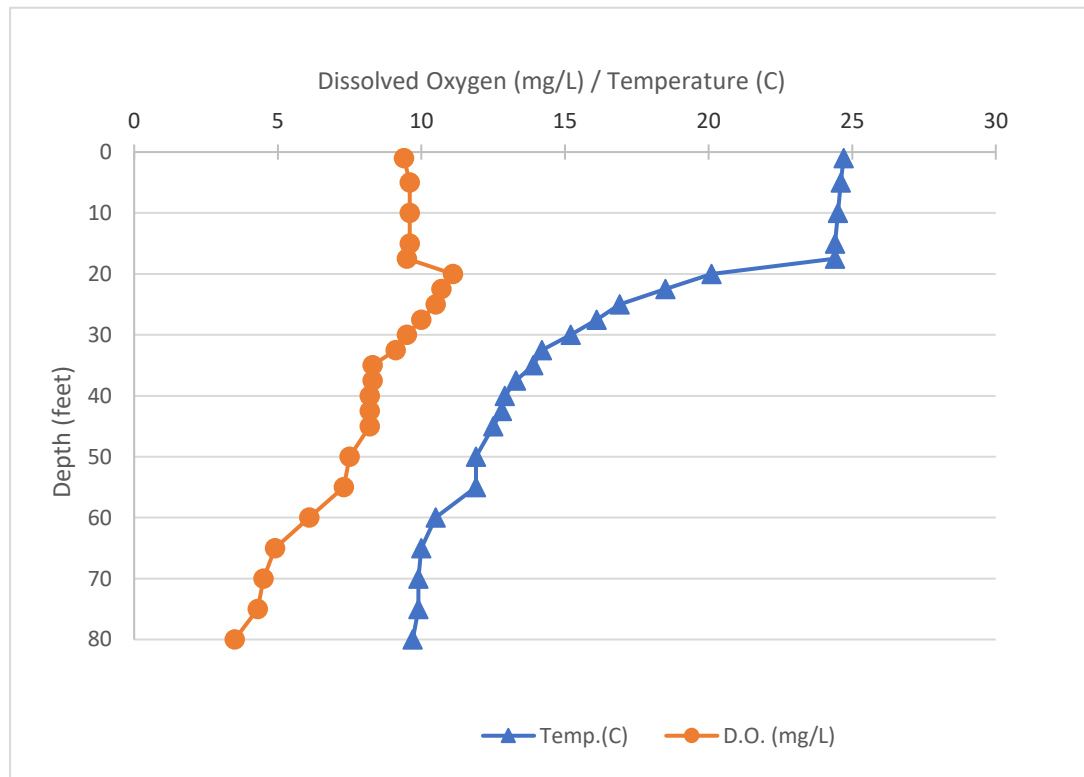
7/10/2019

Depth (ft)	Temp.(C)	D.O. (mg/L)
1	24.7	9.4
5	24.6	9.6
10	24.5	9.6
15	24.4	9.6
17.5	24.4	9.5
20	20.1	11.1
22.5	18.5	10.7
25	16.9	10.5
27.5	16.1	10
30	15.2	9.5
32.5	14.2	9.1
35	13.9	8.3
37.5	13.3	8.3
40	12.9	8.2
42.5	12.8	8.2
45	12.5	8.2
50	11.9	7.5
55	11.9	7.3
60	10.5	6.1
65	10	4.9
70	9.9	4.5
75	9.9	4.3
80	9.7	3.5

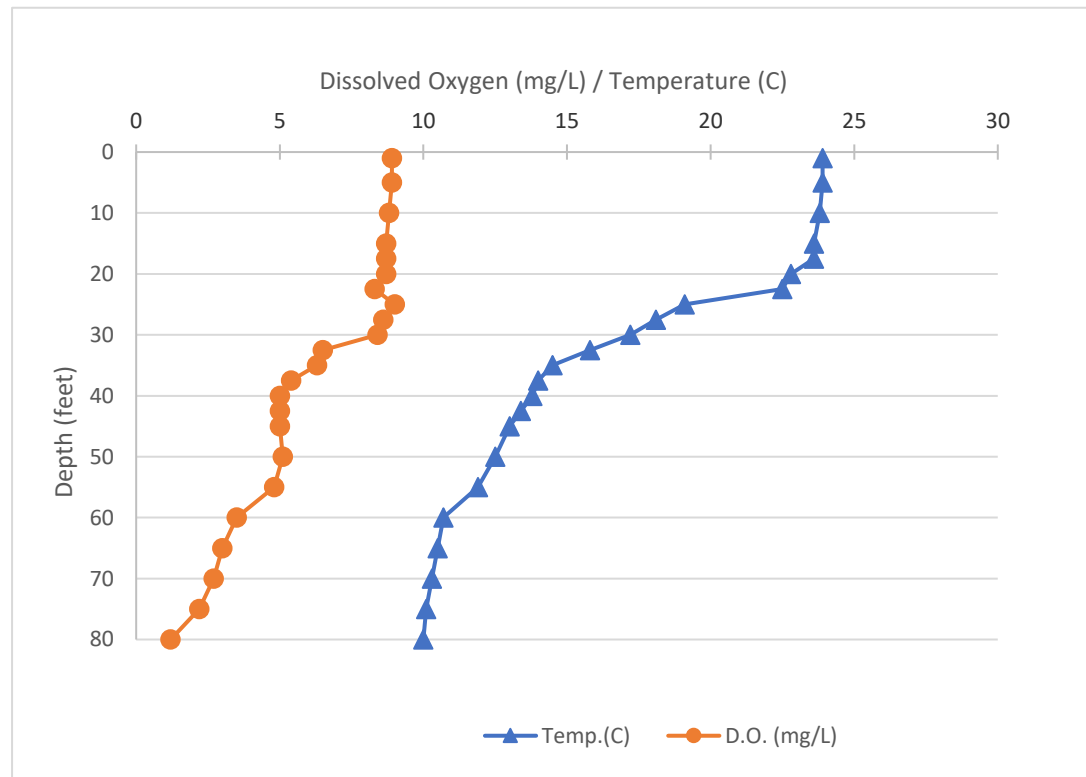
**7/24/2019**

Depth (ft)	Temp.(C)	D.O. (mg/L)
1	23.9	8.9
5	23.9	8.9
10	23.8	8.8
15	23.6	8.7
17.5	23.6	8.7
20	22.8	8.7
22.5	22.5	8.3
25	19.1	9
27.5	18.1	8.6
30	17.2	8.4
32.5	15.8	6.5
35	14.5	6.3
37.5	14	5.4
40	13.8	5
42.5	13.4	5
45	13	5
50	12.5	5.1
55	11.9	4.8
60	10.7	3.5
65	10.5	3
70	10.3	2.7
75	10.1	2.2
80	10	1.2

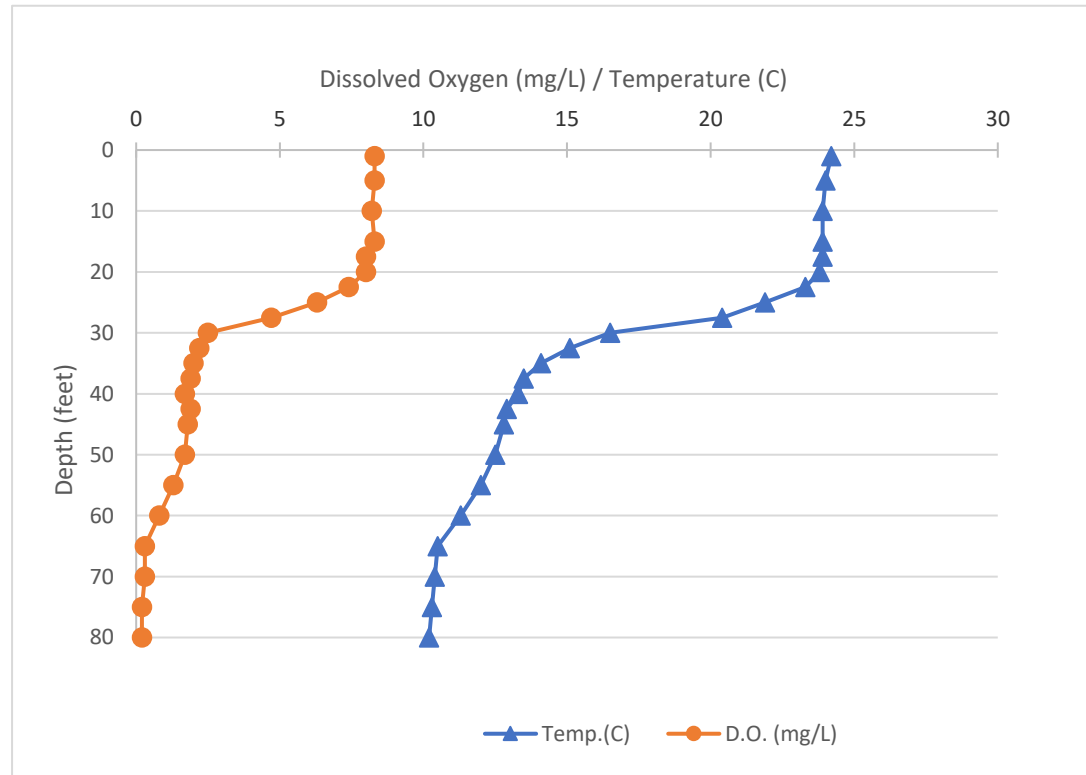
8/14/2019

Depth (ft)	Temp.(C)	D.O. (mg/L)
1	24.2	8.3
5	24	8.3
10	23.9	8.2
15	23.9	8.3
17.5	23.9	8
20	23.8	8
22.5	23.3	7.4
25	21.9	6.3
27.5	20.4	4.7
30	16.5	2.5
32.5	15.1	2.2
35	14.1	2
37.5	13.5	1.9
40	13.3	1.7
42.5	12.9	1.9
45	12.8	1.8
50	12.5	1.7
55	12	1.3
60	11.3	0.8
65	10.5	0.3
70	10.4	0.3
75	10.3	0.2
80	10.2	0.2

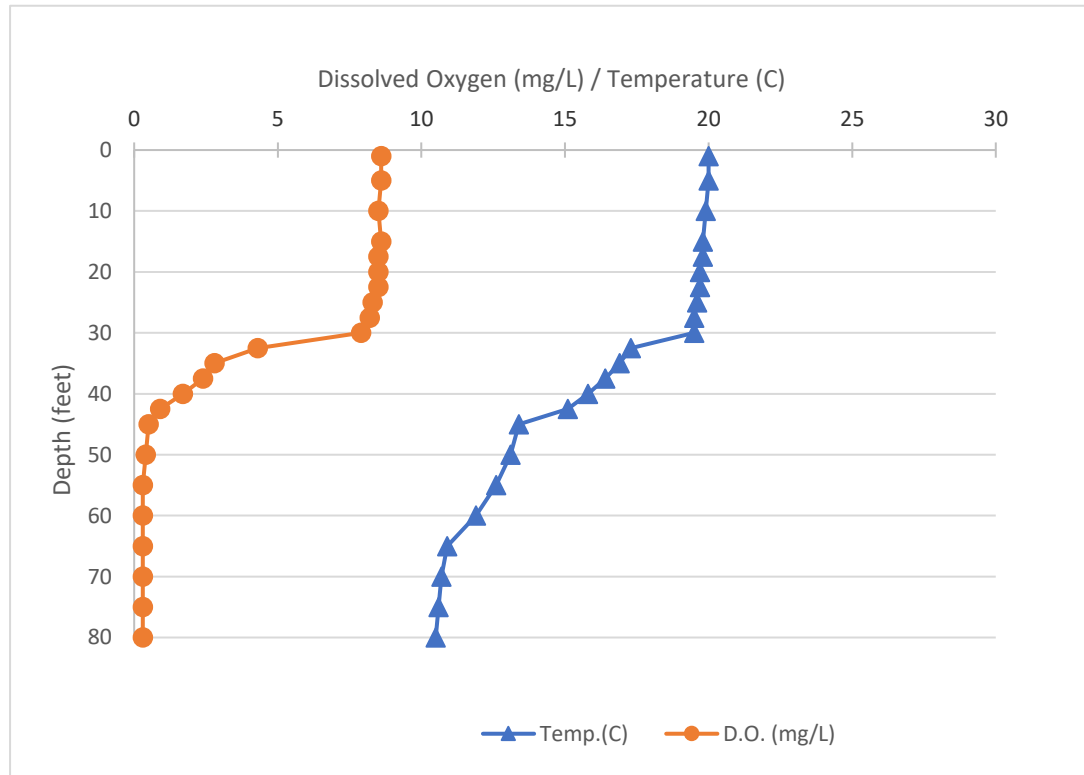
**9/5/2019**

Depth (ft)	Temp.(C)	D.O. (mg/L)
1	20	8.6
5	20	8.6
10	19.9	8.5
15	19.8	8.6
17.5	19.8	8.5
20	19.7	8.5
22.5	19.7	8.5
25	19.6	8.3
27.5	19.5	8.2
30	19.5	7.9
32.5	17.3	4.3
35	16.9	2.8
37.5	16.4	2.4
40	15.8	1.7
42.5	15.1	0.9
45	13.4	0.5
50	13.1	0.4
55	12.6	0.3
60	11.9	0.3
65	10.9	0.3
70	10.7	0.3
75	10.6	0.3
80	10.5	0.3
