**2019 Data Report
for
Stony Lake, Oceana County**

Site ID: 640049

Stony Lake, Oceana County 2019 CLMP Results

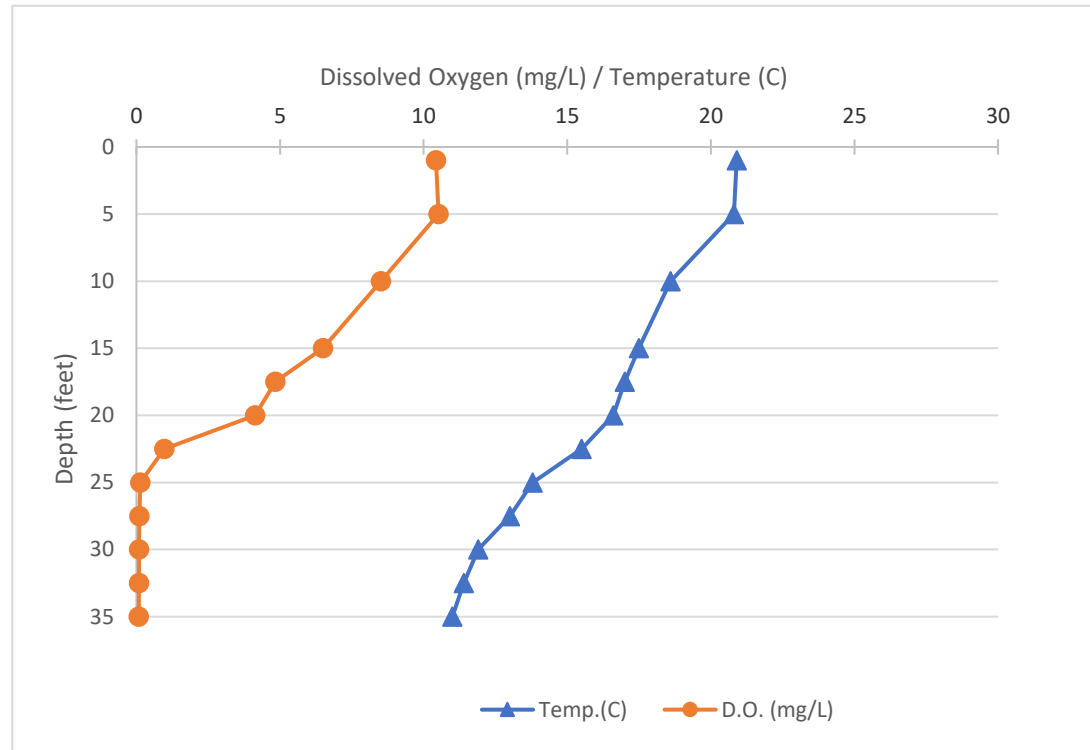
9/18/2019

Dissolved Oxygen and Temperature Profile

Depth (ft)	Temp.(C)	D.O. (mg/L)
1	20.9	10.43
5	20.8	10.52
10	18.6	8.52
15	17.5	6.5
17.5	17	4.84
20	16.6	4.14
22.5	15.5	0.97
25	13.8	0.14
27.5	13	0.1
30	11.9	0.09
32.5	11.4	0.09
35	11	0.08
