2021 Data Report for Chippewa Lake, Mecosta County

Site ID: 540050

Chippewa Lake, Mecosta County 2021 CLMP Results

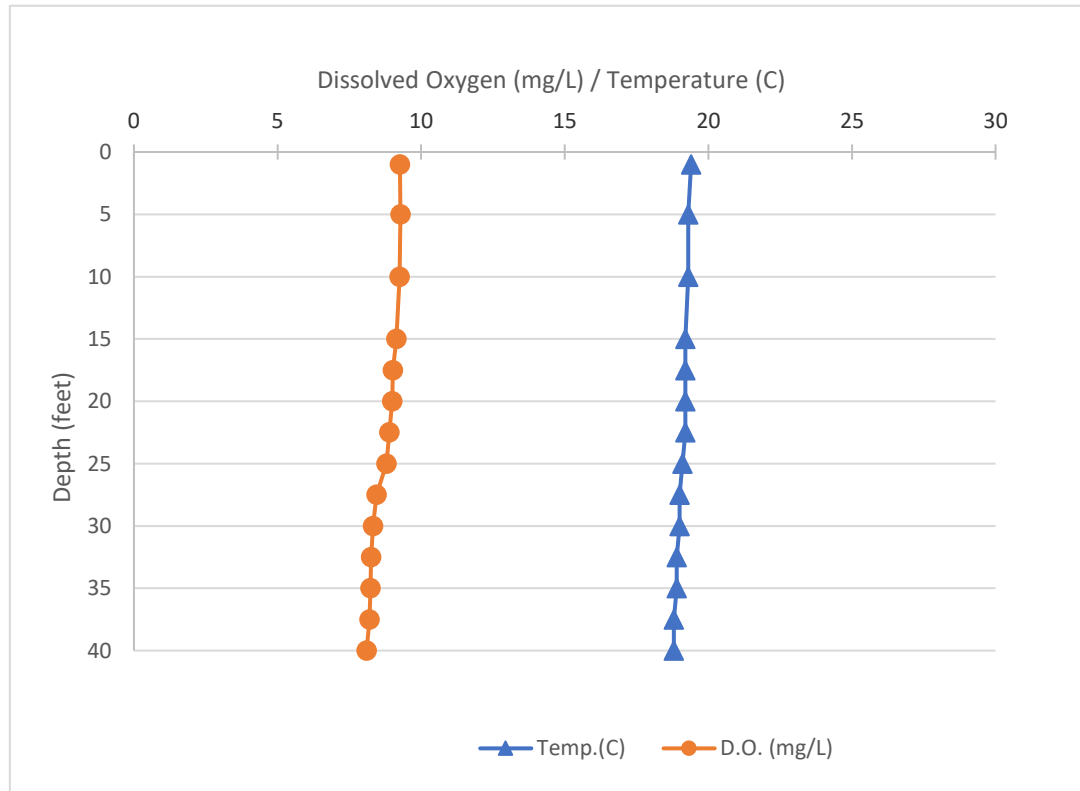
Name: Chippewa Lake
County: Mecosta
Site ID: 540050
Date: 9/15/2019

Dissolved Oxygen and Temperature Profile

Depth (ft)	Temp.(C)	D.O. (mg/L)
1	19.4	9.26
5	19.3	9.28
10	19.3	9.25
15	19.2	9.14
17.5	19.2	9.02
20	19.2	8.99
22.5	19.2	8.89
25	19.1	8.79
27.5	19	8.45
30	19	8.32
32.5	18.9	8.26
35	18.9	8.24
37.5	18.8	8.2
40	18.8	8.1
