2021 Data Report for Klinger Lake, St. Joseph County

Site ID: 750136

Klinger Lake, St. Joseph County 2021 CLMP Results

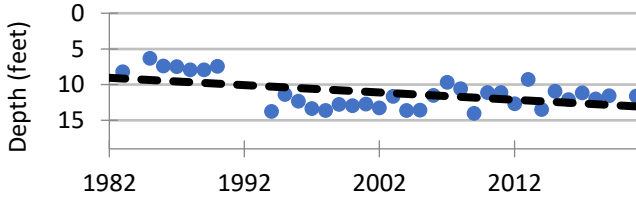
Secchi Disk Transparency (feet)

Year	# Readings	Min	Max	Avg	Std. Dev	Carlson TSI
2021	17	7.5	19.5	11.6	3.9	42
2016-2019	74	5.5	28.5	11.6	4.7	42
1982-2015	502	4.0	32.5	11.1	3.8	43
2021 All CLMP Lakes	2817	1.0	50.0	12.7	2.9	42

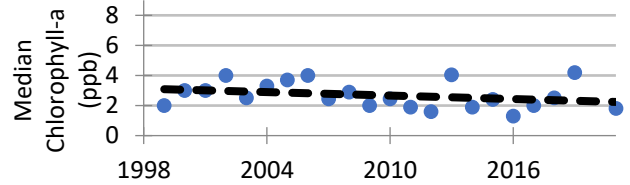
Chlorophyll-a (parts per billion)

Year	# Samples	Min	Max	Med	Std. Dev	Carlson TSI
2021	5	<1.0	2.8	1.8	0.8	36
2016-2019	20	<1.0	5.7	2.3	1.0	38
1999-2015	84	<1.0	5.8	2.3	1.3	40
2021 All CLMP Lakes	635	<1.0	42.0	2.2	3.4	39

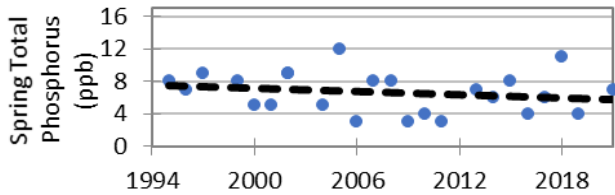
Spring Phosphorus (parts per billion)

Year	# Samples	Min	Max	Avg	Std. Dev
2021	1	7.0	7.0	7.0	NA
2016-2019	4	<5 T	11.0	6.3	3.3
1995-2015	19	<=3 W	12.0	6.7	2.5
2021 All CLMP Lakes	220	<= 3	100.0	14.9	11.0

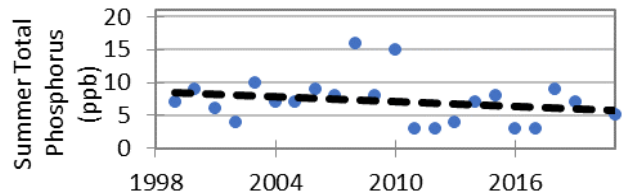
Summer Phosphorus (parts per billion)

Year	# Samples	Min	Max	Avg	Std. Dev	Carlson TSI
2021	1	5.0	5.0	5.0	NA	27
2016-2019	4	<=3 W	9.0	5.5	3.0	27
1999-2015	17	<=3 W	16.0	7.7	3.6	32
2021 All CLMP Lakes	281	<= 3	65.0	12.8	9.3	38

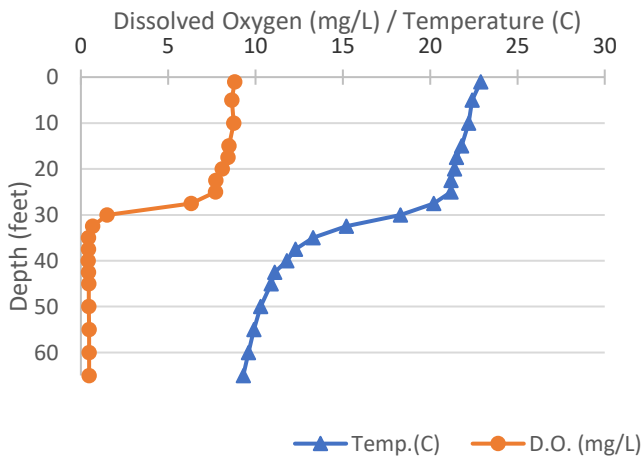
9/11/2019

Dissolved Oxygen and Temperature Profile

The lake keeps some dissolved oxygen in the bottom waters through mid-summer, but by late summer the lake has stratified and the bottom water is devoid of oxygen.

If you enrolled in Dissolved Oxygen/Temperature, the summary page will have a graph of one of the profiles taken during the late summer (typically August or September). If your lake stratifies, we will use a graph showing the earliest time of stratification, because identifying the timing of this condition and the depth at which it occurs is typically the most important use of dissolved oxygen measurements.

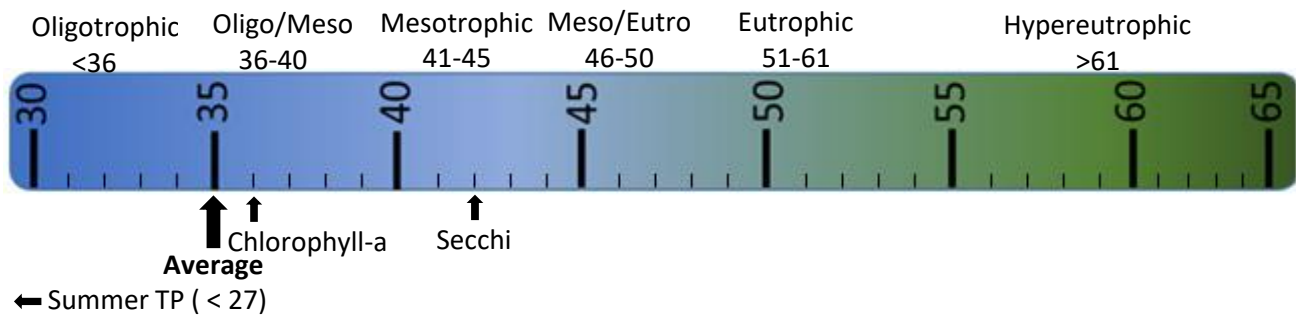
TSI for Klinger Lake in 2021	
Average	35
Secchi Disk	42
Summer TP	27
Chlorophyll-a	36

With an average TSI score of 35 based on 2021 Secchi transparency, chlorophyll-a, and summer total phosphorus data, this lake is rated as an oligotrophic lake.

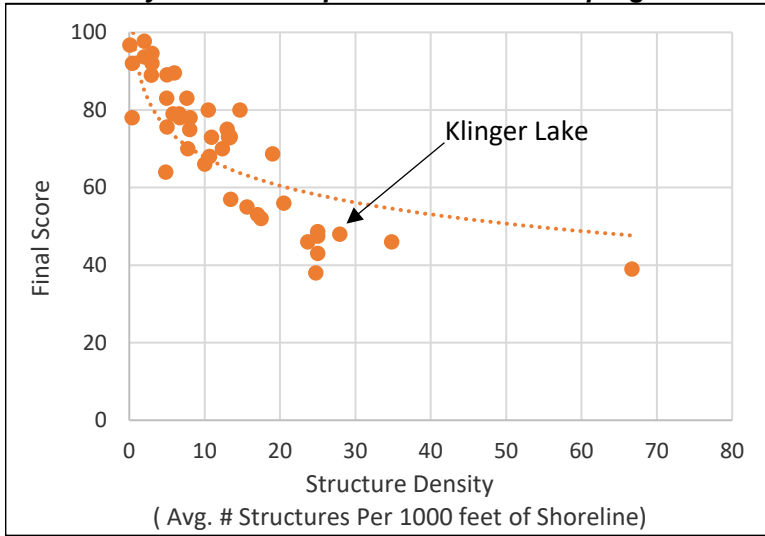
How does your lake compare to others in the program?

Klinger Lake:	
Number of Sections:	25
Number of Structures:	698
Structure Density:	27.9
Final Score:	48

All 42 Participating Lakes from 2015-2018:	
Avg. Number of Sections:	16.3
Avg. Number of Structures:	248.5
Avg. Structure Density:	15.2
Avg. Final Score:	70.5

With a fairly high house and dock density as compared to the other lakes, it would be expected that the quality of the lakeshore habitat would be lower in Klinger Lake. Overall, all of the sections were classified as either poor or fair.

The weakest point of Klinger Lake assessment was the littoral zone (shallow water near the shore). Increasing aquatic vegetation, allowing fallen trees to remain in the water, and reducing shoreline erosion would be the primary way to boost this score.

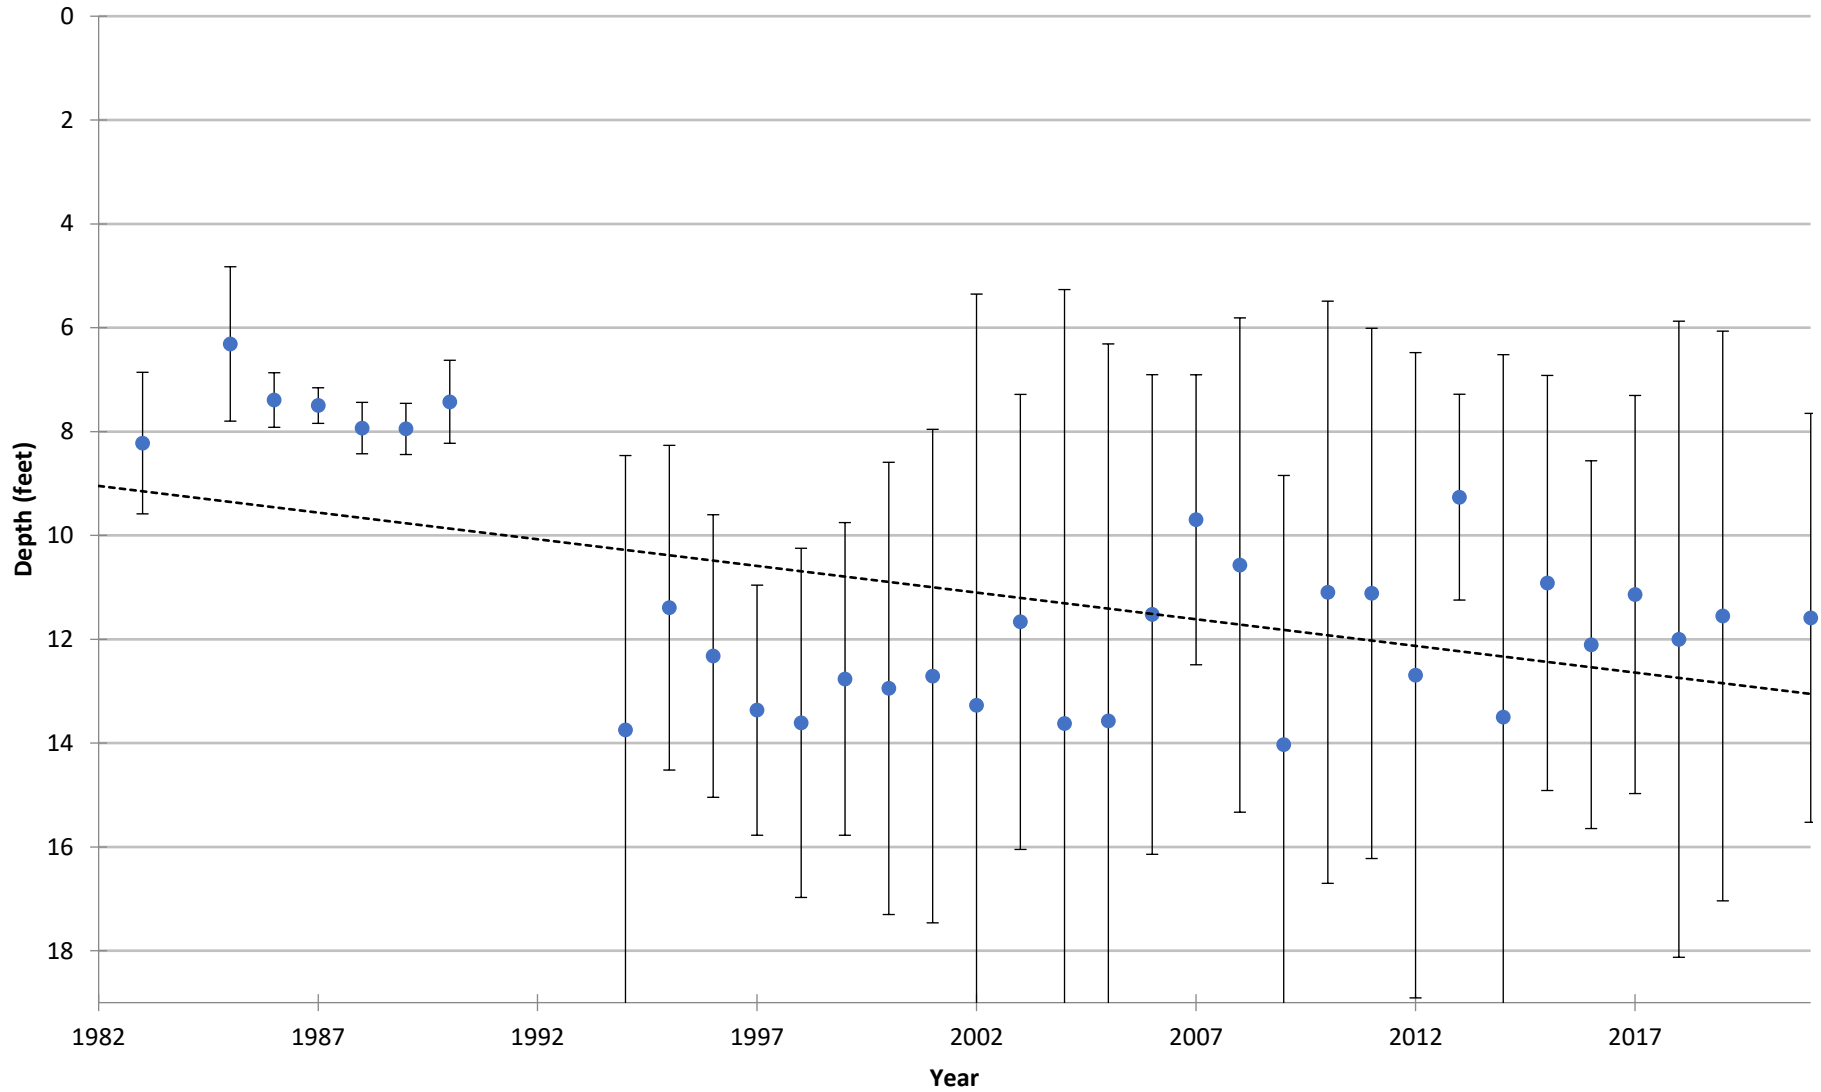
Klinger Lake (St. Joseph Co.), 750136

COOPERATIVE LAKES MONITORING PROGRAM
SUMMER MEAN TRANSPARENCY

Vertical bars indicate standard deviation

Long term monitoring shows slight downward slopes on the parameters, indicating a slow movement toward lower nutrient levels in the lake.

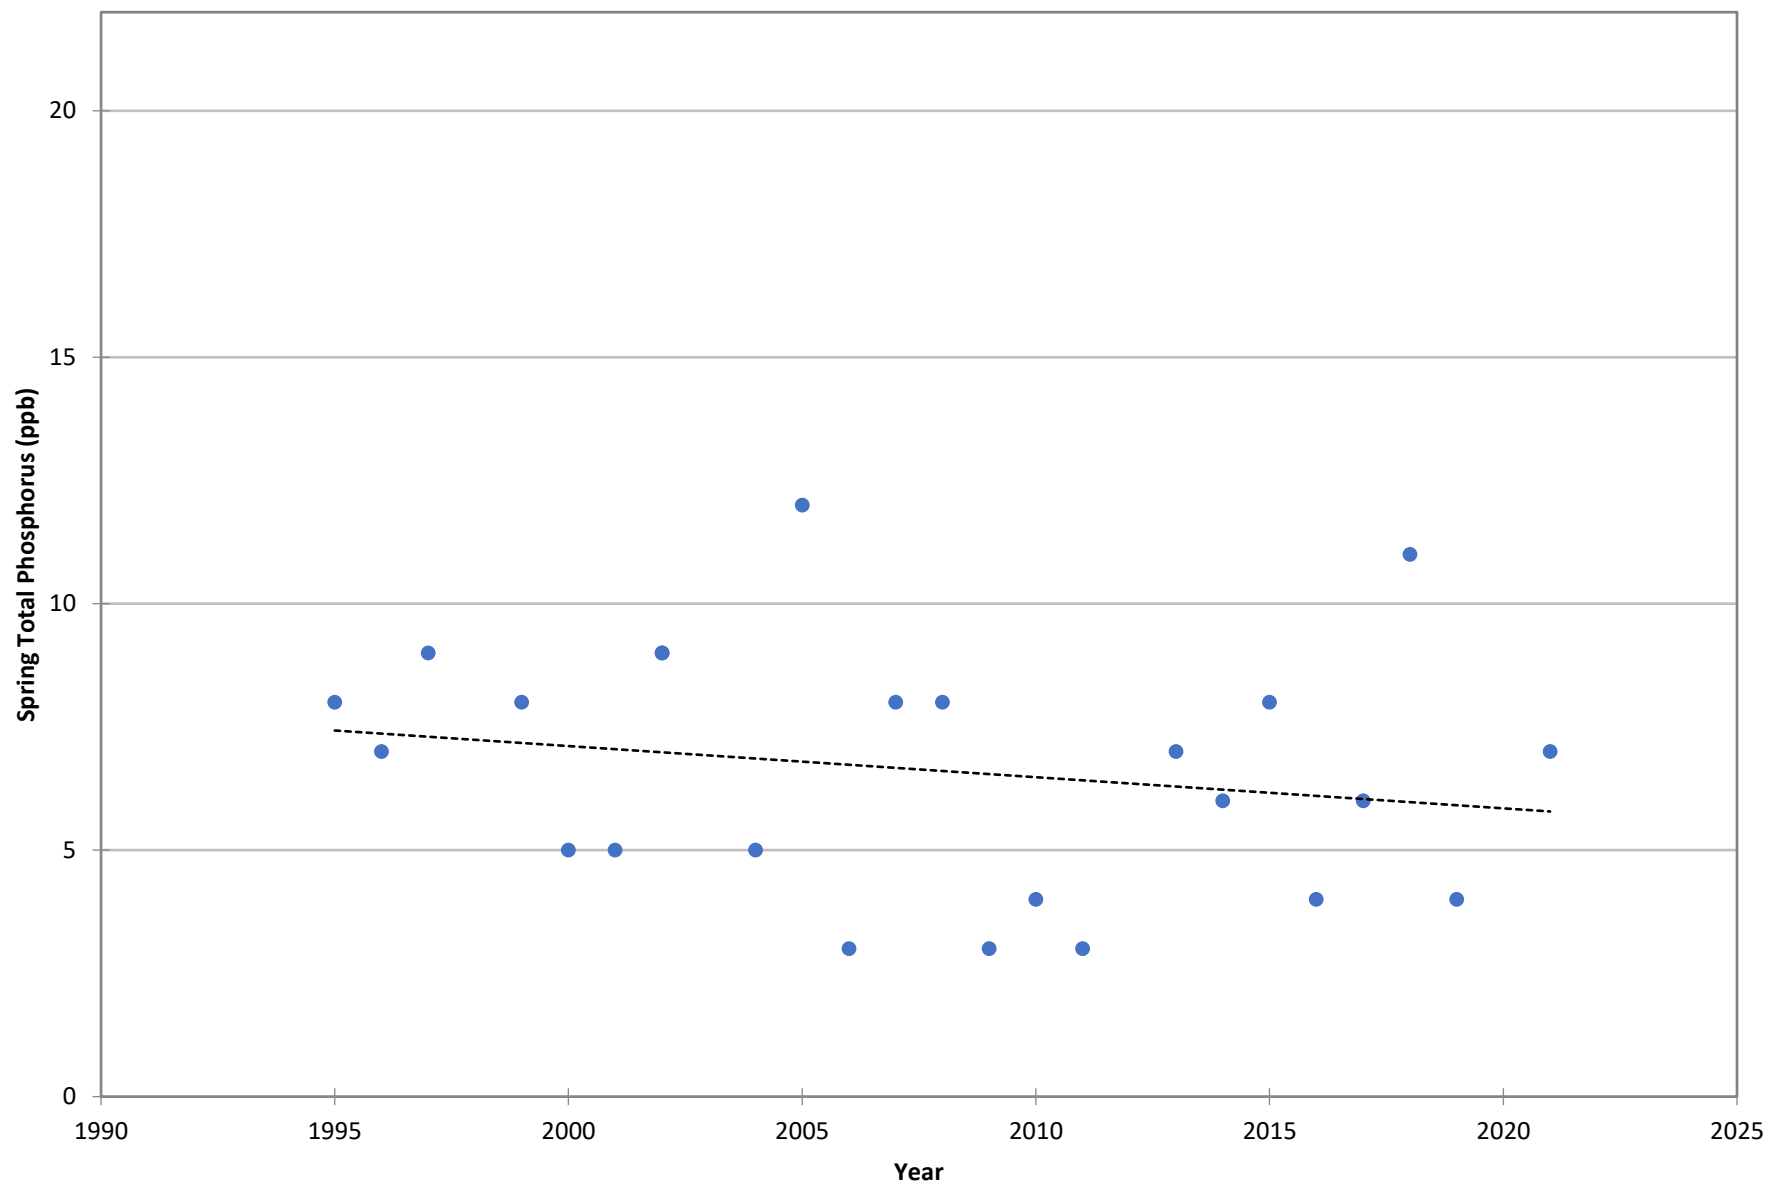
Klinger Lake (St. Joseph Co.), 750136

COOPERATIVE LAKES MONITORING PROGRAM
SPRING TOTAL PHOSPHORUS

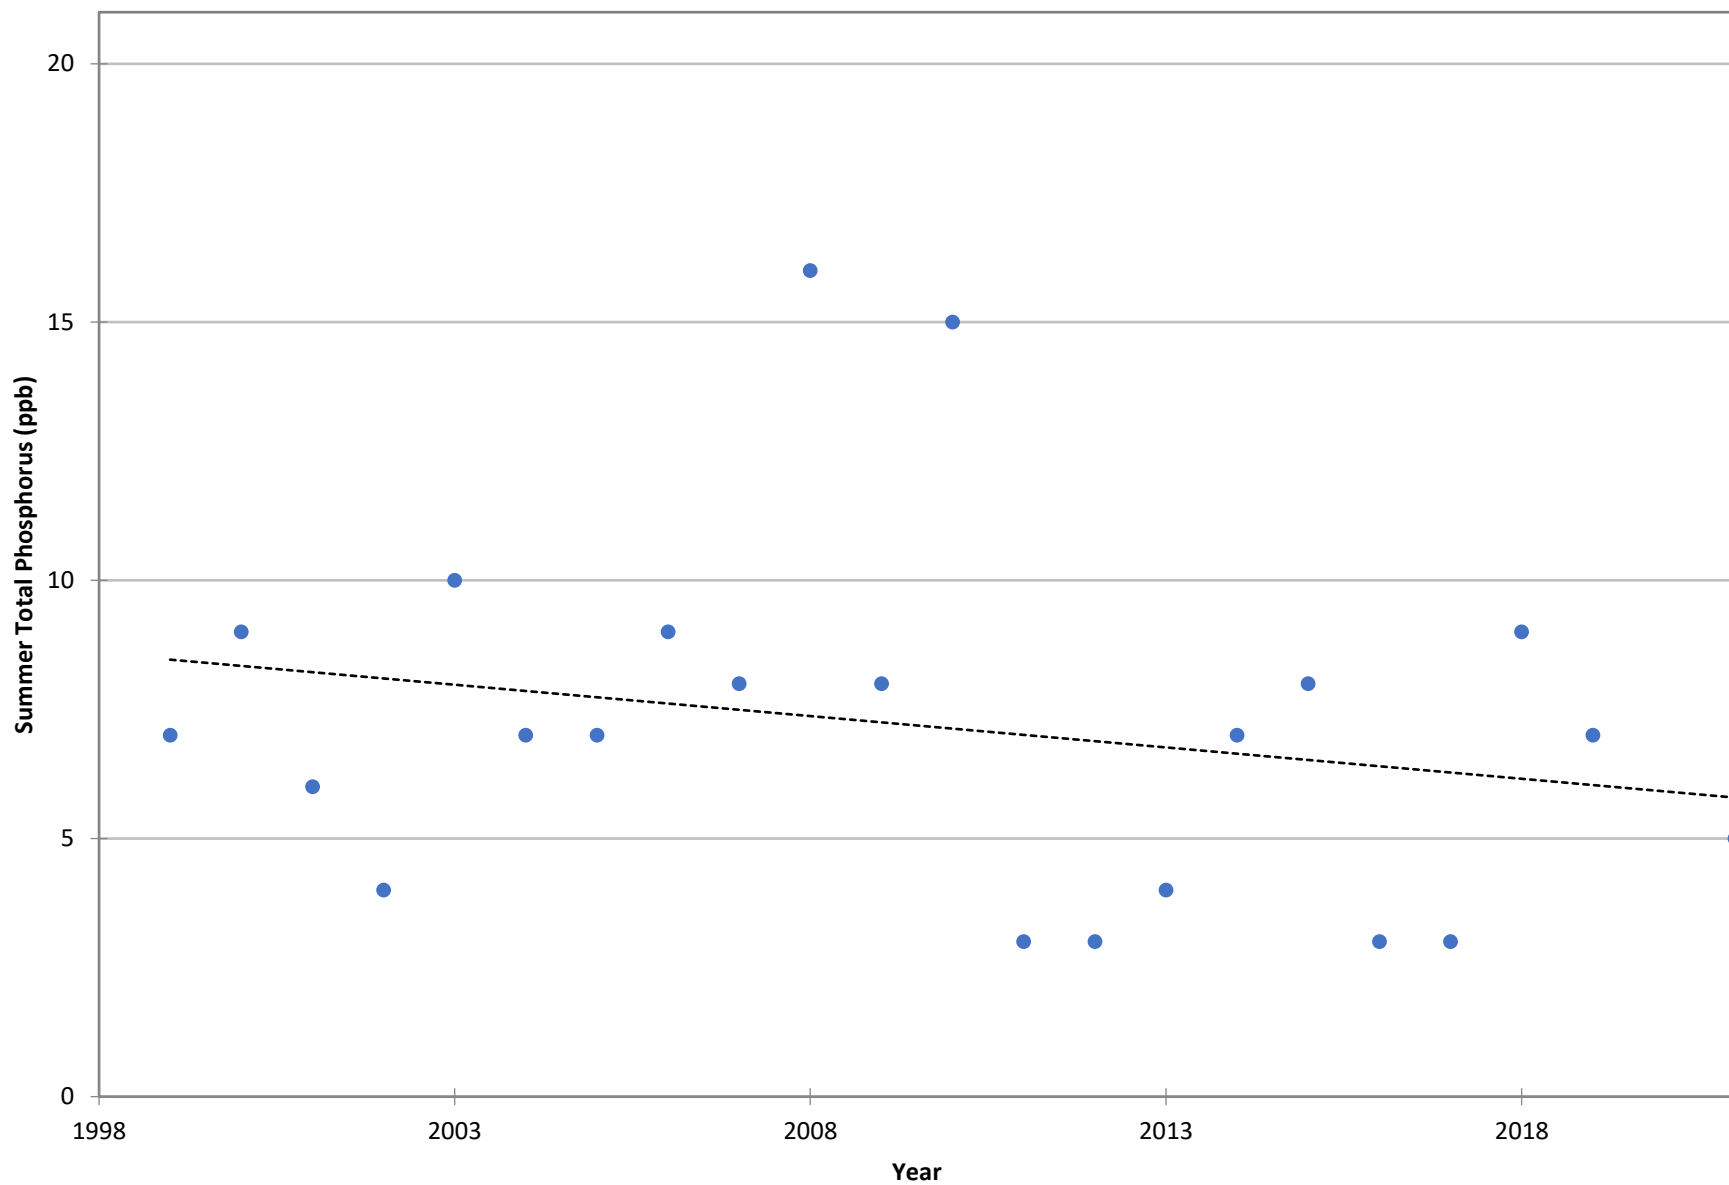
Klinger Lake (St. Joseph Co.), 750136

COOPERATIVE LAKES MONITORING PROGRAM
SUMMER TOTAL PHOSPHORUS

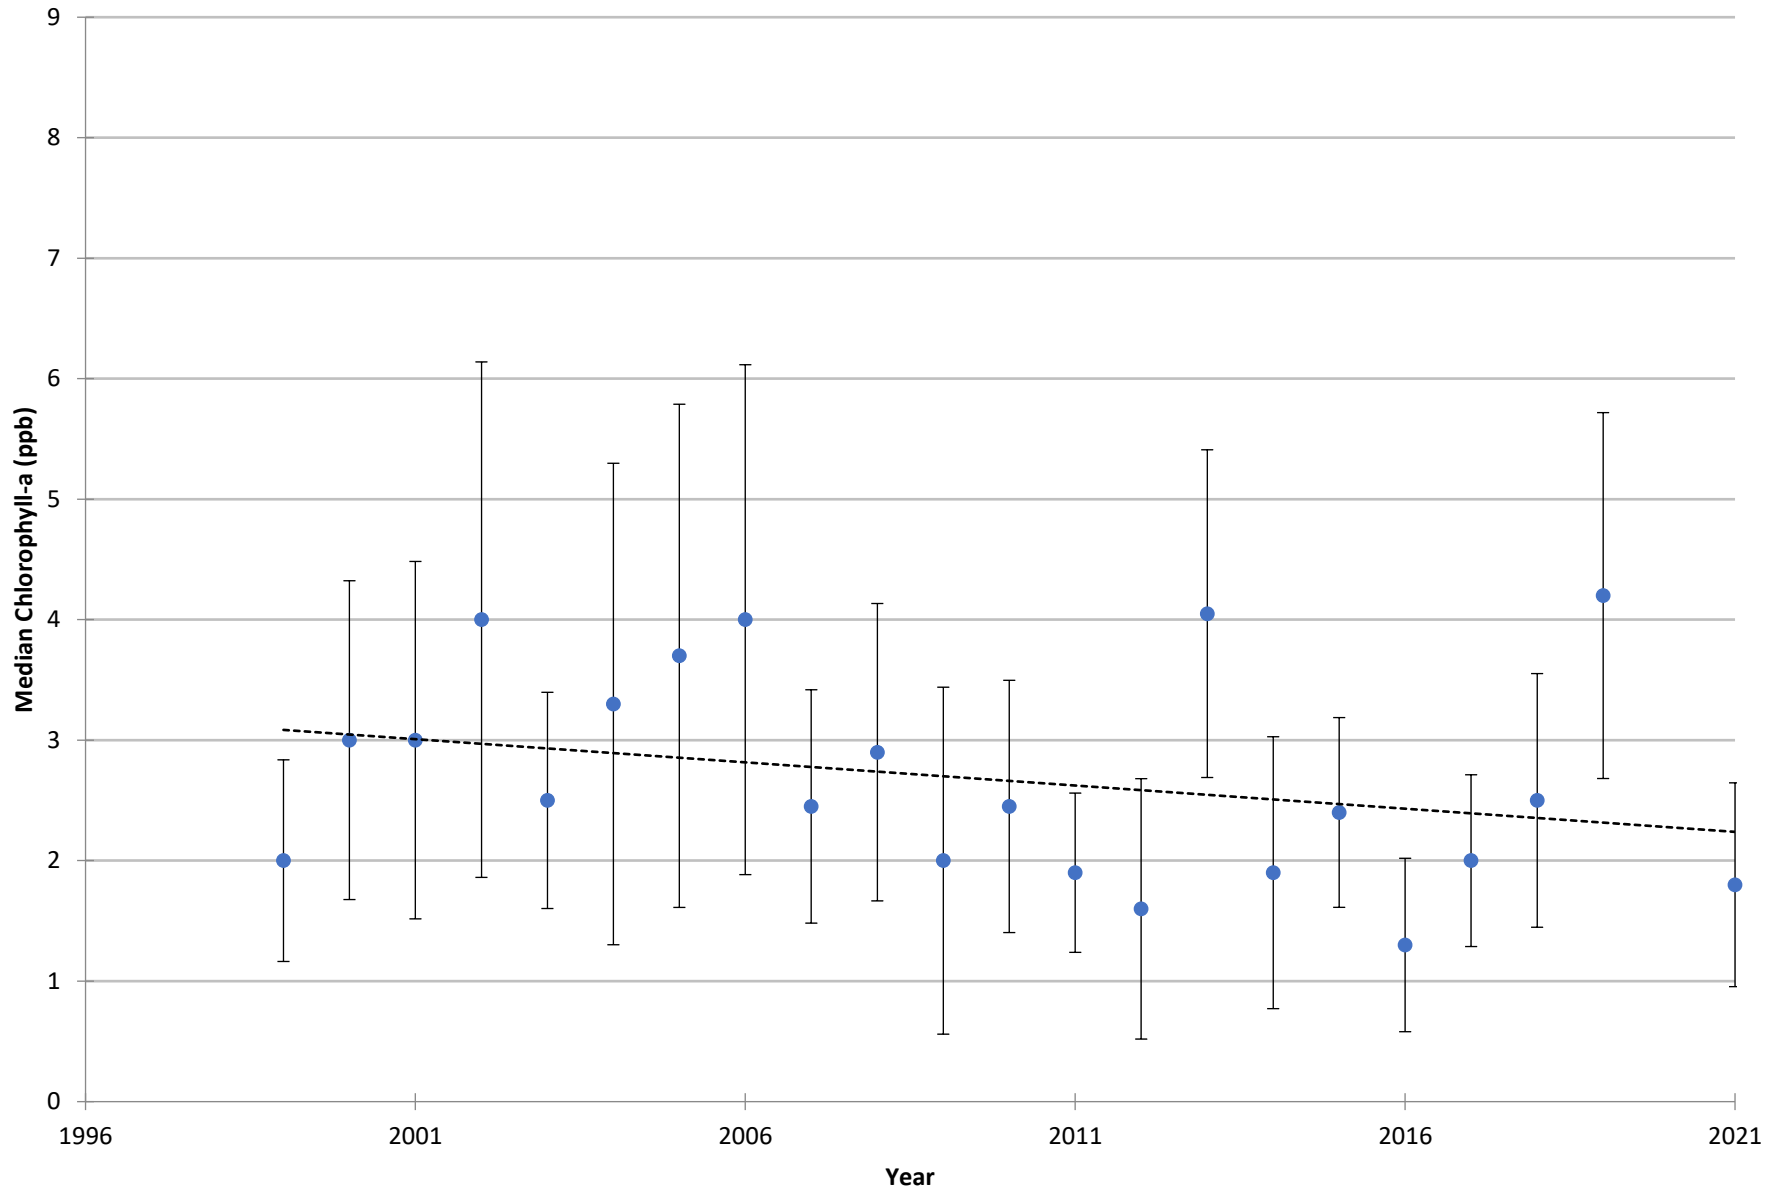
Klinger Lake (St. Joseph Co.), 750136

COOPERATIVE LAKES MONITORING PROGRAM
SUMMER MEDIAN CHLOROPHYLL-A

Vertical bars indicate standard deviation

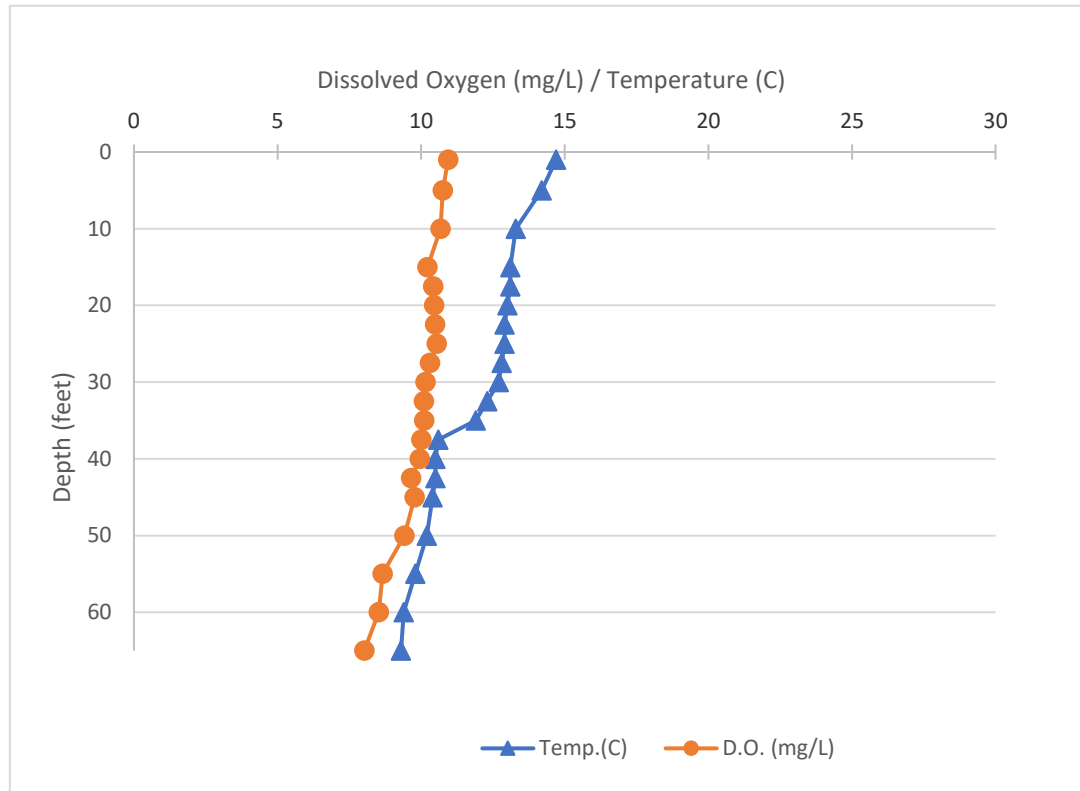
5/15/2019

Dissolved Oxygen and Temperature Profile

Depth (ft)	Temp.(C)	D.O. (mg/L)
1	14.7	10.94
5	14.2	10.75
10	13.3	10.68
15	13.1	10.22
17.5	13.1	10.42
20	13	10.45
22.5	12.9	10.49
25	12.9	10.54
27.5	12.8	10.31
30	12.7	10.15
32.5	12.3	10.1
35	11.9	10.11
37.5	10.6	10.01
40	10.5	9.95
42.5	10.5	9.65
45	10.4	9.77
50	10.2	9.42
55	9.8	8.66
60	9.4	8.53
65	9.3	8.02

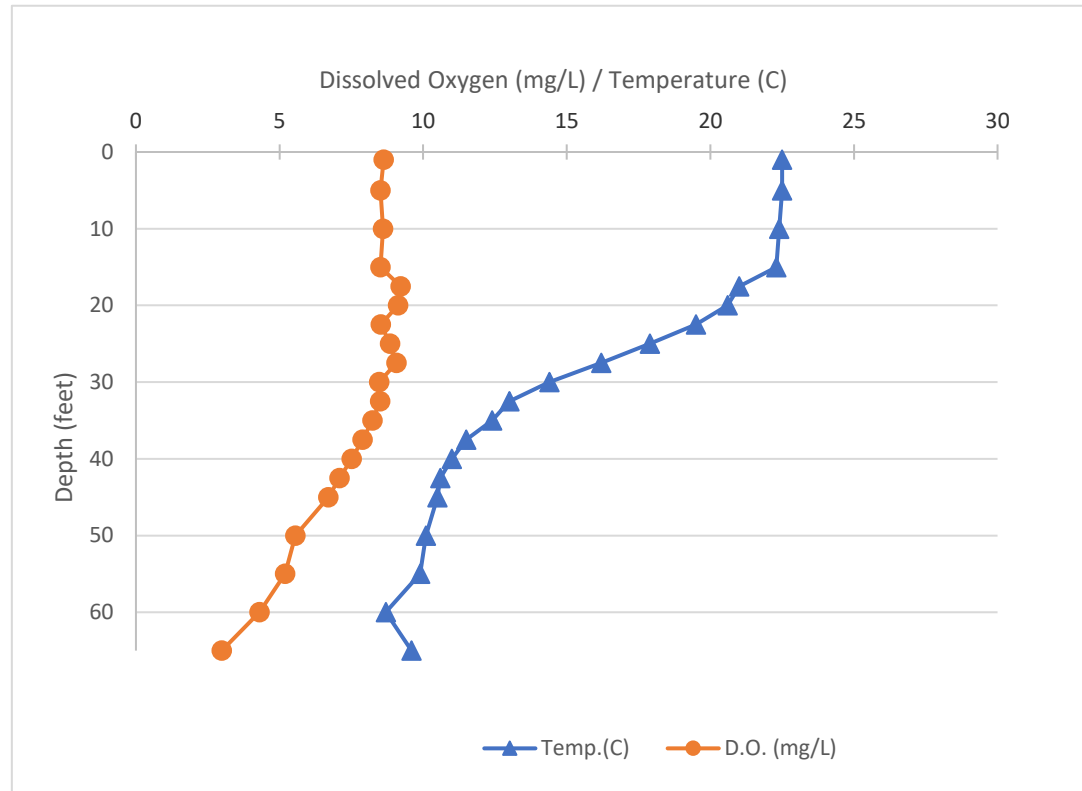
5/25/2019

Dissolved Oxygen and Temperature Profile

Depth (ft)	Temp.(C)	D.O. (mg/L)
1	22.5	8.63
5	22.5	8.51
10	22.4	8.6
15	22.3	8.52
17.5	21	9.22
20	20.6	9.13
22.5	19.5	8.53
25	17.9	8.85
27.5	16.2	9.07
30	14.4	8.47
32.5	13	8.5
35	12.4	8.24
37.5	11.5	7.89
40	11	7.51
42.5	10.6	7.09
45	10.5	6.7
50	10.1	5.55
55	9.9	5.2
60	8.7	4.3
65	9.6	2.99

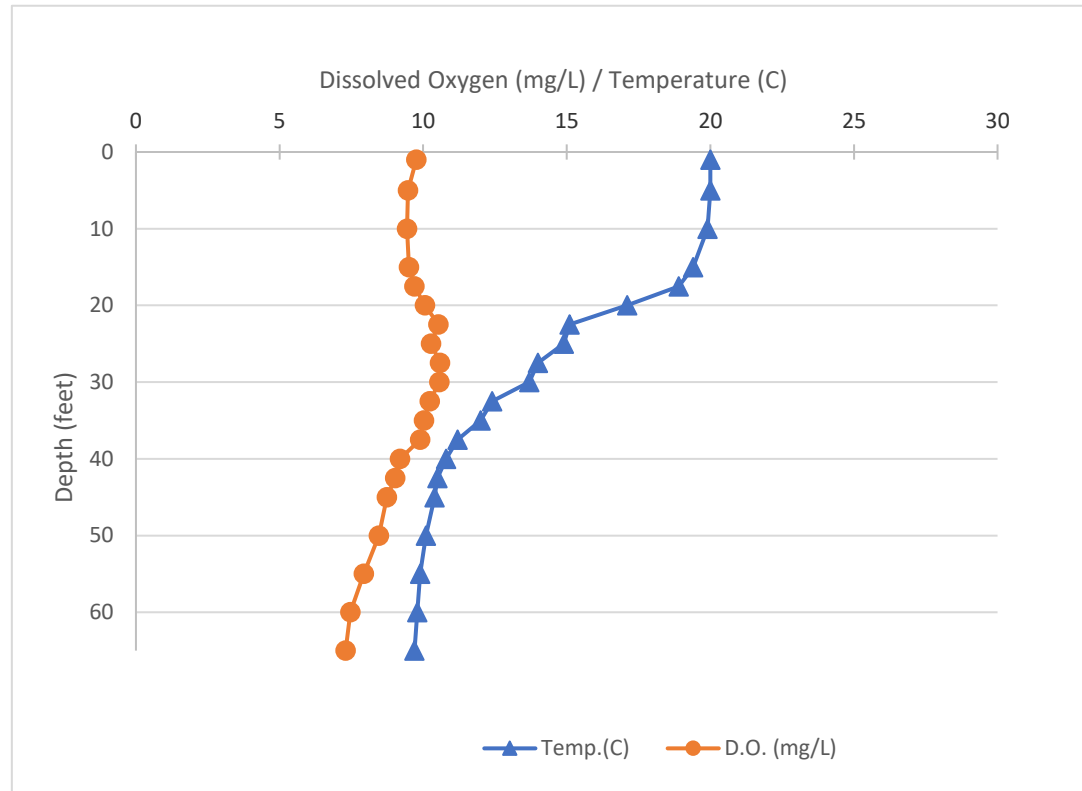
5/29/2019

Dissolved Oxygen and Temperature Profile

Depth (ft)	Temp.(C)	D.O. (mg/L)
1	20	9.76
5	20	9.47
10	19.9	9.44
15	19.4	9.51
17.5	18.9	9.7
20	17.1	10.06
22.5	15.1	10.53
25	14.9	10.27
27.5	14	10.59
30	13.7	10.56
32.5	12.4	10.23
35	12	10.03
37.5	11.2	9.9
40	10.8	9.19
42.5	10.5	9.03
45	10.4	8.74
50	10.1	8.46
55	9.9	7.93
60	9.8	7.47
65	9.7	7.3

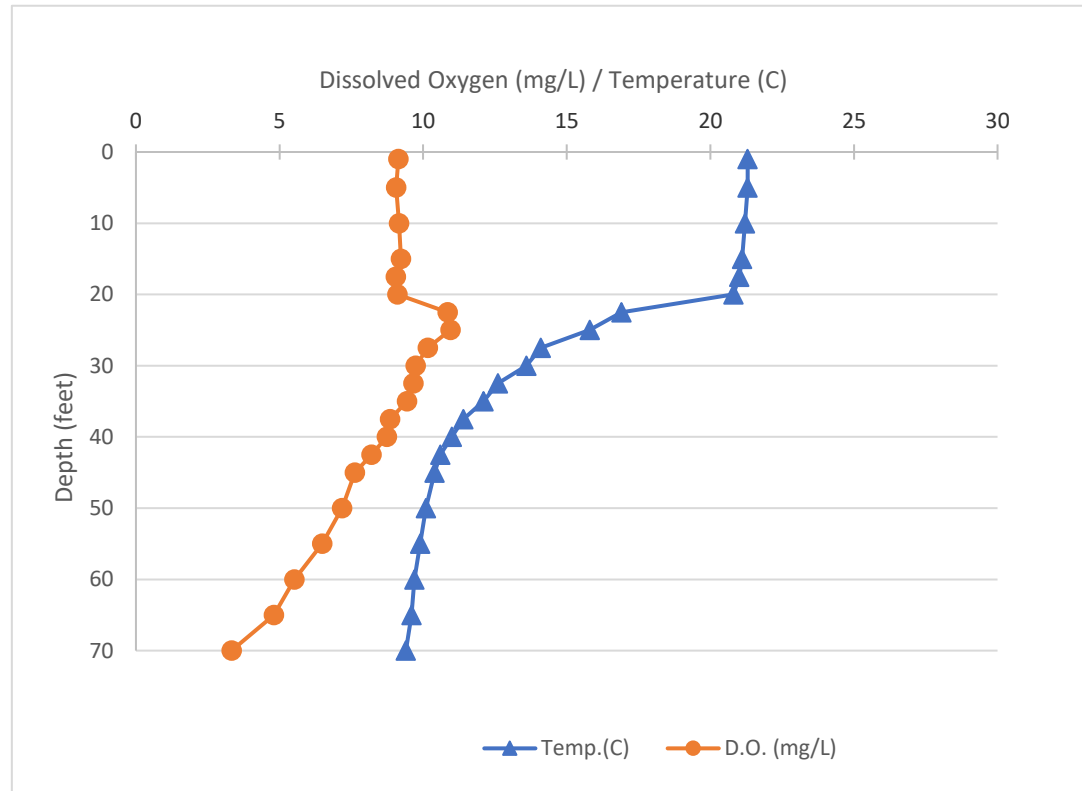
6/11/2019

Dissolved Oxygen and Temperature Profile

Depth (ft)	Temp.(C)	D.O. (mg/L)
1	21.3	9.14
5	21.3	9.06
10	21.2	9.16
15	21.1	9.23
17.5	21	9.05
20	20.8	9.1
22.5	16.9	10.85
25	15.8	10.95
27.5	14.1	10.16
30	13.6	9.74
32.5	12.6	9.66
35	12.1	9.44
37.5	11.4	8.85
40	11	8.74
42.5	10.6	8.2
45	10.4	7.62
50	10.1	7.18
55	9.9	6.49
60	9.7	5.52
65	9.6	4.8
70	9.4	3.33

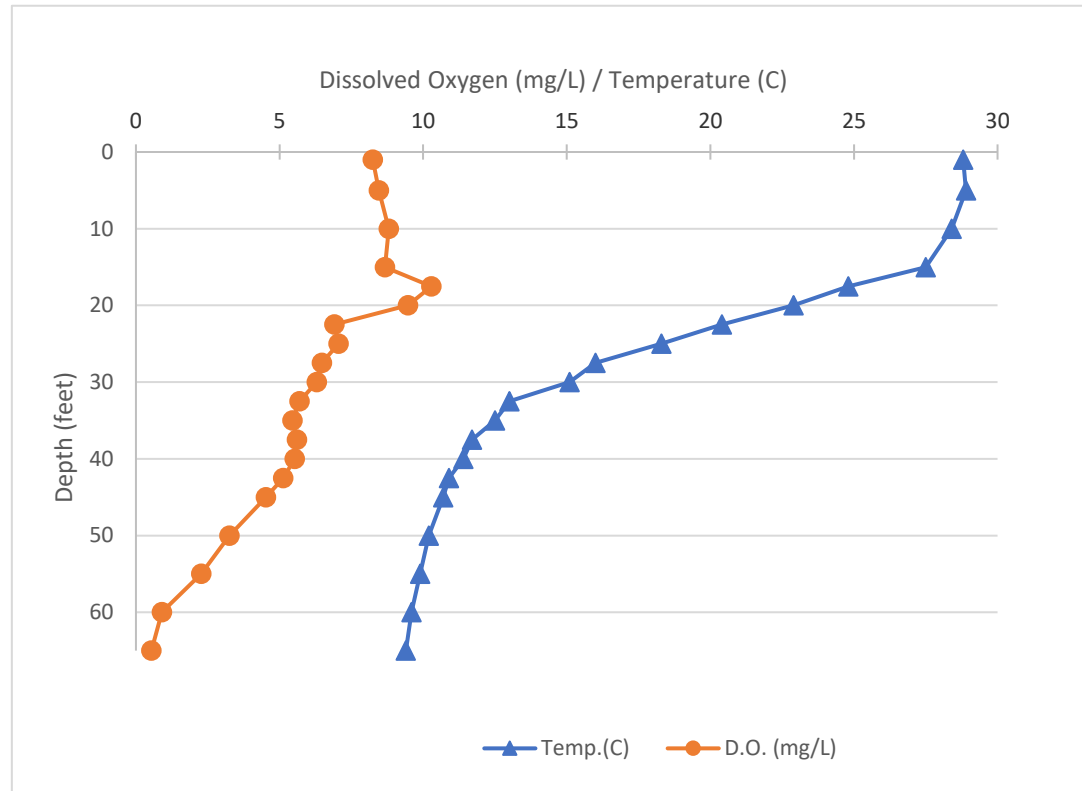
7/18/2019

Dissolved Oxygen and Temperature Profile

Depth (ft)	Temp.(C)	D.O. (mg/L)
1	28.8	8.25
5	28.9	8.46
10	28.4	8.8
15	27.5	8.67
17.5	24.8	10.29
20	22.9	9.47
22.5	20.4	6.91
25	18.3	7.06
27.5	16	6.48
30	15.1	6.3
32.5	13	5.7
35	12.5	5.45
37.5	11.7	5.61
40	11.4	5.53
42.5	10.9	5.13
45	10.7	4.53
50	10.2	3.26
55	9.9	2.27
60	9.6	0.9
65	9.4	0.54

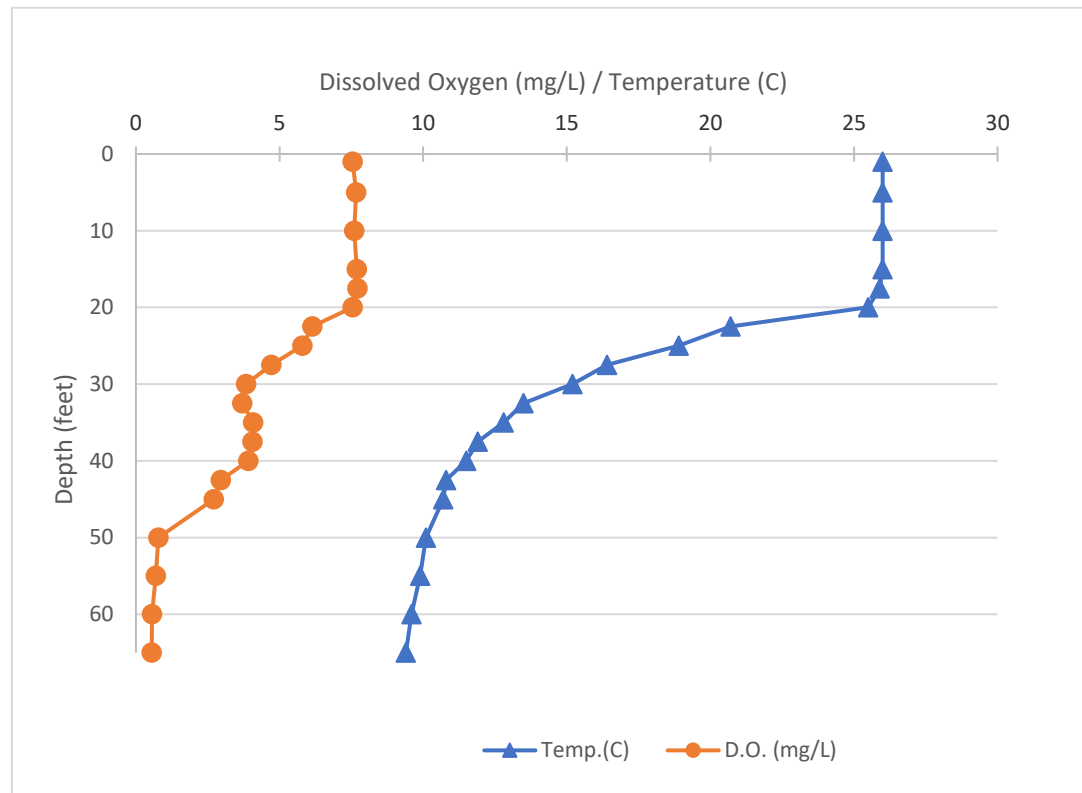
7/31/2019

Dissolved Oxygen and Temperature Profile

Depth (ft)	Temp.(C)	D.O. (mg/L)
1	26	7.55
5	26	7.67
10	26	7.6
15	26	7.69
17.5	25.9	7.71
20	25.5	7.54
22.5	20.7	6.14
25	18.9	5.8
27.5	16.4	4.71
30	15.2	3.84
32.5	13.5	3.7
35	12.8	4.08
37.5	11.9	4.06
40	11.5	3.91
42.5	10.8	2.96
45	10.7	2.71
50	10.1	0.78
55	9.9	0.69
60	9.6	0.56
65	9.4	0.55

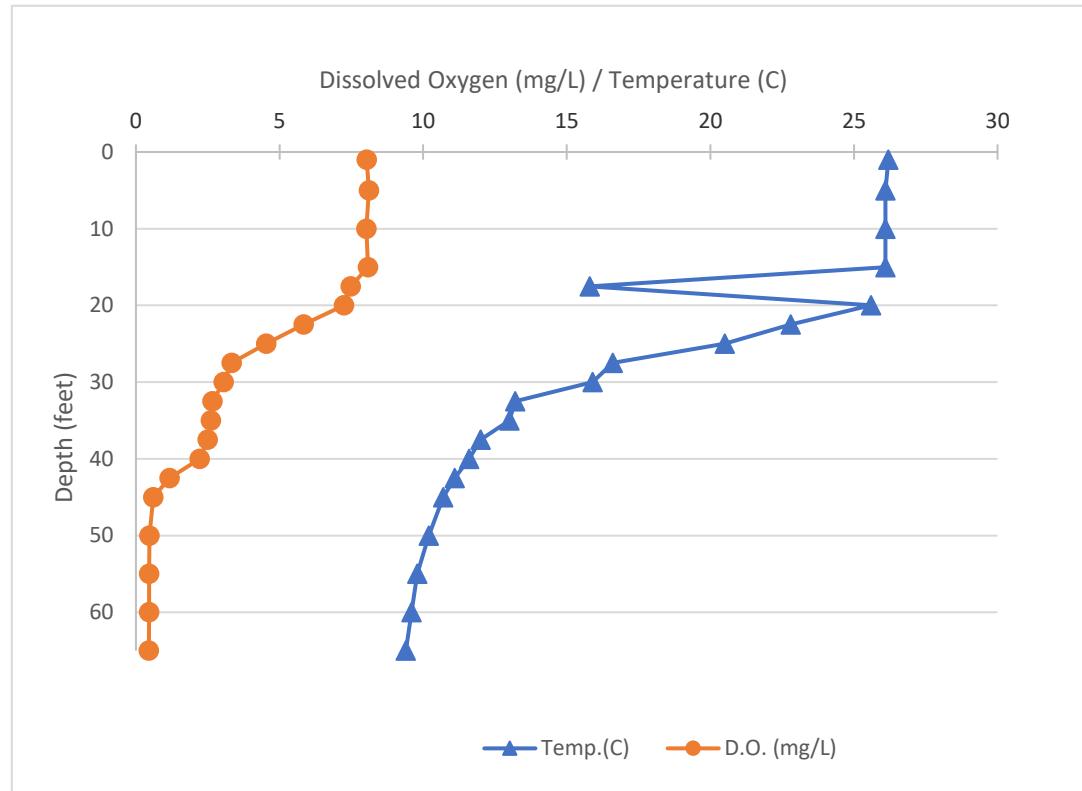
8/14/2019

Dissolved Oxygen and Temperature Profile

Depth (ft)	Temp.(C)	D.O. (mg/L)
1	26.2	8.04
5	26.1	8.11
10	26.1	8.03
15	26.1	8.08
17.5	15.8	7.48
20	25.6	7.25
22.5	22.8	5.84
25	20.5	4.54
27.5	16.6	3.33
30	15.9	3.05
32.5	13.2	2.66
35	13	2.61
37.5	12	2.5
40	11.6	2.22
42.5	11.1	1.17
45	10.7	0.6
50	10.2	0.47
55	9.8	0.46
60	9.6	0.46
65	9.4	0.45

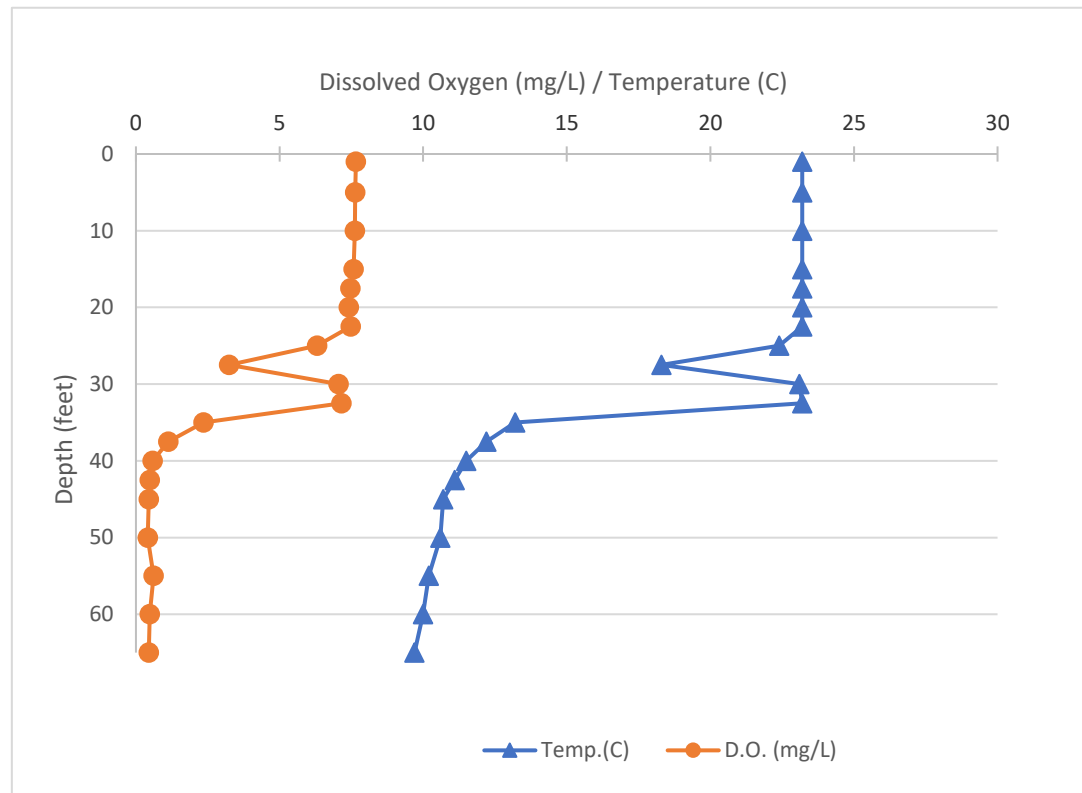
8/28/2019

Dissolved Oxygen and Temperature Profile

Depth (ft)	Temp.(C)	D.O. (mg/L)
1	23.2	7.66
5	23.2	7.63
10	23.2	7.62
15	23.2	7.58
17.5	23.2	7.47
20	23.2	7.41
22.5	23.2	7.48
25	22.4	6.31
27.5	18.3	3.25
30	23.1	7.06
32.5	23.2	7.16
35	13.2	2.35
37.5	12.2	1.13
40	11.5	0.58
42.5	11.1	0.48
45	10.7	0.45
50	10.6	0.41
55	10.2	0.62
60	10	0.48
65	9.7	0.45

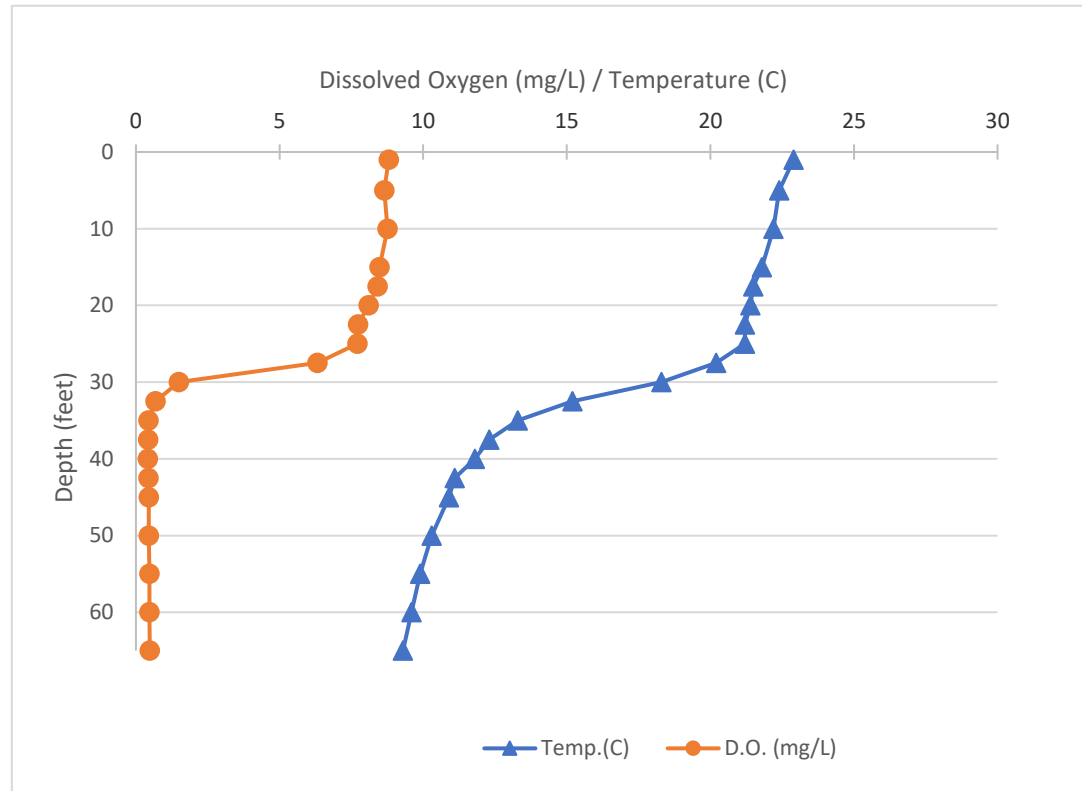
9/11/2019

Dissolved Oxygen and Temperature Profile

Depth (ft)	Temp.(C)	D.O. (mg/L)
1	22.9	8.8
5	22.4	8.65
10	22.2	8.76
15	21.8	8.48
17.5	21.5	8.42
20	21.4	8.1
22.5	21.2	7.73
25	21.2	7.71
27.5	20.2	6.32
30	18.3	1.49
32.5	15.2	0.68
35	13.3	0.44
37.5	12.3	0.43
40	11.8	0.42
42.5	11.1	0.44
45	10.9	0.45
50	10.3	0.45
55	9.9	0.47
60	9.6	0.47
65	9.3	0.48
