**2021 Data Report  
for  
Lake Mecosta, Mecosta County**

Site ID: 540057

# Lake Mecosta, Mecosta County 2021 CLMP Results

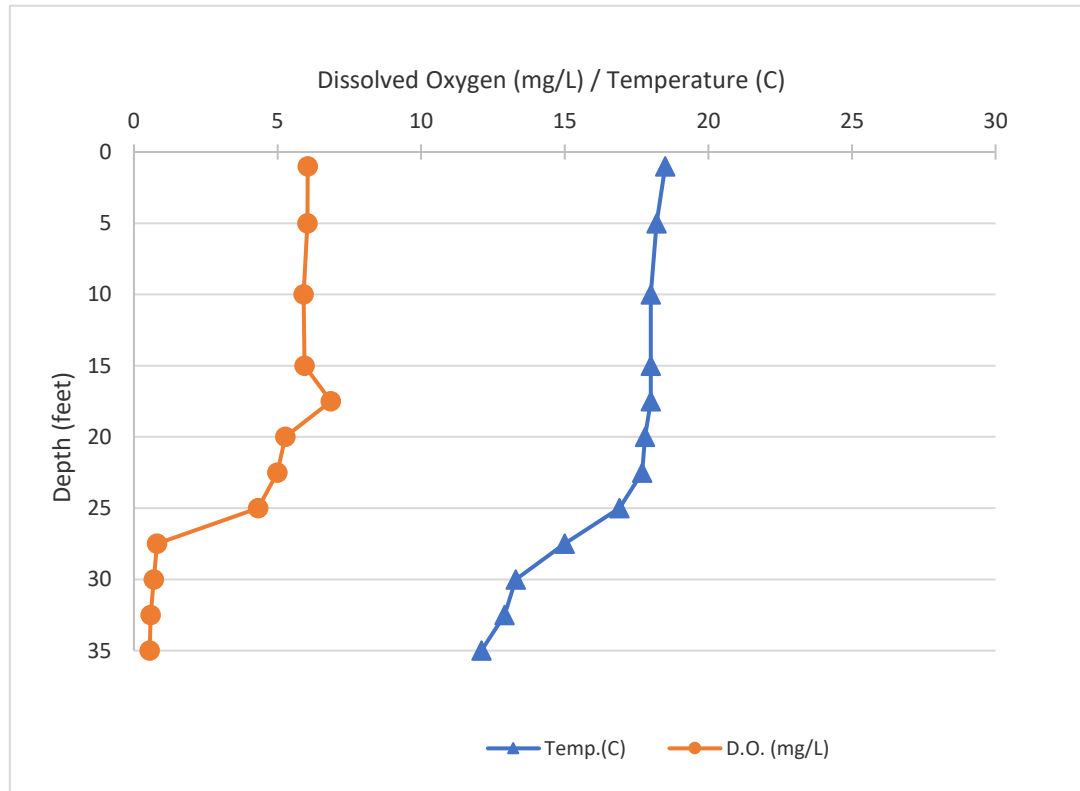
9/14/2006

### Dissolved Oxygen and Temperature Profile

Depth (ft)	Temp.(C)	D.O. (mg/L)
1	18.5	6.05
5	18.2	6.04
10	18	5.91
15	18	5.94
17.5	18	6.86
20	17.8	5.27
22.5	17.7	4.99
25	16.9	4.32
27.5	15	0.8
30	13.3	0.69
32.5	12.9	0.58
35	12.1	0.55
