# 2021 Data Report for

# Pickerel Lake, Newaygo County

Site ID: 620066

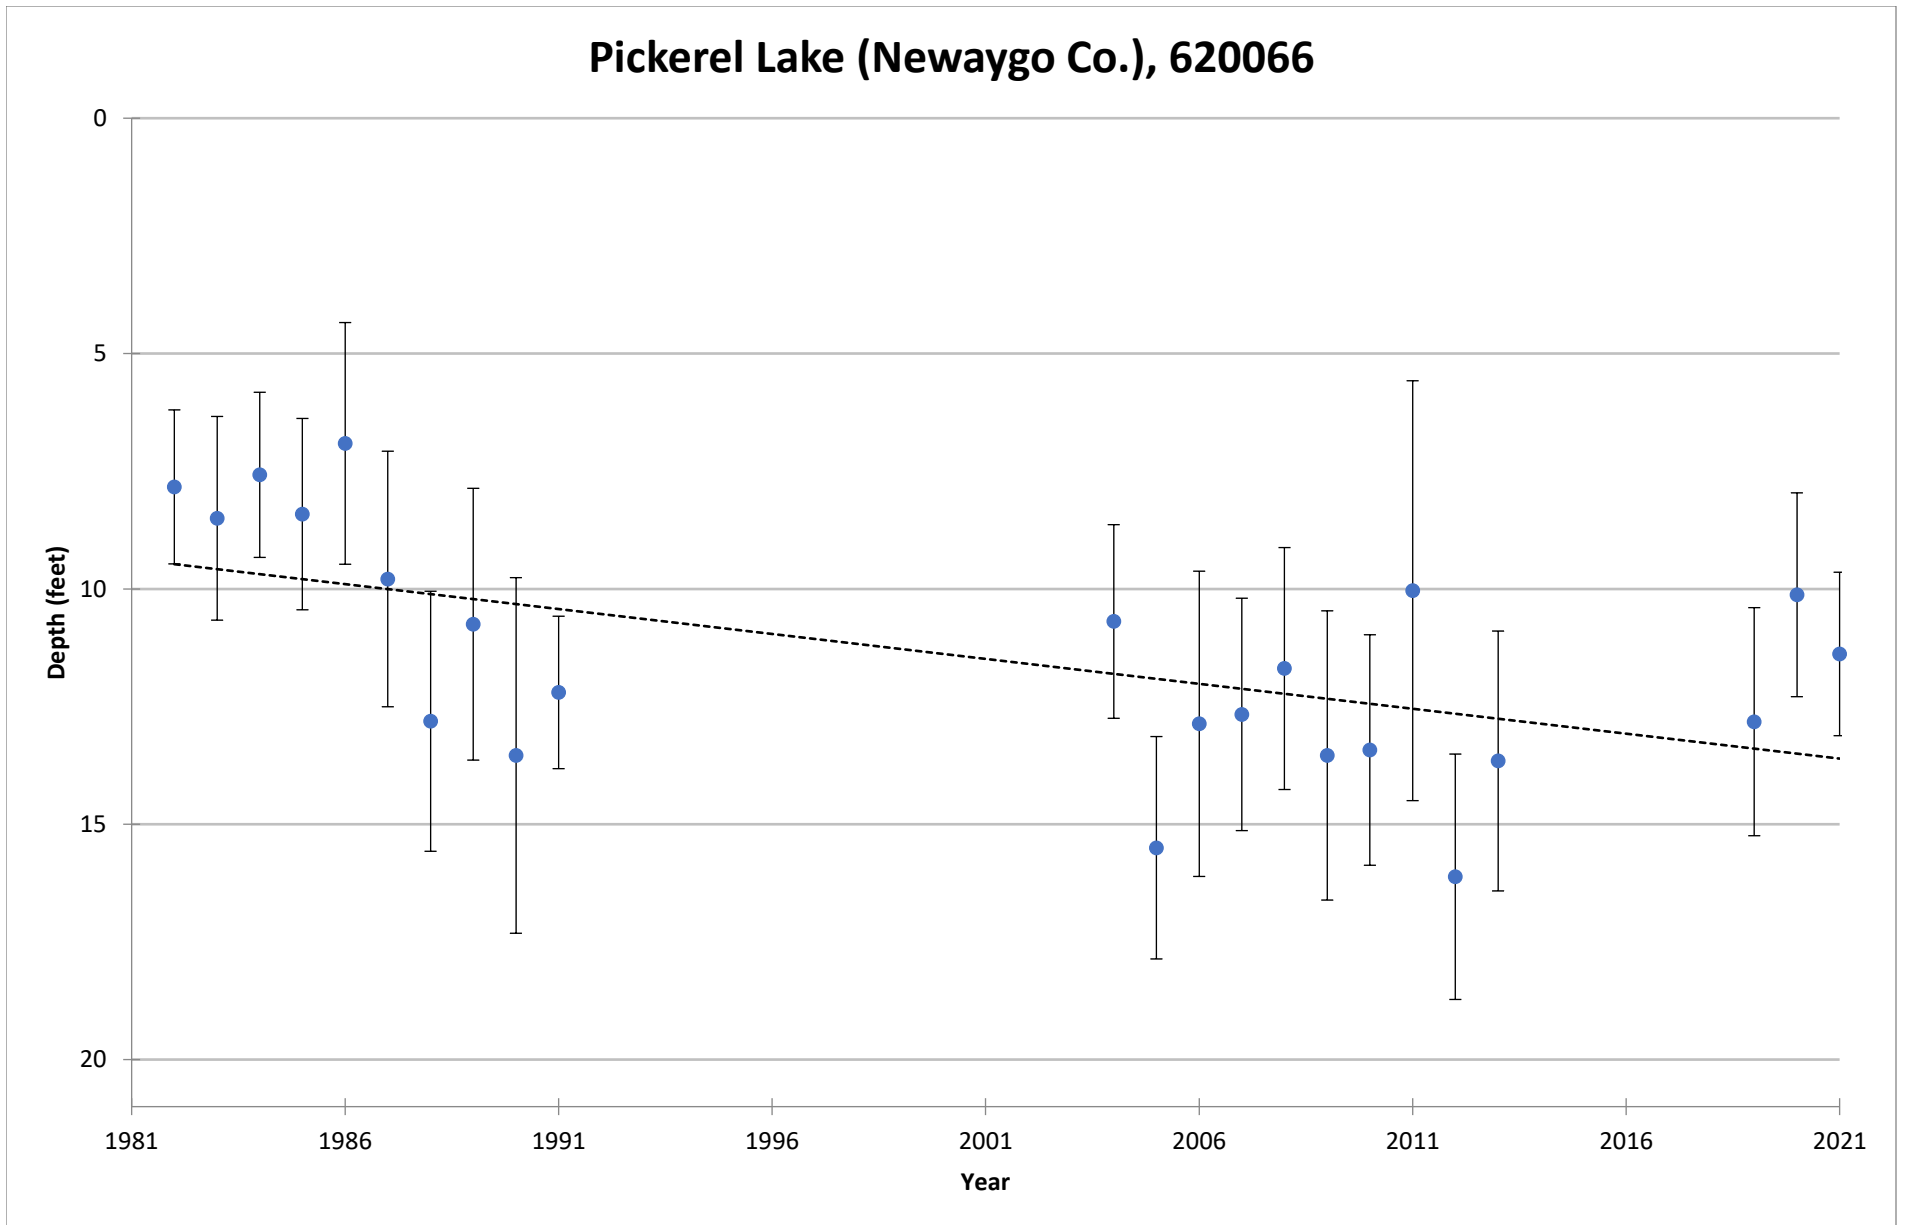
**Pickerel Lake (Newaygo Co.), 620066**

COOPERATIVE LAKES MONITORING PROGRAM  
SUMMER MEAN TRANSPARENCY

Vertical bars indicate standard deviation

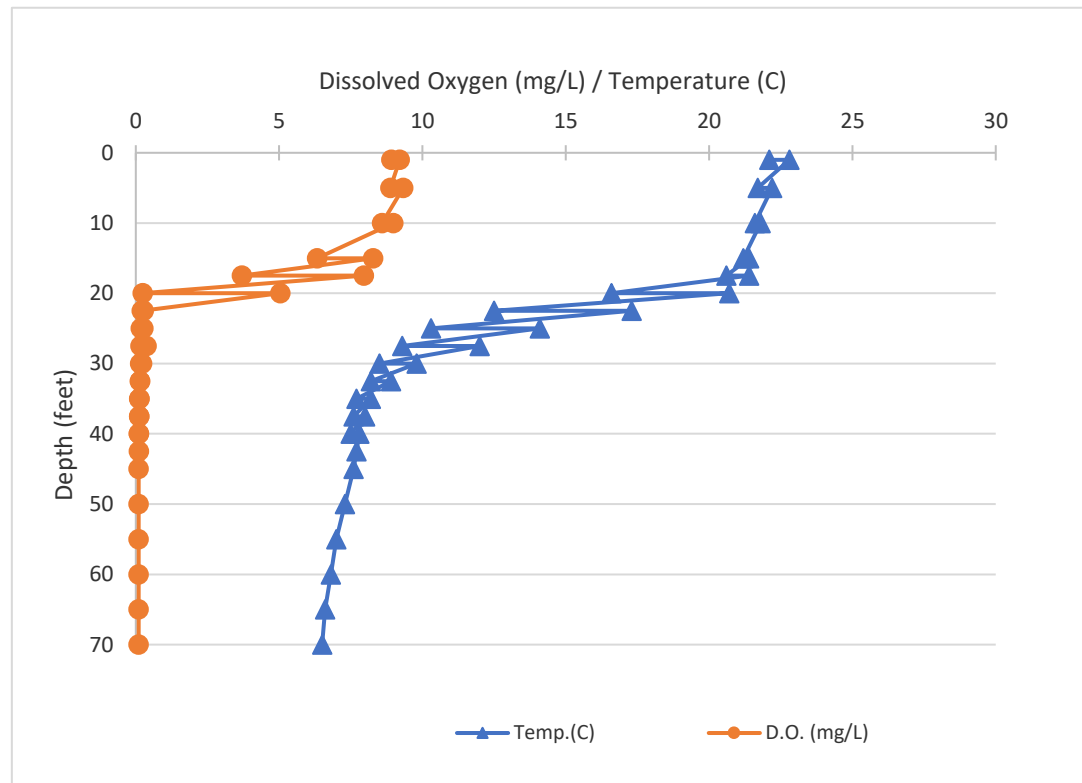
9/18/2021

### Dissolved Oxygen and Temperature Profile
