2021 Data Report for

Crockery Lake, Ottawa County

Site ID: 700422

Crockery Lake, Ottawa County 2021 CLMP Results

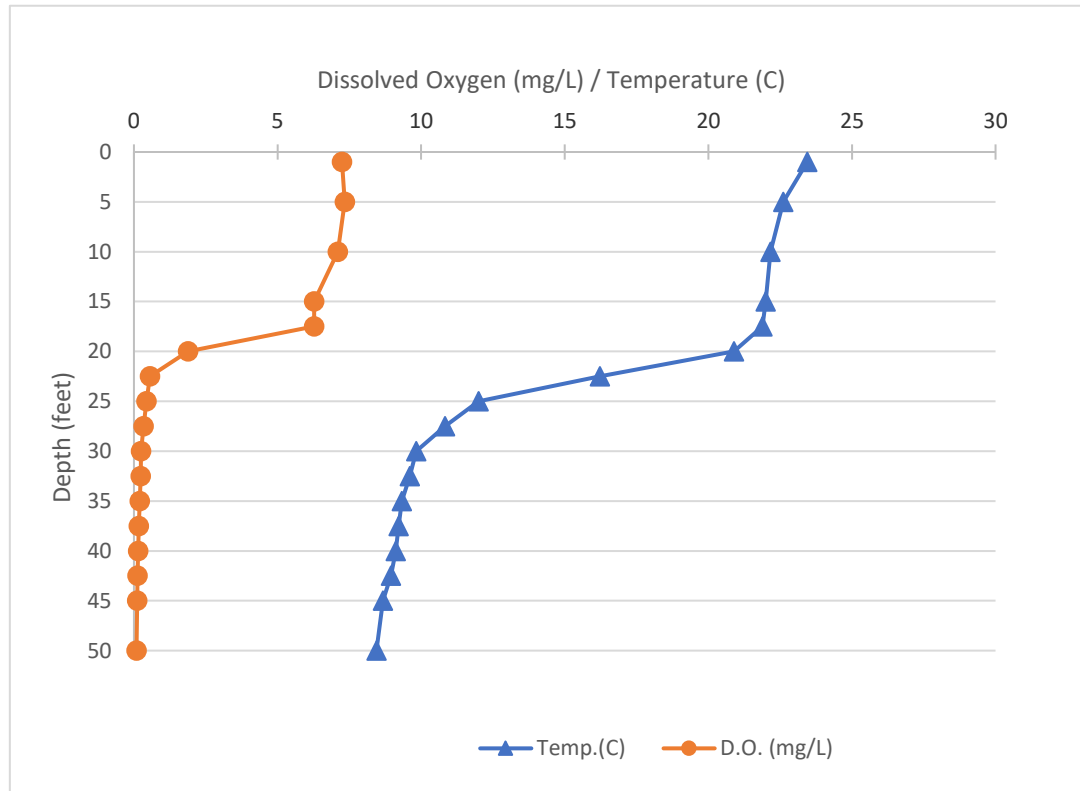
9/15/2021

Dissolved Oxygen and Temperature Profile

Depth (ft)	Temp.(C)	D.O. (mg/L)
1	23.4444444	7.25
5	22.6111111	7.34
10	22.1666667	7.1
15	22	6.28
17.5	21.8888889	6.28
20	20.8888889	1.89
22.5	16.2222222	0.56
25	12	0.44
27.5	10.8333333	0.34
30	9.8333333	0.25
32.5	9.6111111	0.24
35	9.3333333	0.2
37.5	9.2222222	0.17
40	9.1111111	0.15
42.5	8.9444444	0.13
45	8.6666667	0.11
50	8.4444444	0.09
