# **2021 Data Report for Diamond Lake, Osceola County**

Site ID: 670066

# Diamond Lake, Osceola County

## 2021 CLMP Results

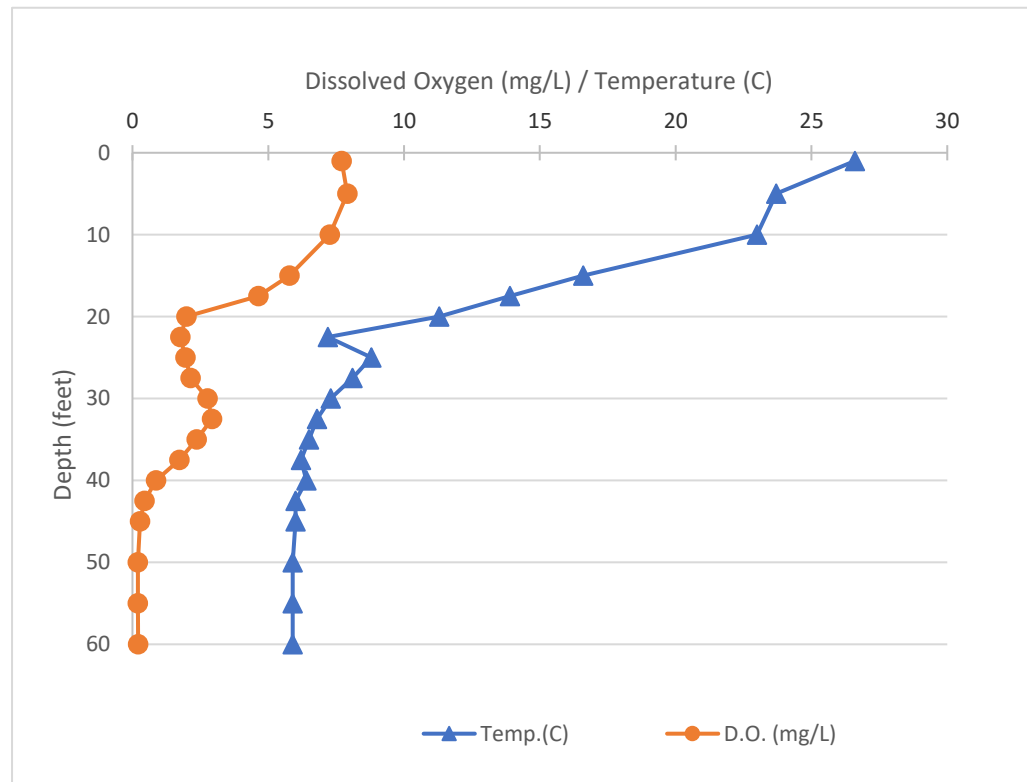
8/4/2021

## Dissolved Oxygen and Temperature Profile

Depth (ft)	Temp.(C)	D.O. (mg/L)
1	26.6	7.7
5	23.7	7.91
10	23	7.26
15	16.6	5.78
17.5	13.9	4.64
20	11.3	1.99
22.5	7.2	1.76
25	8.8	1.95
27.5	8.1	2.14
30	7.3	2.77
32.5	6.8	2.93
35	6.5	2.36
37.5	6.2	1.73
40	6.4	0.87
42.5	6	0.44
45	6	0.28
50	5.9	0.2
55	5.9	0.2
60	5.9	0.21

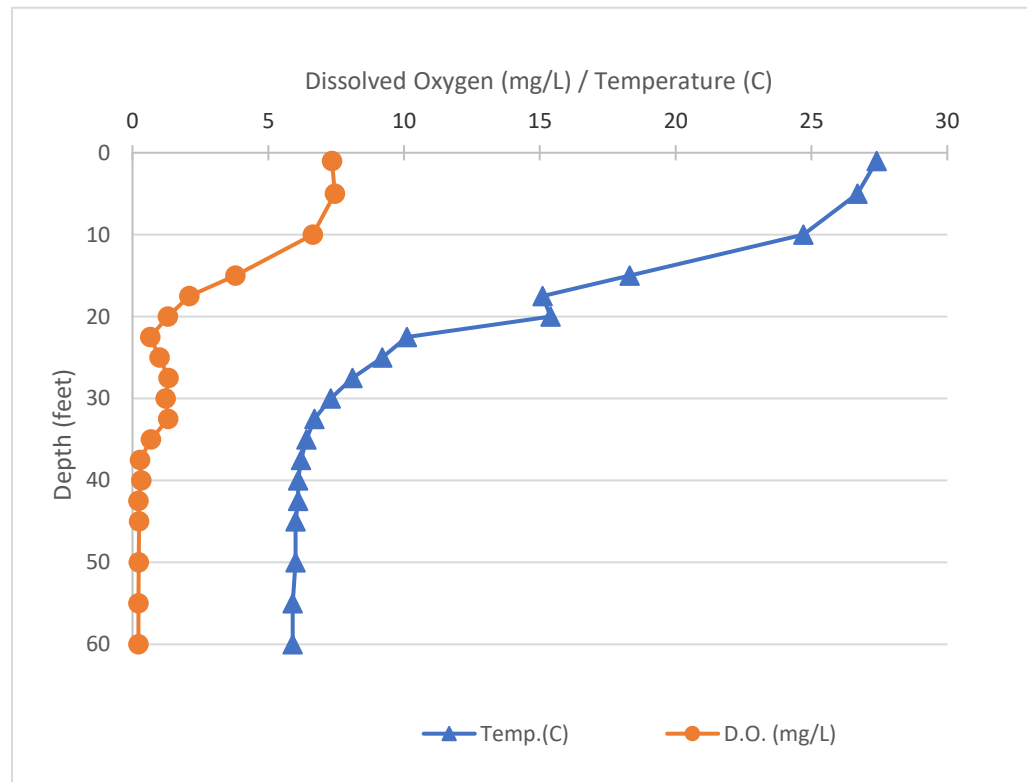
8/21/2021

## Dissolved Oxygen and Temperature Profile

Depth (ft)	Temp.(C)	D.O. (mg/L)
1	27.4	7.35
5	26.7	7.45
10	24.7	6.64
15	18.3	3.79
17.5	15.1	2.09
20	15.4	1.3
22.5	10.1	0.66
25	9.2	1
27.5	8.1	1.33
30	7.3	1.22
32.5	6.7	1.31
35	6.4	0.68
37.5	6.2	0.28
40	6.1	0.33
42.5	6.1	0.22
45	6	0.24
50	6	0.23
55	5.9	0.22
60	5.9	0.22
