2021 Data Report for

Oneida Lake, Livingston County

Site ID: 470593

Oneida Lake, Livingston County 2021 CLMP Results

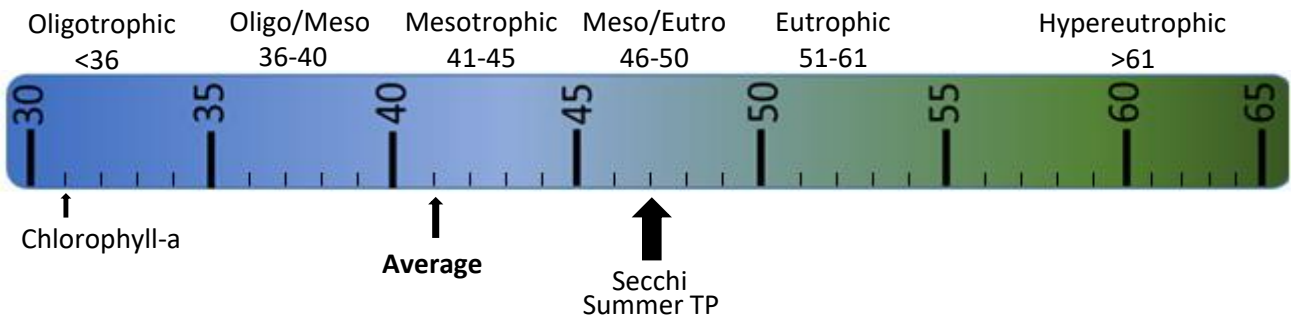
In 1977, limnologist Dr. Robert Carlson developed a numerical scale (0-100) where the numbers indicate the level of nutrient enrichment. Using the proper equations, we can convert results from Summer Total Phosphorus, Secchi Depth, and Chlorophyll-a to this Trophic Status Index (TSI). The TSI numbers are furthermore grouped into general categories (oligotrophic, mesotrophic, eutrophic, and hypereutrophic), to quickly give us a way to understand the general nutrient level of any lake.

TSI for Oneida Lake in 2021	
Average	41
Secchi Disk	47
Summer TP	47
Chlorophyll-a	<31

Oligotrophic: Generally deep and clear lakes with little aquatic plant or algae growth. These lakes maintain sufficient dissolved oxygen in the cool, deep-bottom waters during late summer to support cold water fish, such as trout and whitefish.

Mesotrophic: Lakes that fall between oligotrophic and eutrophic. Mid-ranged amounts of nutrients.

Eutrophic: Highly productive eutrophic lakes are generally shallow, turbid, and support abundant aquatic plant growth. In deep eutrophic lakes, the cool bottom waters usually contain little or no dissolved oxygen. Therefore, these lakes can only support warm water fish, such as bass and pike.

Hypereutrophic: A specialized category of eutrophic lakes. These lakes exhibit extremely high productivity, such as nuisance algae and weed growth.

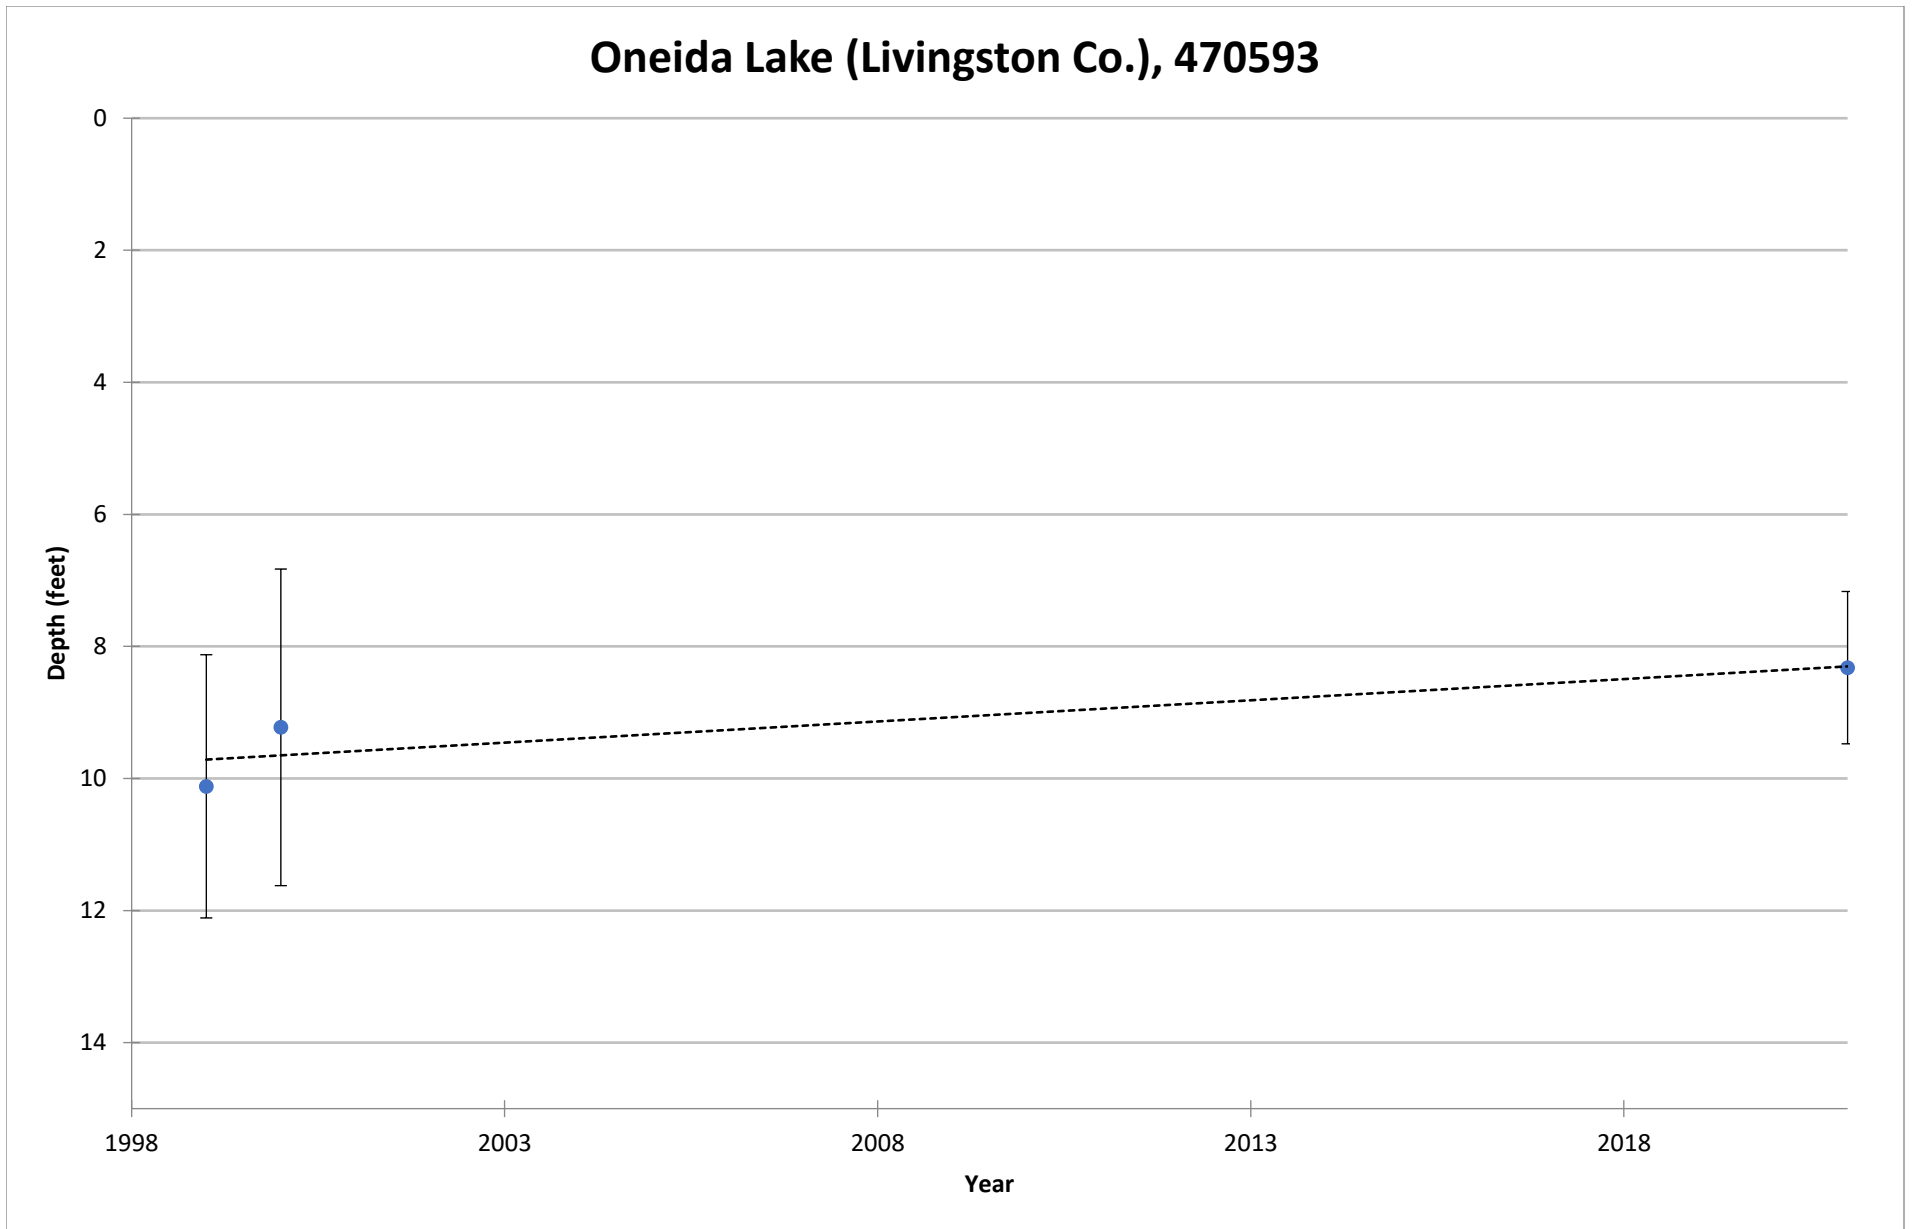
COOPERATIVE LAKES MONITORING PROGRAM
SUMMER MEAN TRANSPARENCY

Oneida Lake (Livingston Co.), 470593

Vertical bars indicate standard deviation

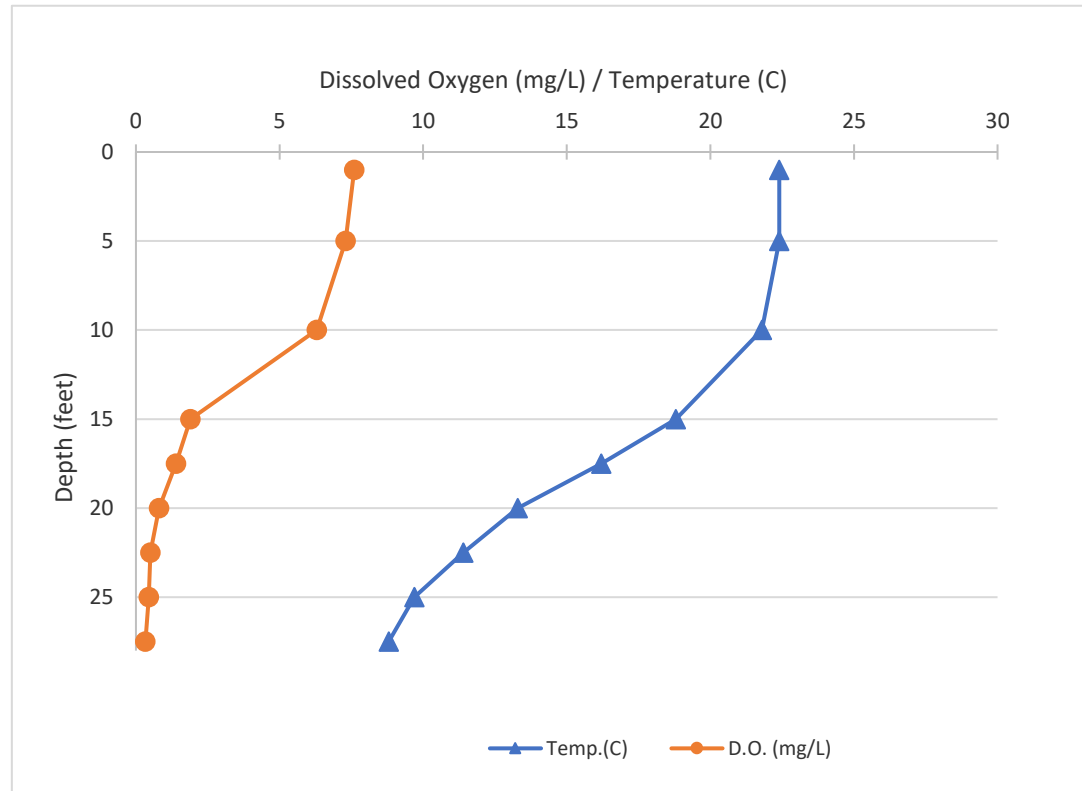
Dissolved Oxygen and Temperature Profile

Name: Oneida Lake
County: Livingston
Site ID: 470593
Date: 9/18/2021

Depth (ft)	Temp.(C)	D.O. (mg/L)
1	22.4	7.6
5	22.4	7.3
10	21.8	6.3
15	18.8	1.9
17.5	16.2	1.4
20	13.3	0.8
22.5	11.4	0.5
25	9.7	0.45
27.5	8.8	0.33

The lake is anoxic on the bottom from the first sampling in the spring; as the summer continues, it continues to stratify into distinct layers. Based on the monitoring, it is not clear if the bottom waters ever have oxygen.
