2021 Data Report for Otter Lake, Oakland County

Site ID: 631193

Otter Lake, Oakland County 2021 CLMP Results

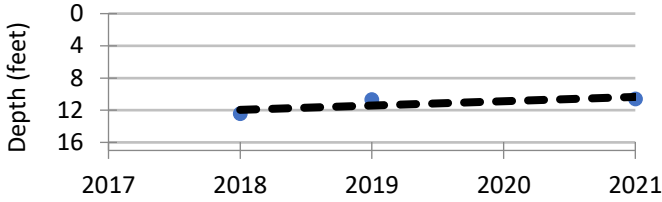
Secchi Disk Transparency (feet)

Year	# Readings	Min	Max	Avg	Std. Dev	Carlson TSI
2021	11	7.0	16.5	10.6	3.1	43
2018-2019	35	7.0	22.0	10.6	3.2	42
2021 All CLMP Lakes	2817	1.0	50.0	12.7	2.9	42

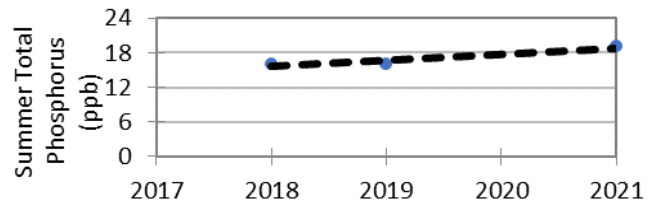
Summer Phosphorus (parts per billion)

Year	# Samples	Min	Max	Avg	Std. Dev	Carlson TSI
2021	1	19.0	19.0	19.0	NA	47
2018-2019	2	16.0	16.0	16.0	0.0	44
2021 All CLMP Lakes	281	<= 3	65.0	12.8	9.3	38

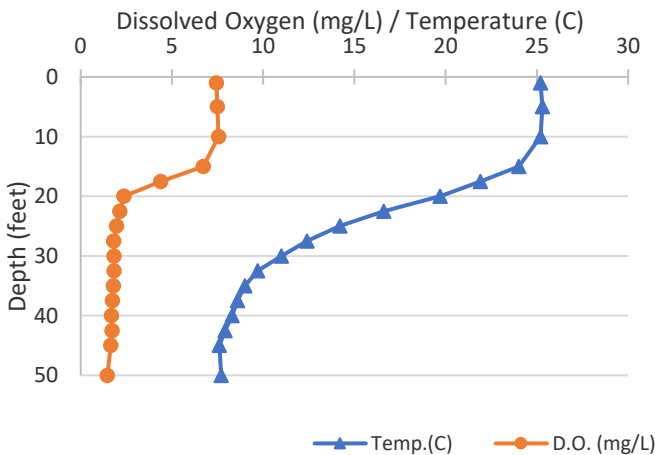
Dissolved Oxygen and Temperature Profile

The lake keeps some dissolved oxygen in the bottom waters through mid-summer, but by late summer the lake has stratified and the bottom water is devoid of oxygen.

If you enrolled in Dissolved Oxygen/Temperature, the summary page will have a graph of one of the profiles taken during the late summer (typically August or September). If your lake stratifies, we will use a graph showing the earliest time of stratification, because identifying the timing of this condition and the depth at which it occurs is typically the most important use of dissolved oxygen measurements.

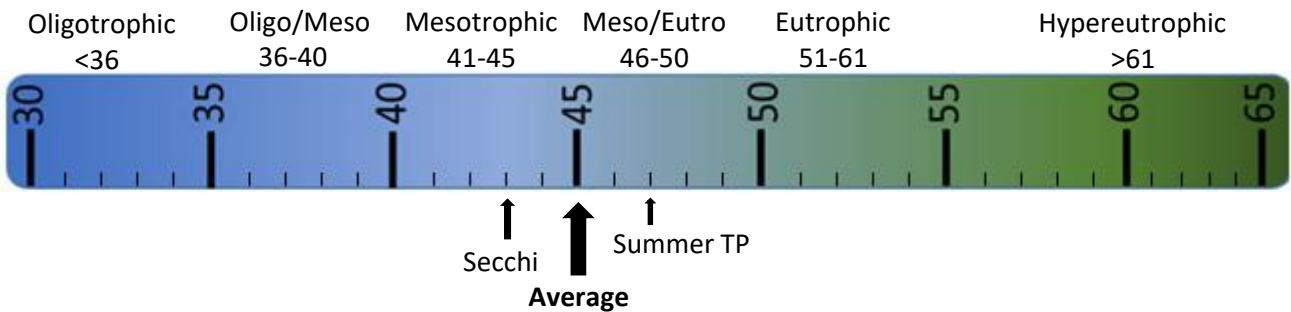
With an average TSI score of 45 based on 2021 Secchi transparency and summer total phosphorus data, this lake is rated as a mesotrophic lake.

TSI for Otter Lake in 2021	
Average	45
Secchi Disk	43
Summer TP	47
Chlorophyll-a

In 1977, limnologist Dr. Robert Carlson developed a numerical scale (0-100) where the numbers indicate the level of nutrient enrichment. Using the proper equations, we can convert results from Summer Total Phosphorus, Secchi Depth, and Chlorophyll-a to this Trophic Status Index (TSI). The TSI numbers are furthermore grouped into general categories (oligotrophic, mesotrophic, eutrophic, and hypereutrophic), to quickly give us a way to understand the general nutrient level of any lake.

Oligotrophic: Generally deep and clear lakes with little aquatic plant or algae growth. These lakes maintain sufficient dissolved oxygen in the cool, deep-bottom waters during late summer to support cold water fish, such as trout and whitefish.

Mesotrophic: Lakes that fall between oligotrophic and eutrophic. Mid-ranged amounts of nutrients.

Eutrophic: Highly productive eutrophic lakes are generally shallow, turbid, and support abundant aquatic plant growth. In deep eutrophic lakes, the cool bottom waters usually contain little or no dissolved oxygen. Therefore, these lakes can only support warm water fish, such as bass and pike.

Hypereutrophic: A specialized category of eutrophic lakes. These lakes exhibit extremely high productivity, such as nuisance algae and weed growth.

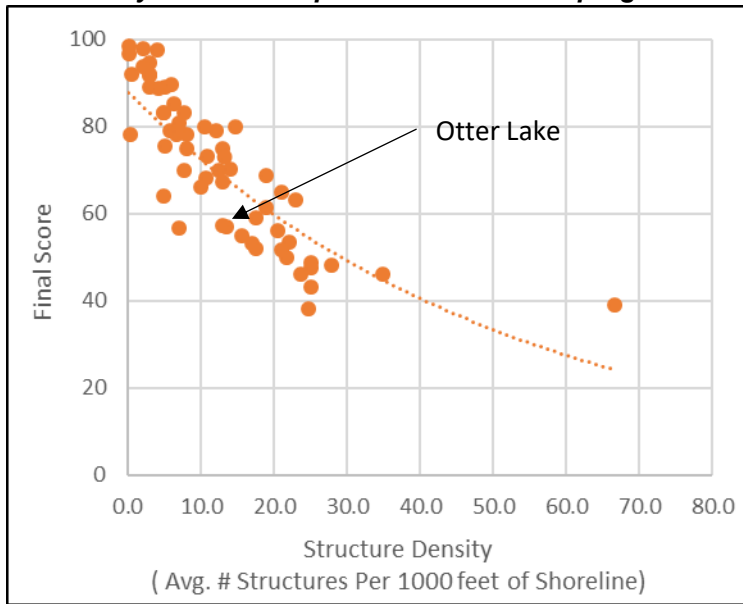
How does your lake compare to others in the program?

Otter Lake:	
Number of Sections:	26
Number of Structures:	57
Structure Density:	13
Final Score:	57

All 62 Participating Lakes from 2015-2019:	
Avg. Number of Sections:	16
Avg. Number of Structures:	228
Avg. Structure Density:	12.6
Avg. Final Score:	71

Overall, the lakeshore habitat of Otter Lake is below average when compared to the other lakes in the program. About 1/3 of the lake sections score poor (9 poor, 14 fair, 3 good).

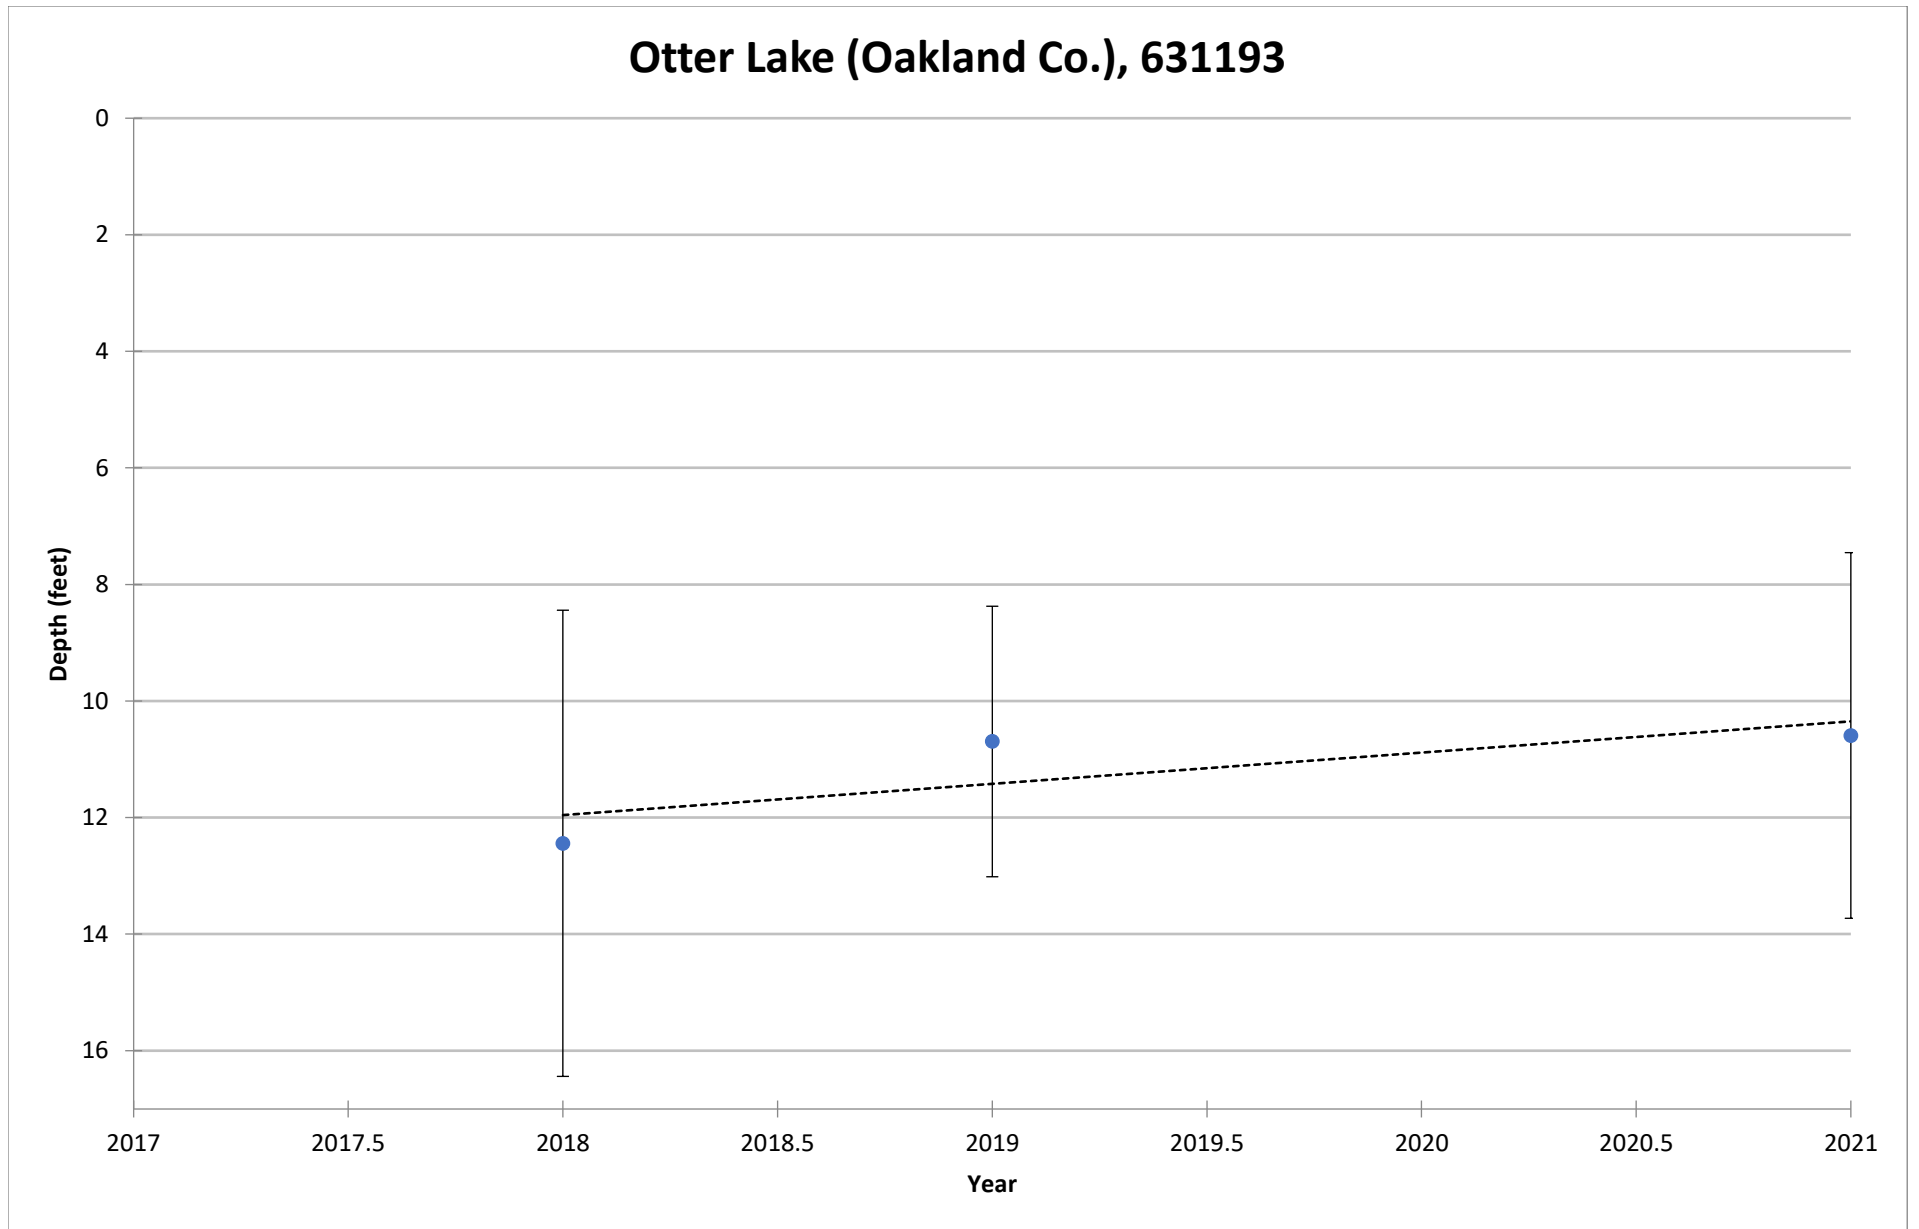
COOPERATIVE LAKES MONITORING PROGRAM
SUMMER MEAN TRANSPARENCY

Otter Lake (Oakland Co.), 631193

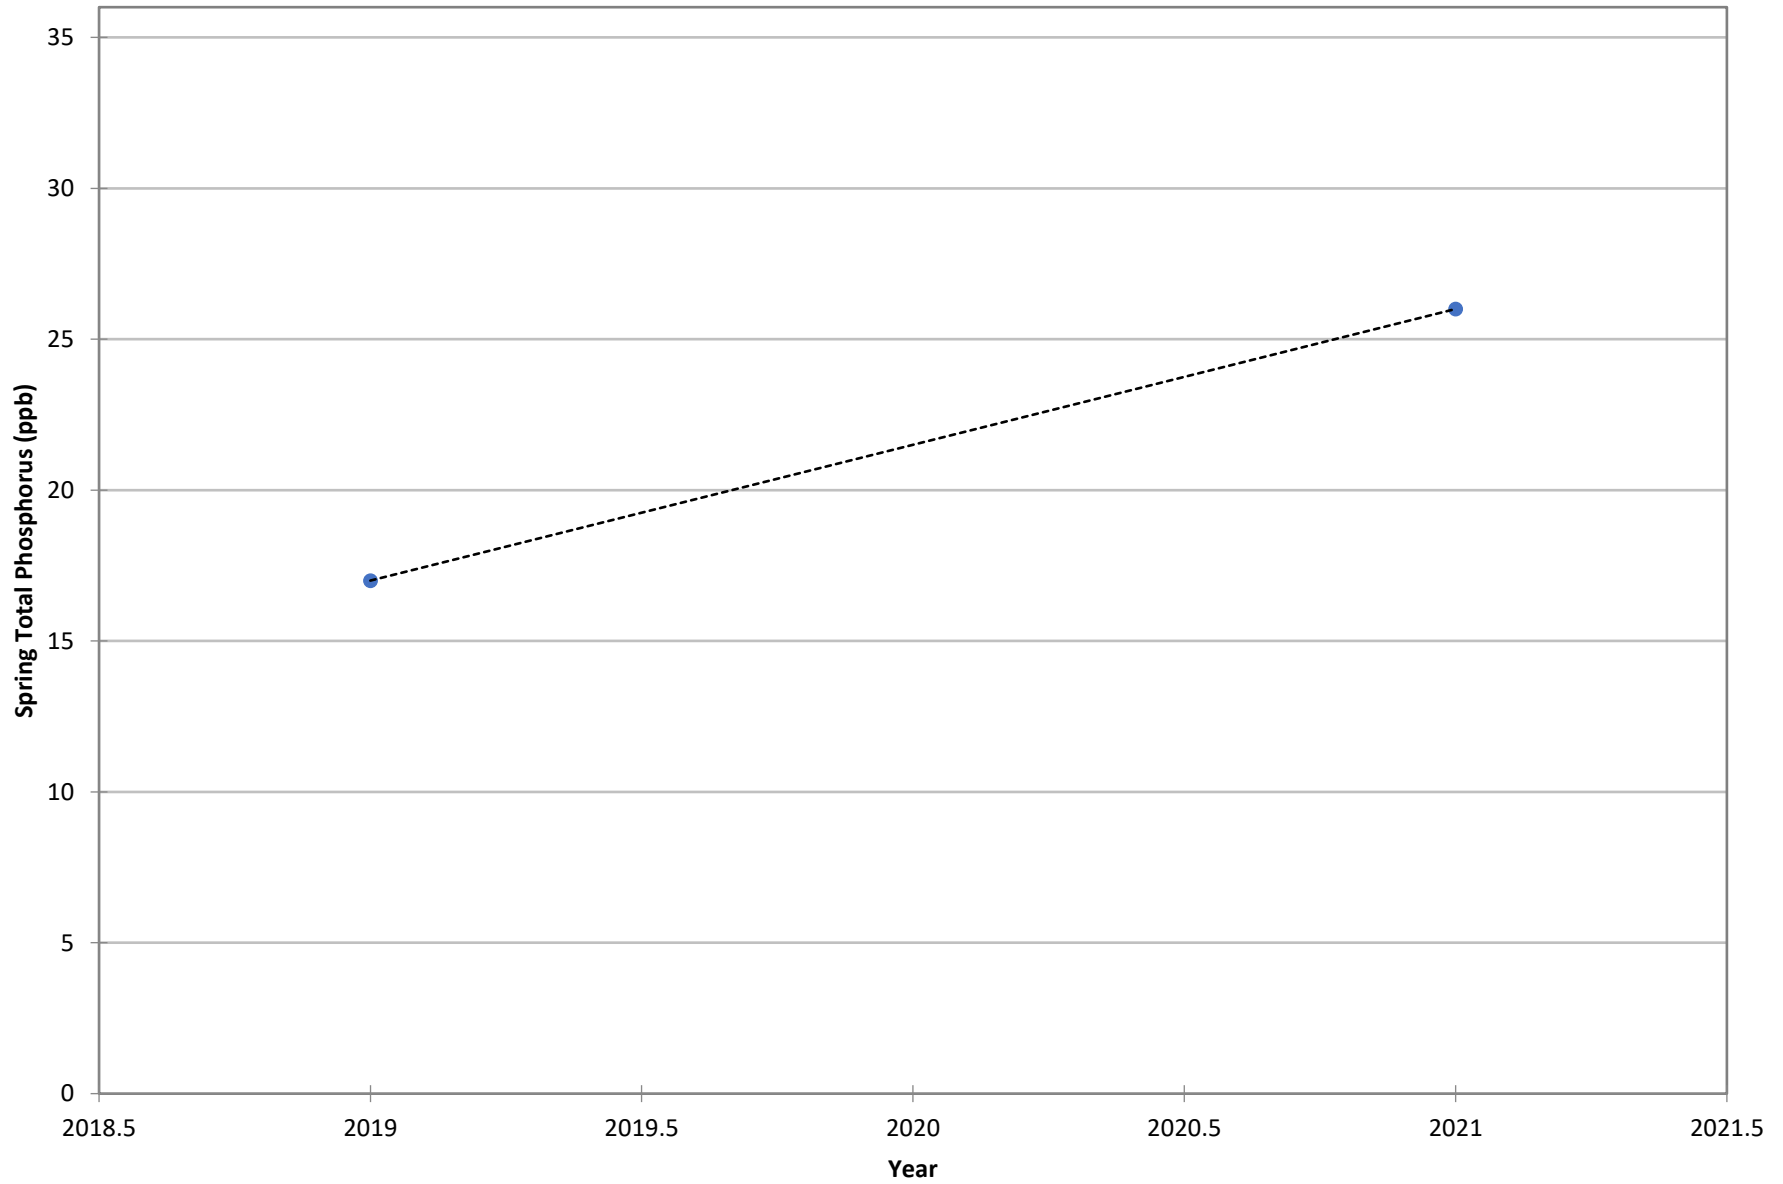
COOPERATIVE LAKES MONITORING PROGRAM
SPRING TOTAL PHOSPHORUS

Vertical bars indicate standard deviation

Otter Lake (Oakland Co.), 631193

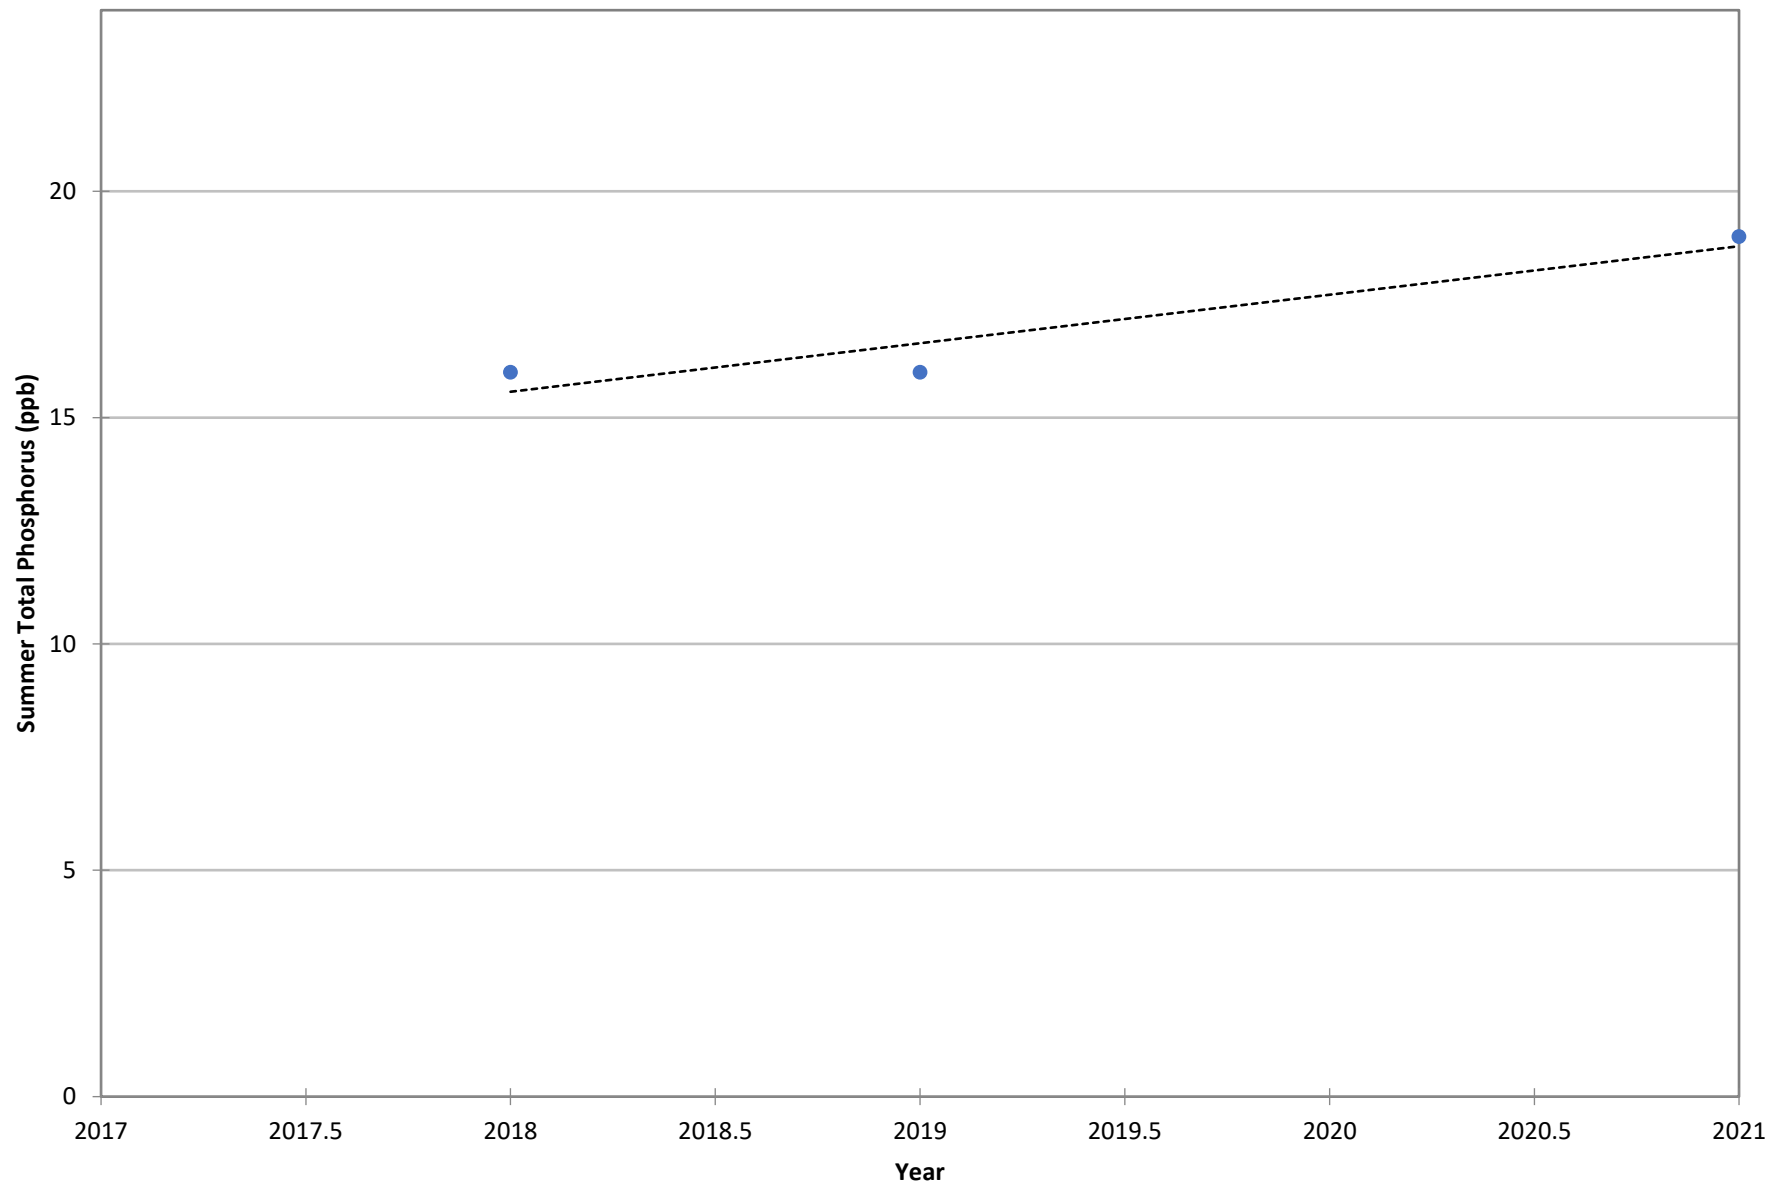
COOPERATIVE LAKES MONITORING PROGRAM
SUMMER TOTAL PHOSPHORUS

Otter Lake (Oakland Co.), 631193

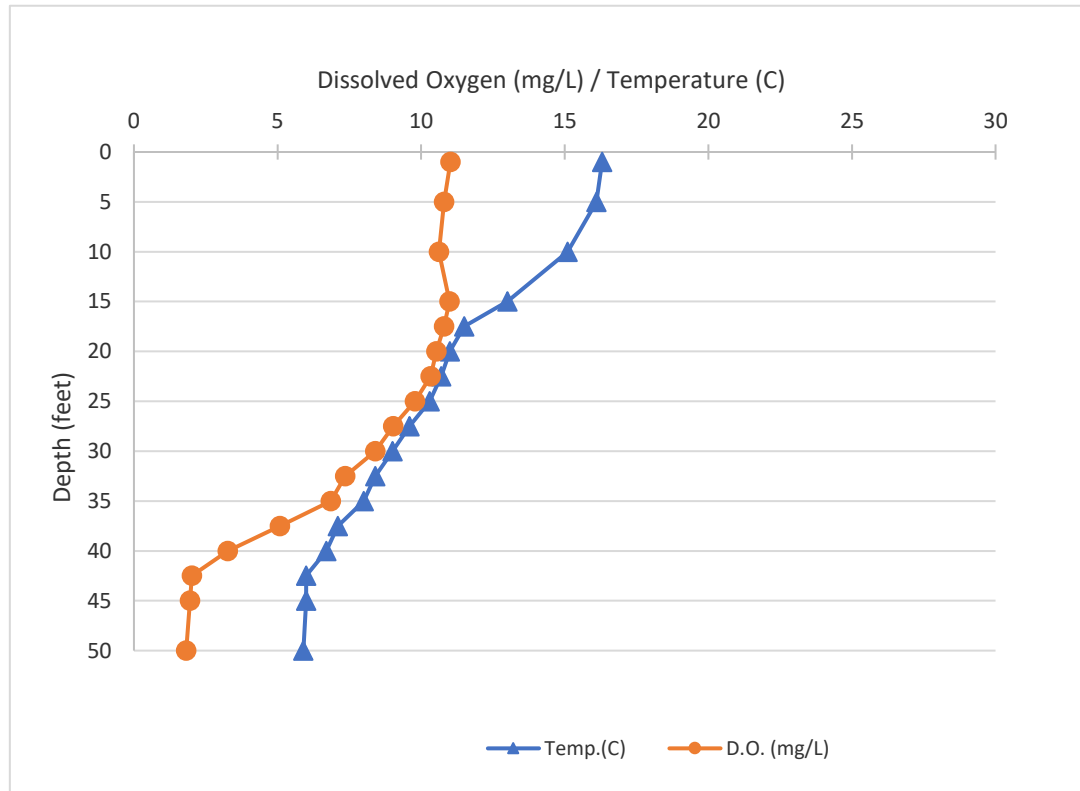
Name: Otter Lake
 County: Oakland
 Site ID: 631193
 Date: 5/17/2019

Depth (ft)	Temp.(C)	D.O. (mg/L)
1	16.3	11.02
5	16.1	10.8
10	15.1	10.62
15	13	10.99
17.5	11.5	10.8
20	11	10.53
22.5	10.7	10.33
25	10.3	9.78
27.5	9.6	9.03
30	9	8.4
32.5	8.4	7.36
35	8	6.85
37.5	7.1	5.08
40	6.7	3.27
42.5	6	2.02
45	6	1.95
50	5.9	1.82

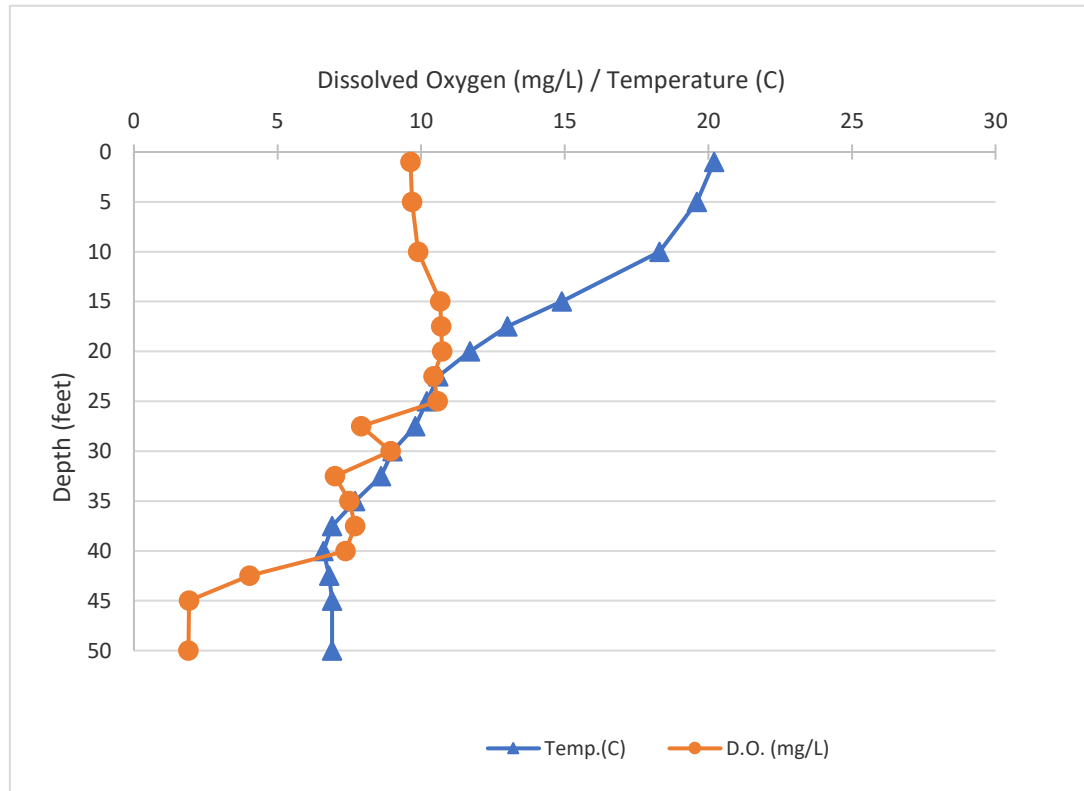
Name: Otter Lake
 County: Oakland
 Site ID: 631193
 Date: 5/31/2019

Depth (ft)	Temp.(C)	D.O. (mg/L)
1	20.2	9.63
5	19.6	9.69
10	18.3	9.9
15	14.9	10.67
17.5	13	10.7
20	11.7	10.73
22.5	10.6	10.43
25	10.2	10.58
27.5	9.8	7.91
30	9	8.94
32.5	8.6	7
35	7.7	7.5
37.5	6.9	7.7
40	6.6	7.37
42.5	6.8	4.02
45	6.9	1.92
50	6.9	1.9

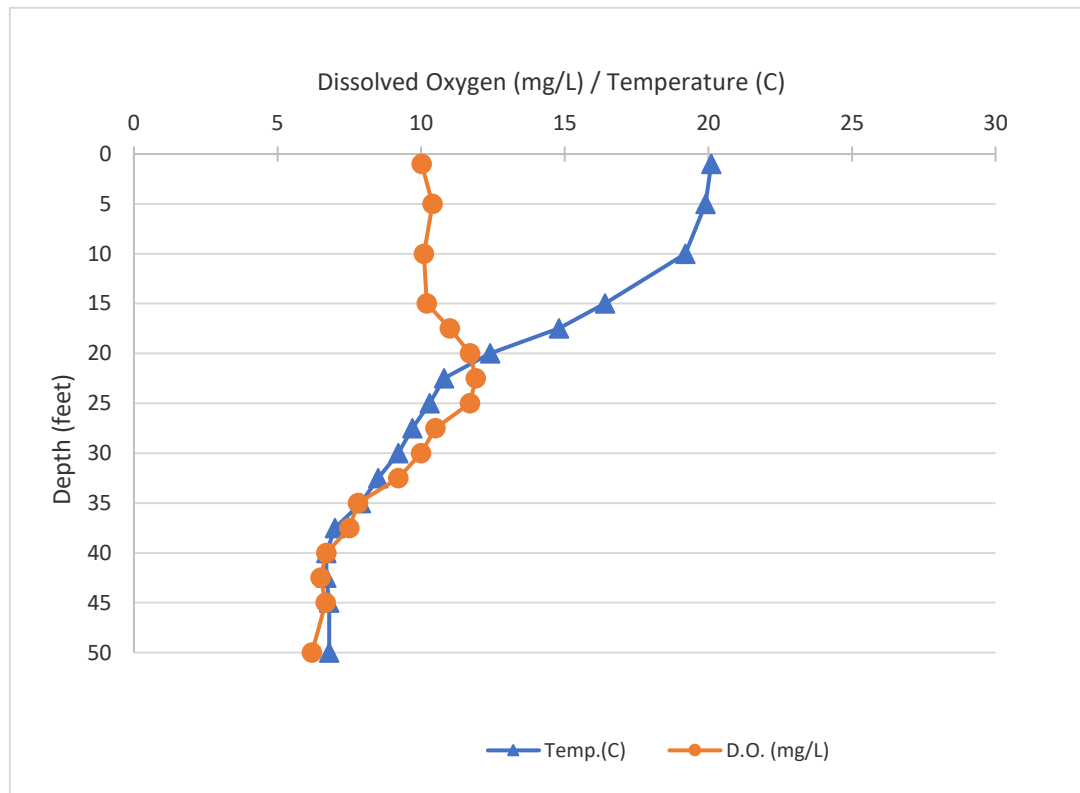
Name: Otter Lake
 County: Oakland
 Site ID: 631193
 Date: 6/11/2019

Depth (ft)	Temp.(C)	D.O. (mg/L)
1	20.1	10.02
5	19.9	10.4
10	19.2	10.1
15	16.4	10.2
17.5	14.8	11
20	12.4	11.7
22.5	10.8	11.9
25	10.3	11.7
27.5	9.7	10.5
30	9.2	10
32.5	8.5	9.2
35	7.9	7.8
37.5	7	7.5
40	6.7	6.7
42.5	6.7	6.5
45	6.8	6.68
50	6.8	6.2

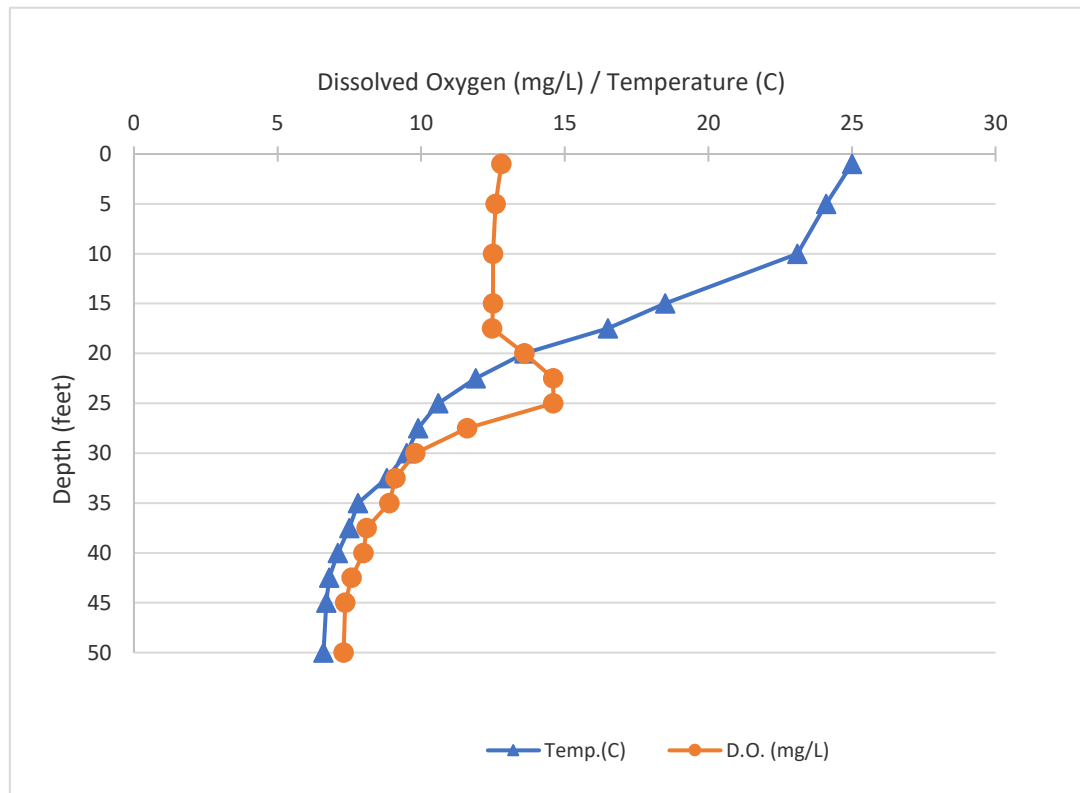
Name: Otter Lake
County: Oakland
Site ID: 631193
Date: 6/27/2019

Depth (ft)	Temp.(C)	D.O. (mg/L)
1	25	12.79
5	24.1	12.59
10	23.1	12.5
15	18.5	12.5
17.5	16.5	12.47
20	13.6	13.6
22.5	11.9	14.6
25	10.6	14.6
27.5	9.9	11.6
30	9.5	9.8
32.5	8.8	9.1
35	7.8	8.89
37.5	7.5	8.1
40	7.1	7.99
42.5	6.8	7.58
45	6.7	7.36
50	6.6	7.3

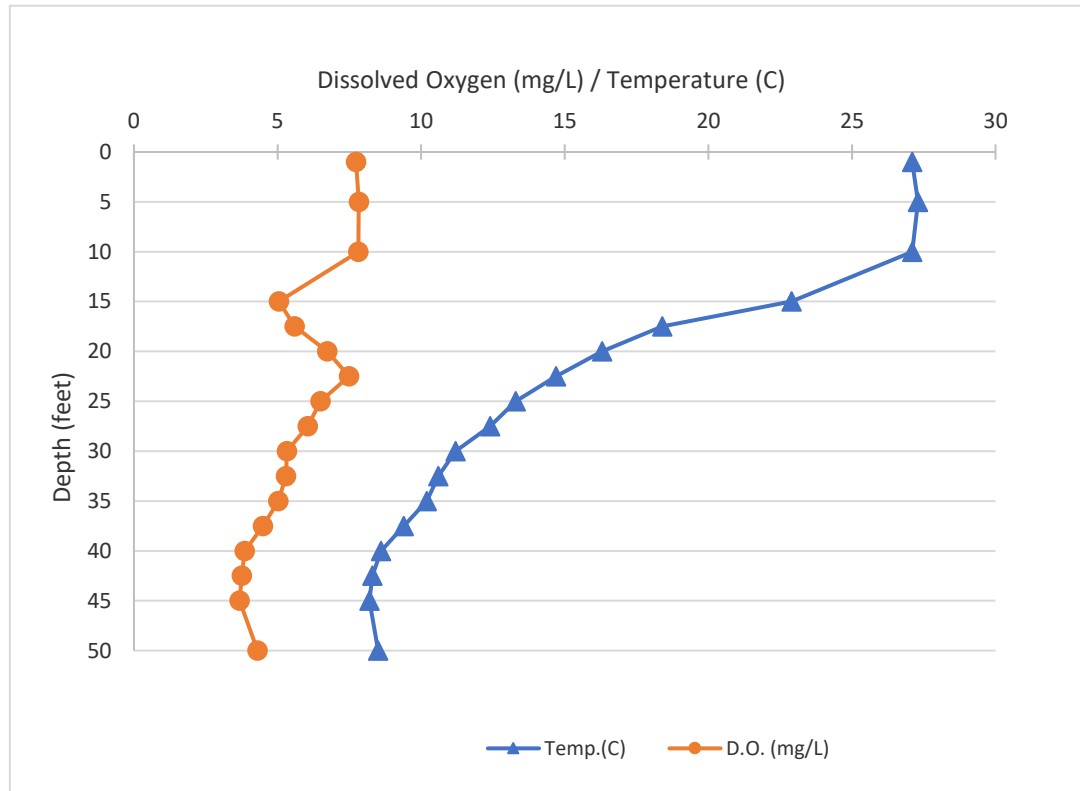
Name: Otter Lake
 County: Oakland
 Site ID: 631193
 Date: 7/12/2019

Depth (ft)	Temp.(C)	D.O. (mg/L)
1	27.1	7.73
5	27.3	7.83
10	27.1	7.81
15	22.9	5.05
17.5	18.4	5.6
20	16.3	6.73
22.5	14.7	7.49
25	13.3	6.5
27.5	12.4	6.05
30	11.2	5.33
32.5	10.6	5.29
35	10.2	5.03
37.5	9.4	4.49
40	8.6	3.86
42.5	8.3	3.76
45	8.2	3.68
50	8.5	4.3

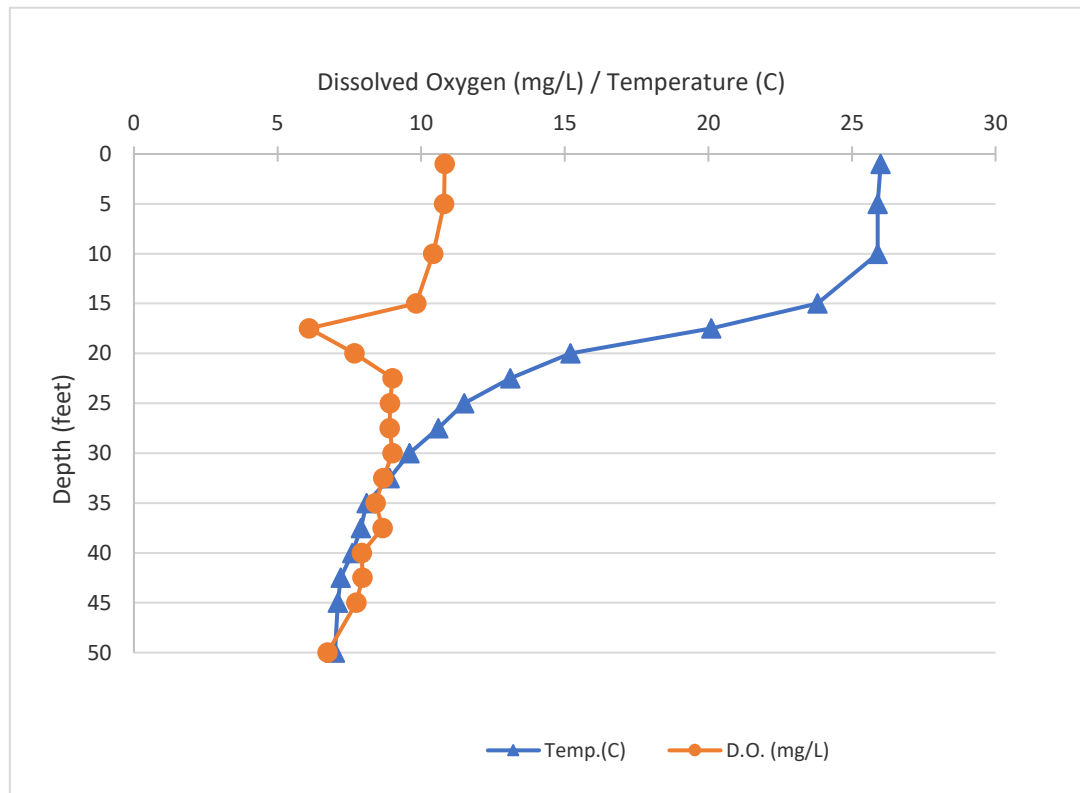
Name: Otter Lake
 County: Oakland
 Site ID: 631193
 Date: 7/27/2019

Depth (ft)	Temp.(C)	D.O. (mg/L)
1	26	10.82
5	25.9	10.8
10	25.9	10.42
15	23.8	9.83
17.5	20.1	6.1
20	15.2	7.68
22.5	13.1	9
25	11.5	8.92
27.5	10.6	8.9
30	9.6	9
32.5	8.9	8.68
35	8.1	8.41
37.5	7.9	8.66
40	7.6	7.93
42.5	7.2	7.96
45	7.1	7.75
50	7	6.74

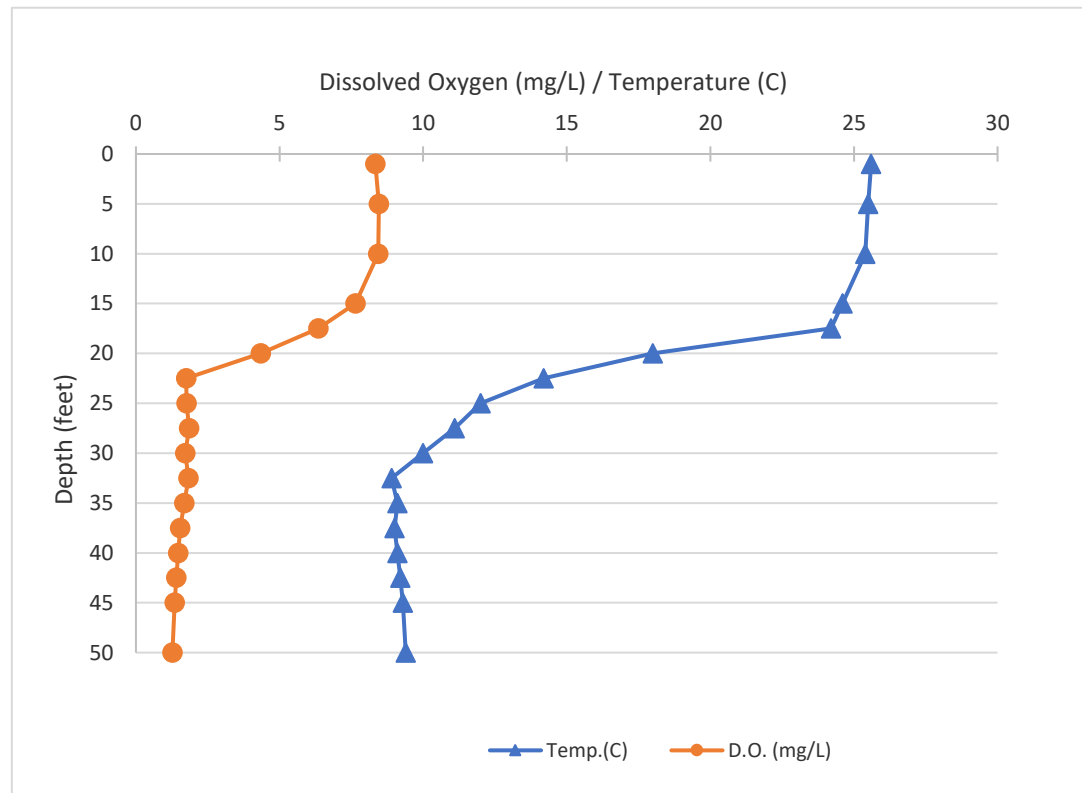
Name: Otter Lake
 County: Oakland
 Site ID: 631193
 Date: 8/10/2019

Depth (ft)	Temp.(C)	D.O. (mg/L)
1	25.6	8.34
5	25.5	8.46
10	25.4	8.44
15	24.6	7.65
17.5	24.2	6.35
20	18	4.35
22.5	14.2	1.75
25	12	1.76
27.5	11.1	1.85
30	10	1.72
32.5	8.9	1.83
35	9.1	1.68
37.5	9	1.54
40	9.1	1.47
42.5	9.2	1.41
45	9.3	1.35
50	9.4	1.27

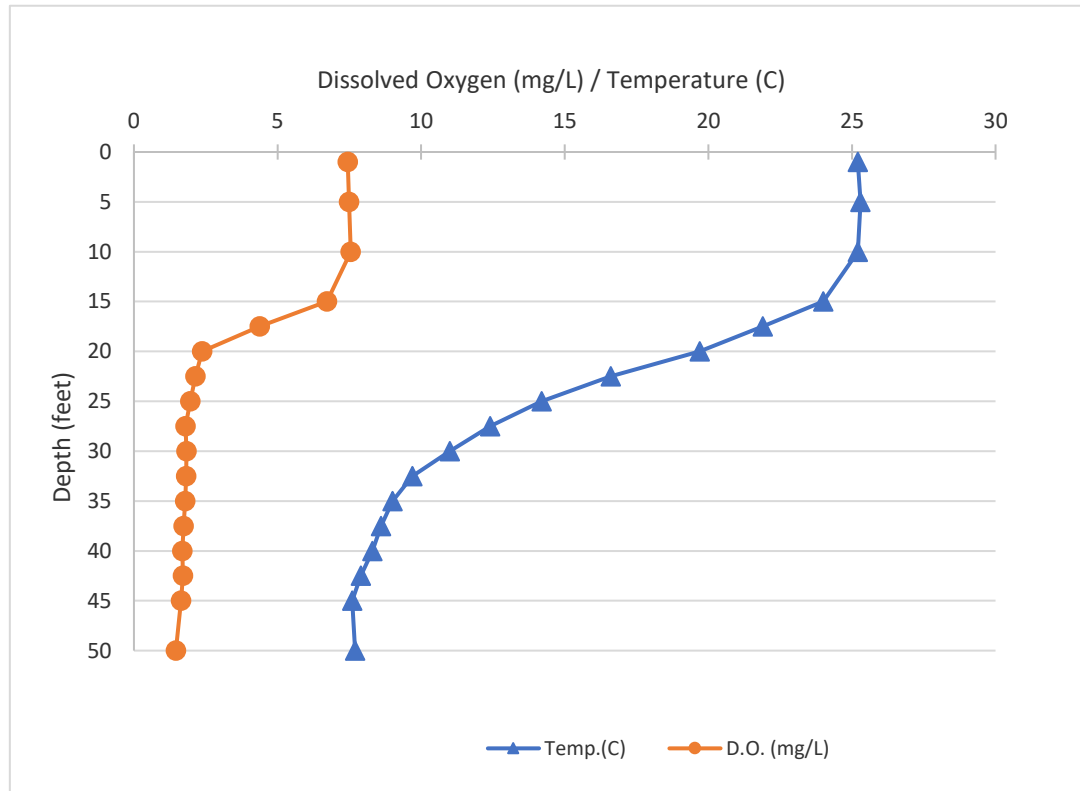
Name: Otter Lake
 County: Oakland
 Site ID: 631193
 Date: 8/23/2019

Depth (ft)	Temp.(C)	D.O. (mg/L)
1	25.2	7.44
5	25.3	7.49
10	25.2	7.55
15	24	6.72
17.5	21.9	4.38
20	19.7	2.37
22.5	16.6	2.14
25	14.2	1.96
27.5	12.4	1.8
30	11	1.83
32.5	9.7	1.82
35	9	1.78
37.5	8.6	1.73
40	8.3	1.69
42.5	7.9	1.71
45	7.6	1.64
50	7.7	1.46

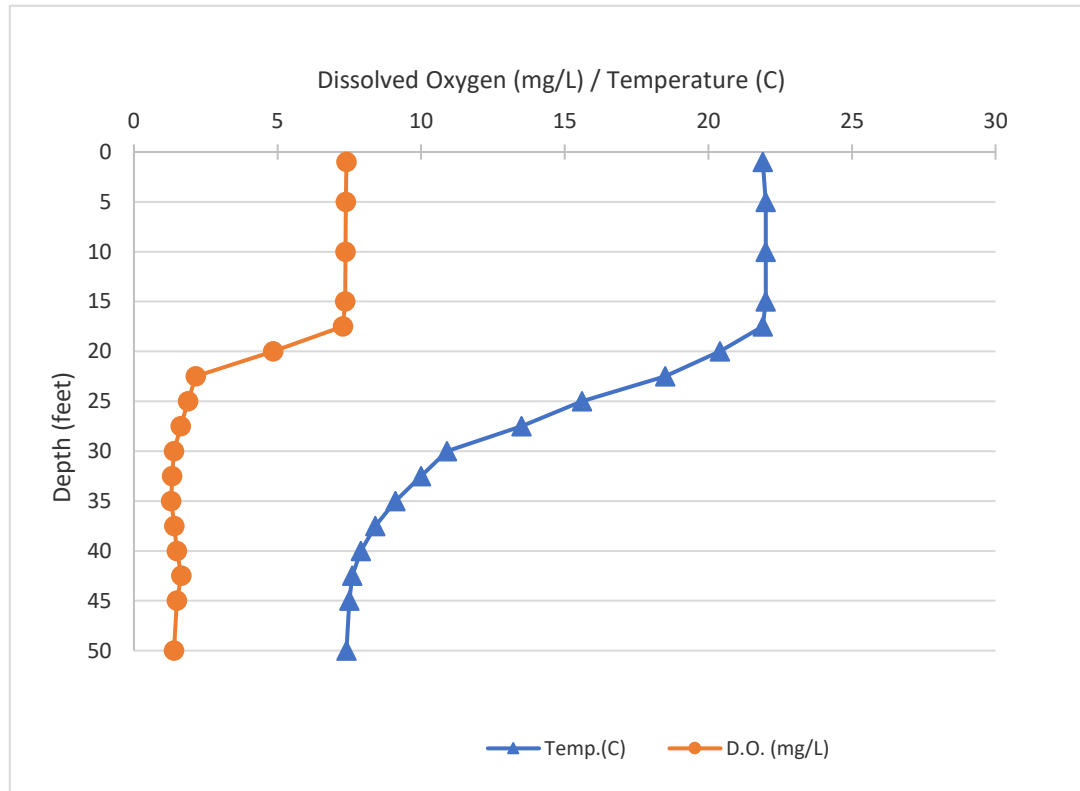
Name: Otter Lake
 County: Oakland
 Site ID: 631193
 Date: 9/4/2019

Depth (ft)	Temp.(C)	D.O. (mg/L)
1	21.9	7.4
5	22	7.38
10	22	7.37
15	22	7.36
17.5	21.9	7.28
20	20.4	4.85
22.5	18.5	2.15
25	15.6	1.89
27.5	13.5	1.63
30	10.9	1.39
32.5	10	1.33
35	9.1	1.3
37.5	8.4	1.41
40	7.9	1.49
42.5	7.6	1.65
45	7.5	1.5
50	7.4	1.39

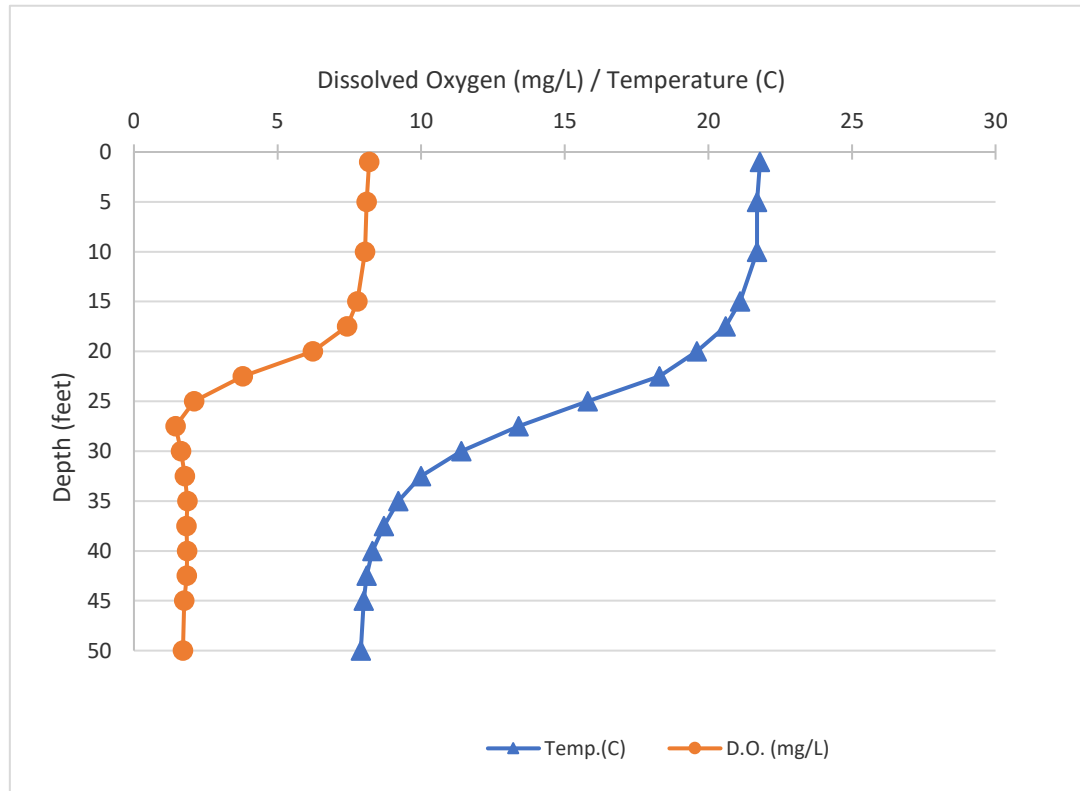
Name: Otter Lake
 County: Oakland
 Site ID: 631193
 Date: 9/16/2019

Depth (ft)	Temp.(C)	D.O. (mg/L)
1	21.8	8.19
5	21.7	8.1
10	21.7	8.05
15	21.1	7.78
17.5	20.6	7.42
20	19.6	6.23
22.5	18.3	3.79
25	15.8	2.1
27.5	13.4	1.45
30	11.4	1.64
32.5	10	1.77
35	9.2	1.86
37.5	8.7	1.83
40	8.3	1.85
42.5	8.1	1.84
45	8	1.75
50	7.9	1.71
