2022 Data Report for Big Bass Lake, Lake County

Site ID: 430029

Big Bass Lake, Lake County 2022 CLMP Results

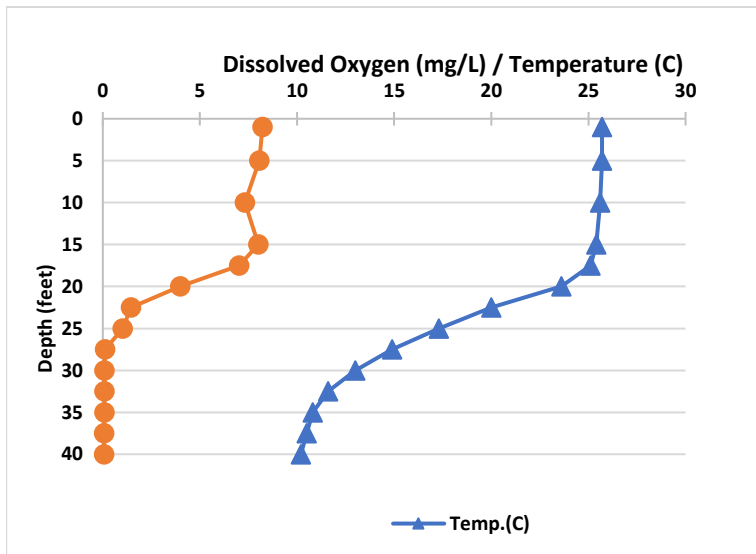
Dissolved Oxygen and Temperature Profile 8/5/2022

The lake keeps some dissolved oxygen in the bottom waters through mid-summer, but by late summer the lake has stratified and the bottom water is devoid of oxygen.

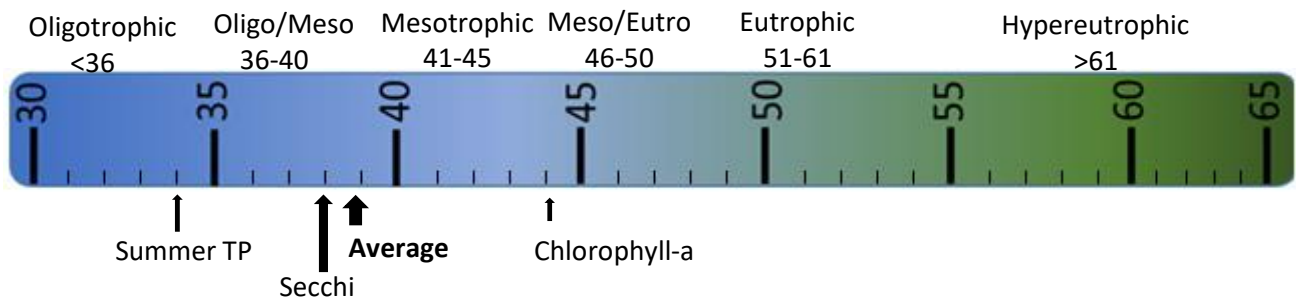
TSI for Big Bass Lake in 2022	
Average	39
Secchi Disk	38
Summer TP	34
Chlorophyll-a	44

With an average TSI score of 39 based on 2022 Secchi transparency, chlorophyll-a, and summer total phosphorus data, this lake is rated between the oligotrophic and mesotrophic lake classification. The lake leans slightly more mesotrophic than oligotrophic.

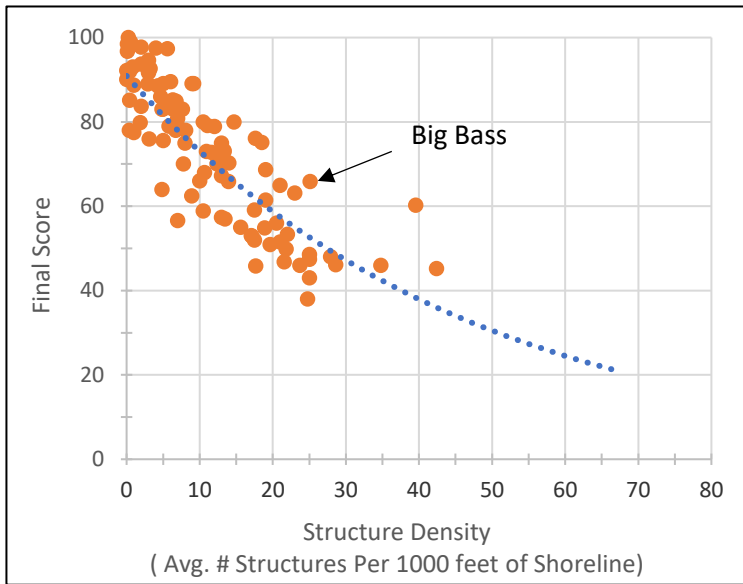
Big Bass Lake	
Number of Sections:	36
Number of Structures:	904
Structure Density:	25
Final Score:	65.9

All 97 Participating Lakes from 2015-2022:	
Avg. Number of Sections:	16
Avg. Number of Structures:	228
Avg. Structure Density:	12
Avg. Final Score:	73

Note about graph to the left: The dotted line sets your average expectation of the score of your lake. If your lake is lower than the dotted line, then your shoreline health is lower than average compared to lakes with similar amount of shoreline development. And vice-versa in regards to a lake above the dotted line.

Overall, the lakeshore habitat of Big Bass Lake scored quite a bit better than could be expected when compared to other lakes in the program with similar amount of development. Most of the 1000 foot sections scored either Fair or Good (18 fair and 12 good), while six sections scored Poor. While Big Bass is doing well compared to other similar lakes, given the six poor sections, there is plenty of room for improvement.

Looking specifically at those six sections, the score category they struggle the most with is "Riparian" and to a lesser extent, the "Littoral." Therefore the best way to improve would be to concentrate on planting native vegetation on areas that are currently mowed lawns and keeping native plants and woody debris in the shallows. The Score the Shore datasheets themselves are useful to instruct you on what each section needs the most-- where it scores badly, work to improve that particular aspect of the habitat. You can get plenty of ideas for improving shoreline health from the Michigan Natural Shoreline Partnership (<https://www.shorelinepartnership.org/>).

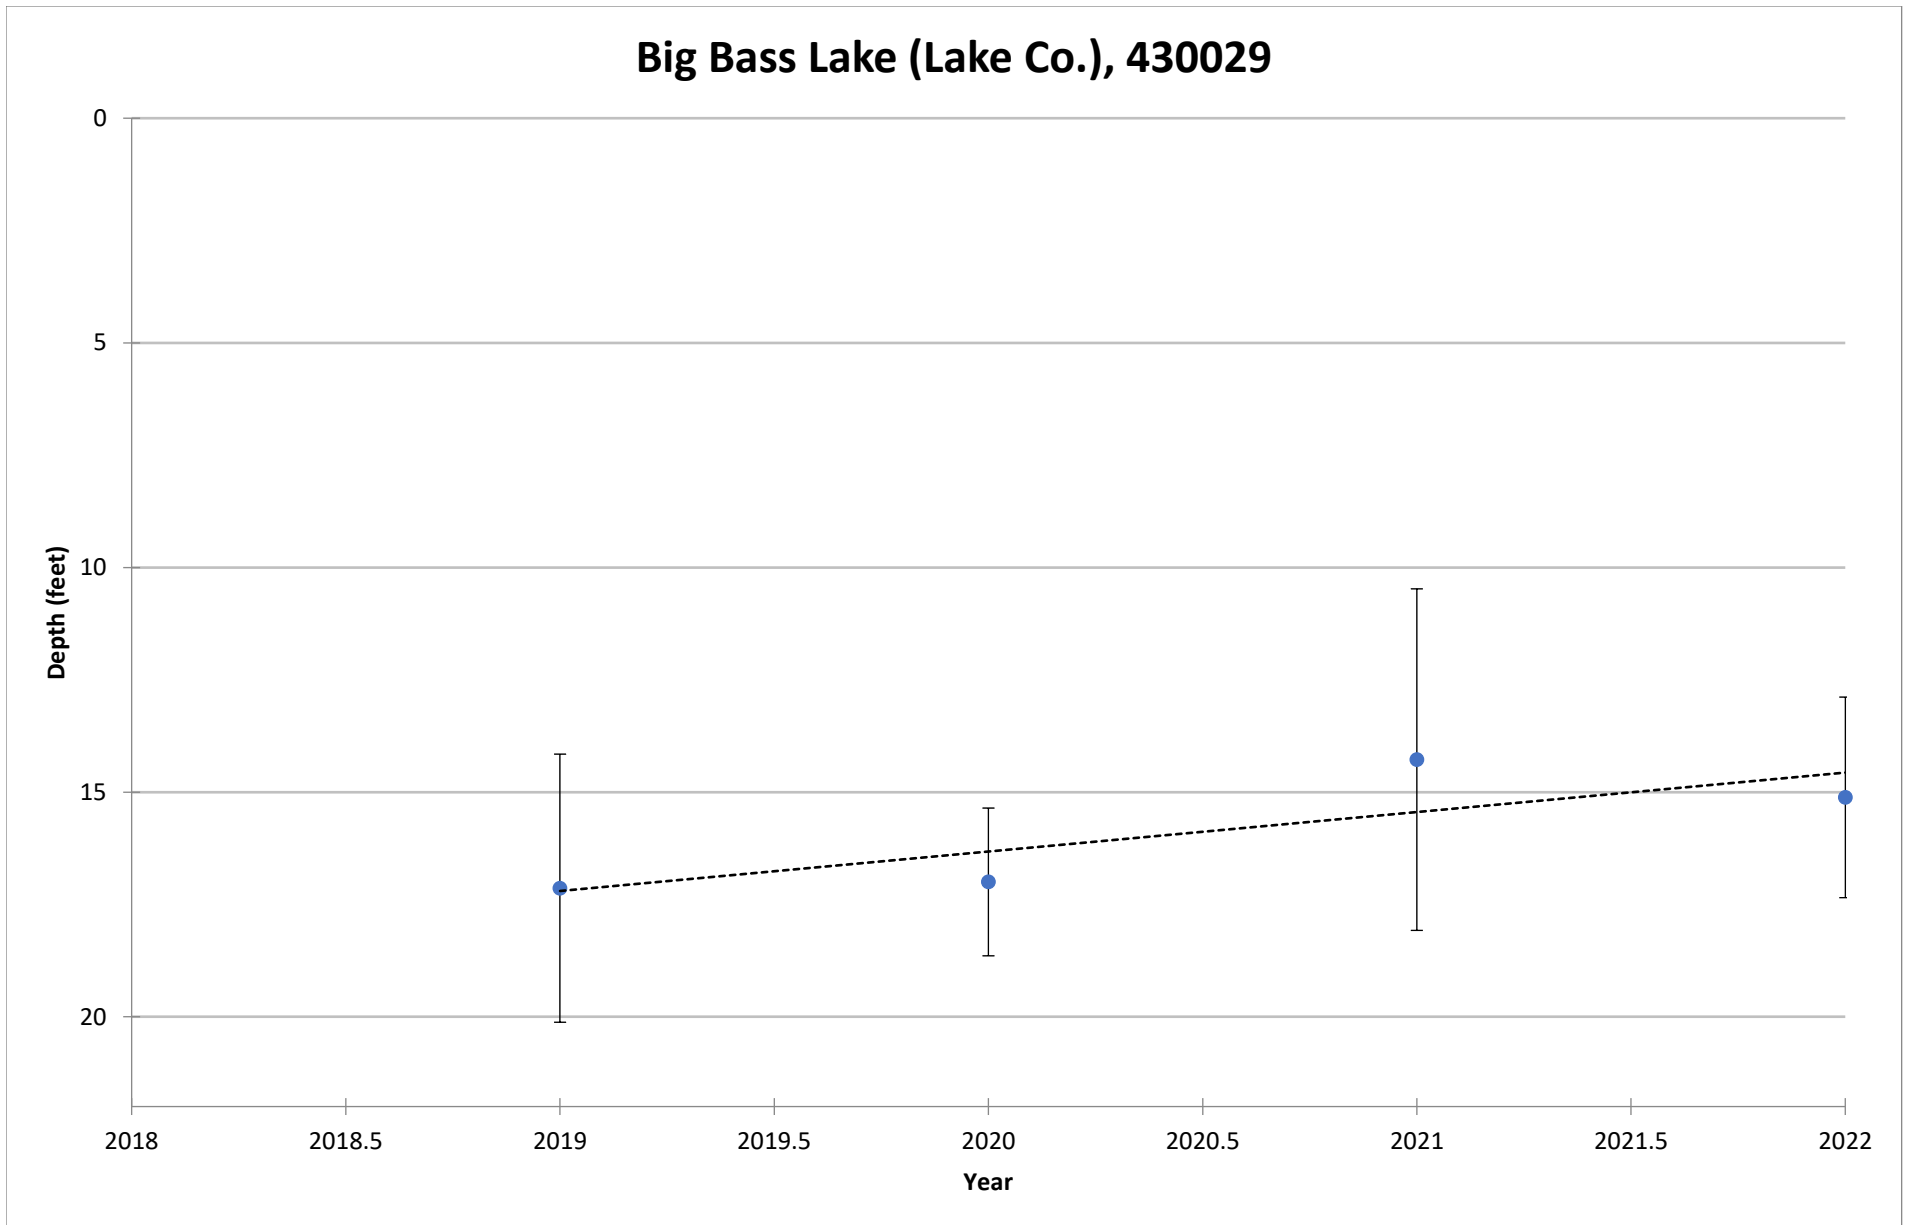
COOPERATIVE LAKES MONITORING PROGRAM
SUMMER MEAN TRANSPARENCY

Big Bass Lake (Lake Co.), 430029

Vertical bars indicate standard deviation

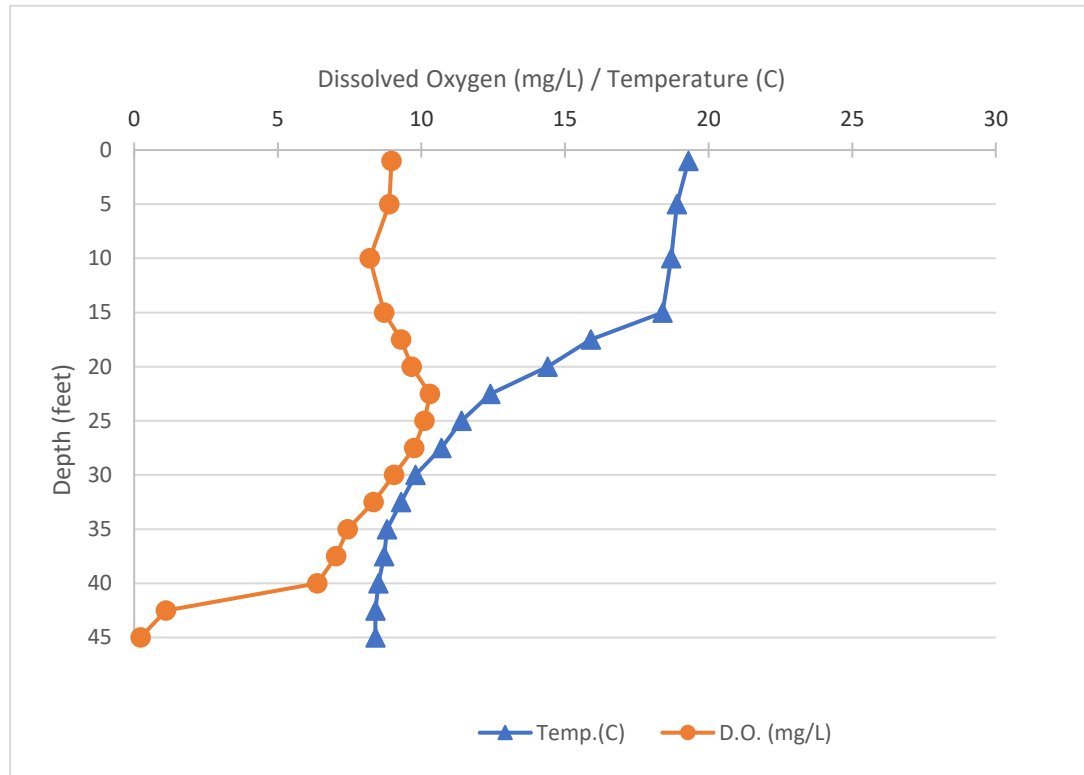
Name: Big Bass Lake
 County: Lake
 Site ID: 430029
 Date: 5/24/2022

Dissolved Oxygen and Temperature Profile

Depth (ft)	Temp.(C)	D.O. (mg/L)
1	19.3	8.96
5	18.9	8.88
10	18.7	8.2
15	18.4	8.7
17.5	15.9	9.3
20	14.4	9.66
22.5	12.4	10.3
25	11.4	10.11
27.5	10.7	9.75
30	9.8	9.05
32.5	9.3	8.34
35	8.8	7.43
37.5	8.7	7.03
40	8.5	6.38
42.5	8.4	1.1
45	8.4	0.22

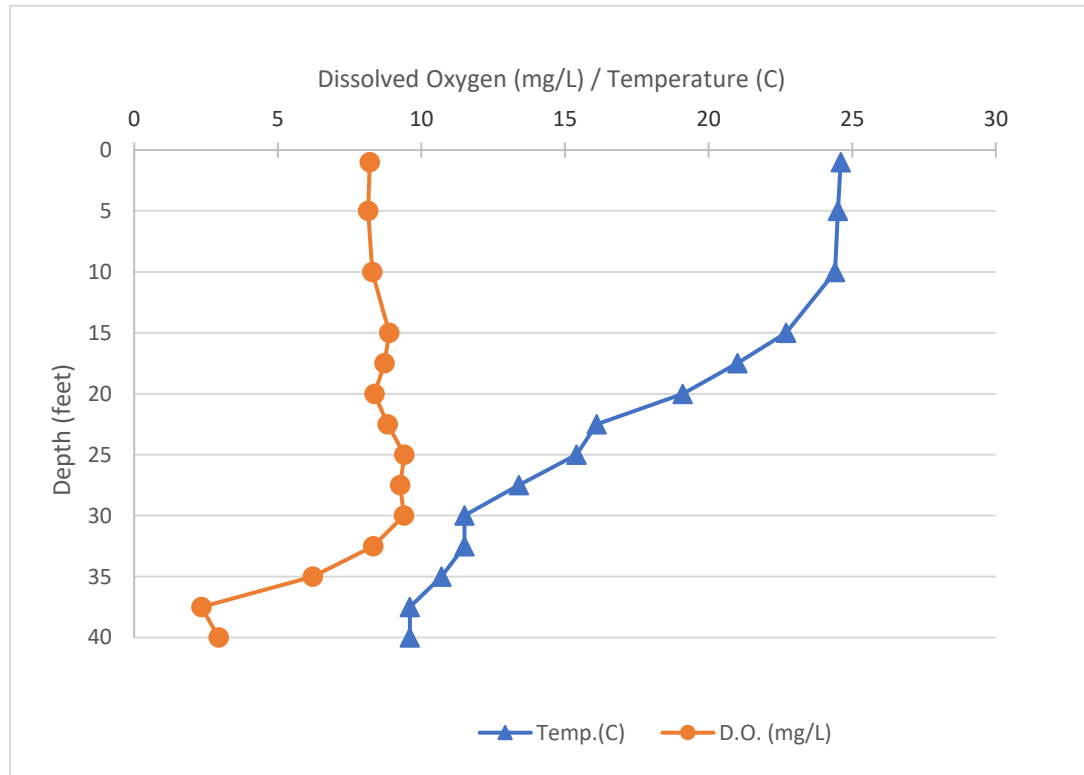
Name: Big Bass Lake
County: Lake
Site ID: 430029
Date: 6/21/2022

Dissolved Oxygen and Temperature Profile

Depth (ft)	Temp.(C)	D.O. (mg/L)
1	24.6	8.2
5	24.5	8.15
10	24.4	8.29
15	22.7	8.88
17.5	21	8.71
20	19.1	8.37
22.5	16.1	8.83
25	15.4	9.41
27.5	13.4	9.26
30	11.5	9.4
32.5	11.5	8.33
35	10.7	6.22
37.5	9.6	2.34
40	9.6	2.94

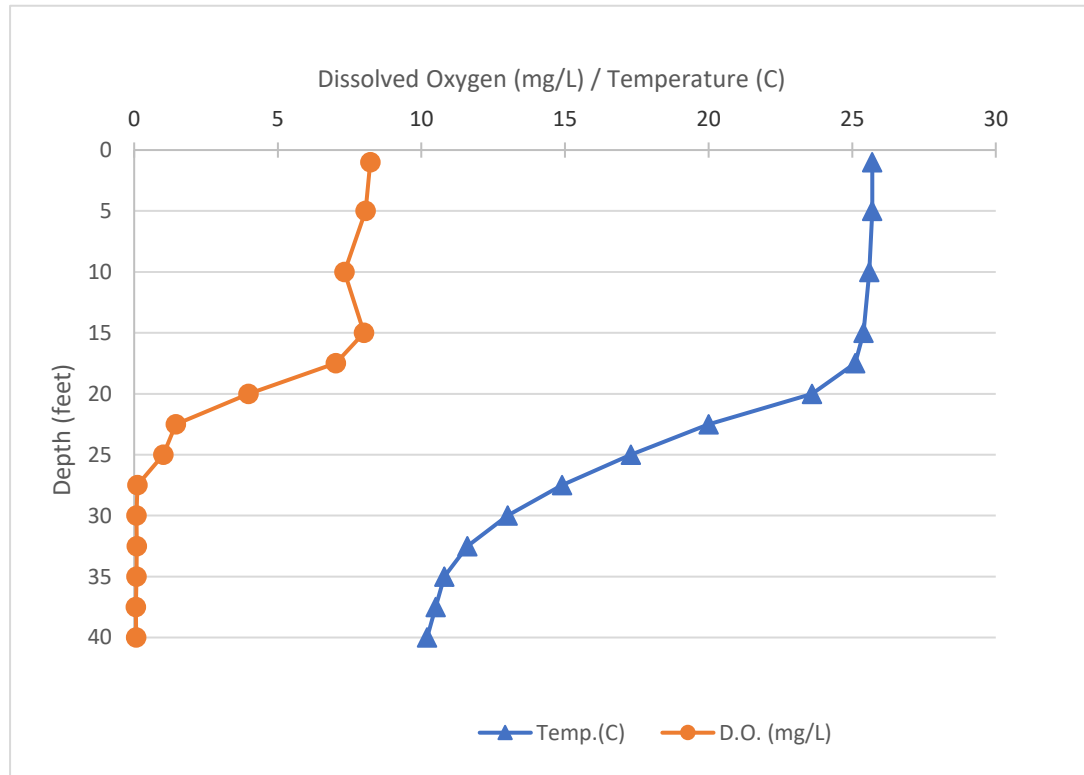
Name: Big Bass Lake
 County: Lake
 Site ID: 430029
 Date: 8/5/2022

Dissolved Oxygen and Temperature Profile

Depth (ft)	Temp.(C)	D.O. (mg/L)
1	25.7	8.22
5	25.7	8.06
10	25.6	7.32
15	25.4	8
17.5	25.1	7.02
20	23.6	3.98
22.5	20	1.45
25	17.3	1.02
27.5	14.9	0.11
30	13	0.08
32.5	11.6	0.09
35	10.8	0.08
37.5	10.5	0.06
40	10.2	0.07

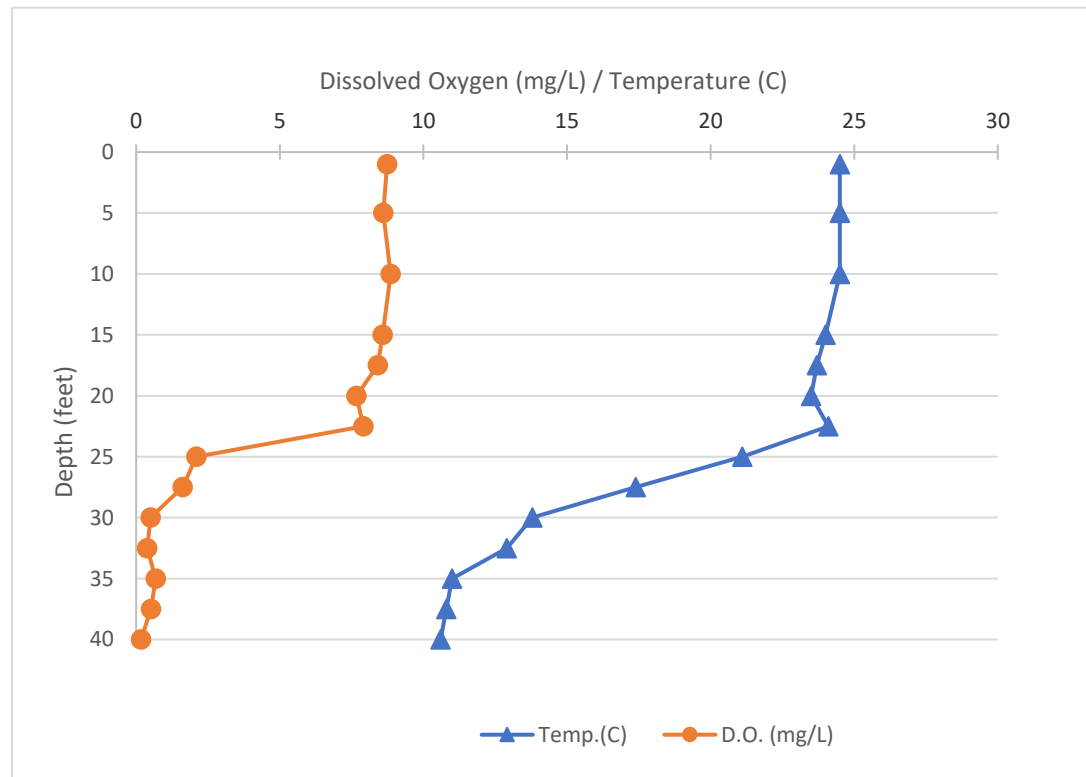
Name: Big Bass Lake
 County: Lake
 Site ID: 430029
 Date: 9/2/2022

Dissolved Oxygen and Temperature Profile

Depth (ft)	Temp.(C)	D.O. (mg/L)
1	24.5	8.74
5	24.5	8.6
10	24.5	8.86
15	24	8.58
17.5	23.7	8.41
20	23.5	7.67
22.5	24.1	7.91
25	21.1	2.1
27.5	17.4	1.62
30	13.8	0.5
32.5	12.9	0.38
35	11	0.68
37.5	10.8	0.51
40	10.6	0.17
