2022 Data Report for

Bass Lake, Marquette County

Bass Lake, Marquette County 2022 CLMP Results

Bass Lake, Marquette County 2022 Score the Shore Results

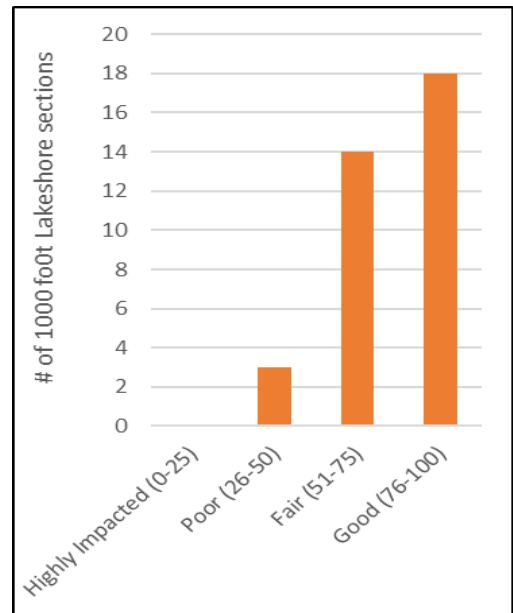
The lake sections scored in the Fair to Good range for erosion control (average of 80) and riparian habitat (average of 75), meaning that there are a low amount of sea walls, rock rip-rap, and other shoreline erosion structures, and suitable non-mowed areas providing a buffer between houses and roads and the lake.

The littoral zone was the overall weak point in Bass Lake’s habitat (scoring an average of 62). For residents who want to improve the overall shoreline quality, this is the component to concentrate on. Leave woody debris in place, or introduce it specially, and allow native aquatic vegetation to grow in the shallow waters. You can get plenty of ideas for improving shoreline health from the Michigan Natural Shoreline Partnership <https://www.shorelinepartnership.org/>.
