# 2022 Data Report for

# **Birch Lake, Cass County**

Site ID: 140187

# Birch Lake, Cass County 2022 CLMP Results

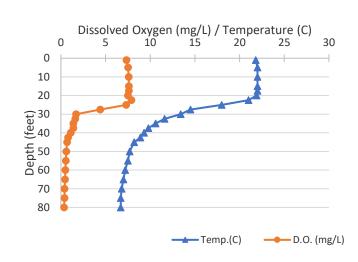
#### **Dissolved Oxygen and Temperature Profile**

The lake keeps some dissolved oxygen in the bottom waters through mid-summer, but by late summer the lake has stratified and the bottom water is devoid of oxygen.

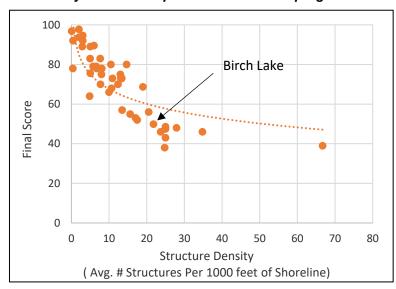
#### How does your lake compare to others in the program?

Overall, the lakeshore habitat of Birch Lake is below average when compared to the other lakes in the program. All of the lake sections score poor or fair (9 poor, 7 fair).

This Lake scored best in the littoral score (with an average of 69), meaning that (in general) erosion was low and aquatic vegetation was present.

The riparian zone and erosion control scores were approximately the same (scoring an average of 46 and 45).

Reduce the amount of mowed grass and increase the amount of unmowed native vegetation along the lakeshore to boost the riparian zone aspect of the shoreline habitat.

To improve the erosion control score, lake residents need to remove seawalls and riprapped slopes and replace them with a natural shoreline like those seen at www.mishorelinepartnership.org.
