2022 Data Report for

Cedar Lake, Van Buren County

Site ID: 800241

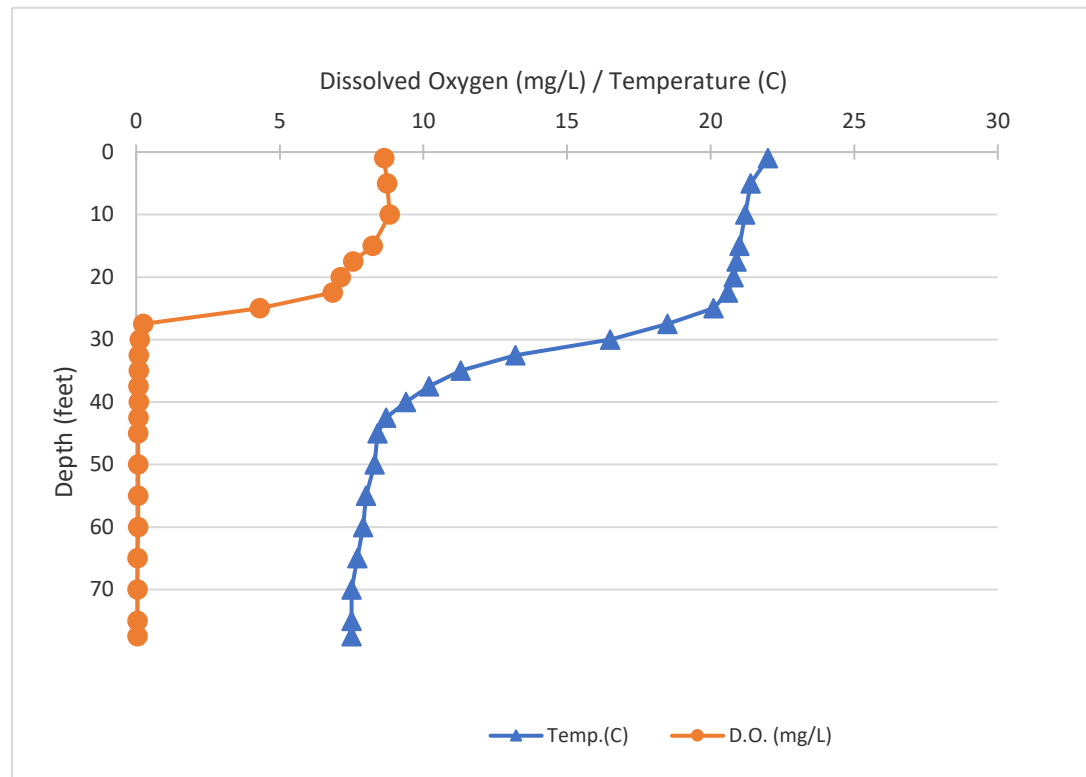
Name: Cedar Lake
 County: Van Buren
 Site ID: 800241
 Date: 9/20/2008

Dissolved Oxygen and Temperature Profile

Depth (ft)	Temp.(C)	D.O. (mg/L)
1	22	8.64
5	21.4	8.74
10	21.2	8.83
15	21	8.24
17.5	20.9	7.56
20	20.8	7.12
22.5	20.6	6.84
25	20.1	4.3
27.5	18.5	0.25
30	16.5	0.12
32.5	13.2	0.09
35	11.3	0.09
37.5	10.2	0.08
40	9.4	0.09
42.5	8.7	0.08
45	8.4	0.07
50	8.3	0.07
55	8	0.07
60	7.9	0.07
65	7.7	0.05
70	7.5	0.05
75	7.5	0.05
77.5	7.5	0.05
