2022 Data Report for

Chippewa Lake, Mecosta County

Site ID: 540050

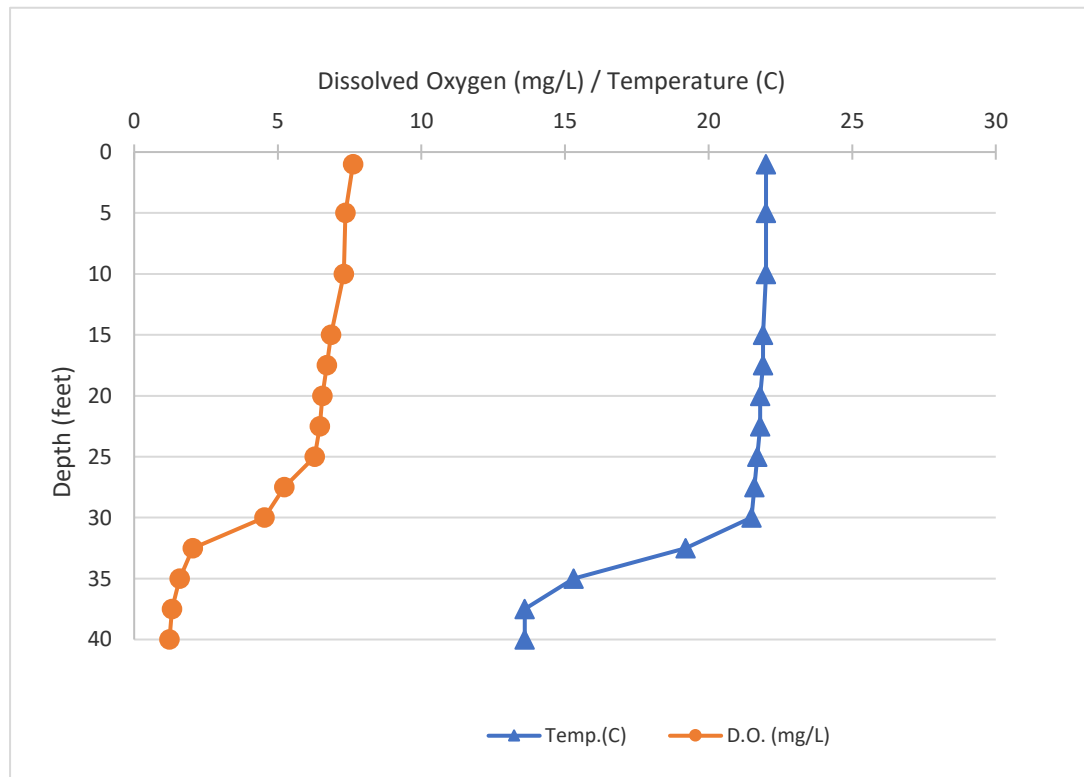
Dissolved Oxygen and Temperature Profile

Depth (ft)	Temp.(C)	D.O. (mg/L)
1	22	7.62
5	22	7.36
10	22	7.3
15	21.9	6.86
17.5	21.9	6.71
20	21.8	6.55
22.5	21.8	6.47
25	21.7	6.29
27.5	21.6	5.23
30	21.5	4.54
32.5	19.2	2.04
35	15.3	1.59
37.5	13.6	1.32
40	13.6	1.23
