# 2022 Data Report for

# Lake Christiana, Cass County

Site ID: 140055

# Lake Christiana, Cass County 2022 CLMP Results

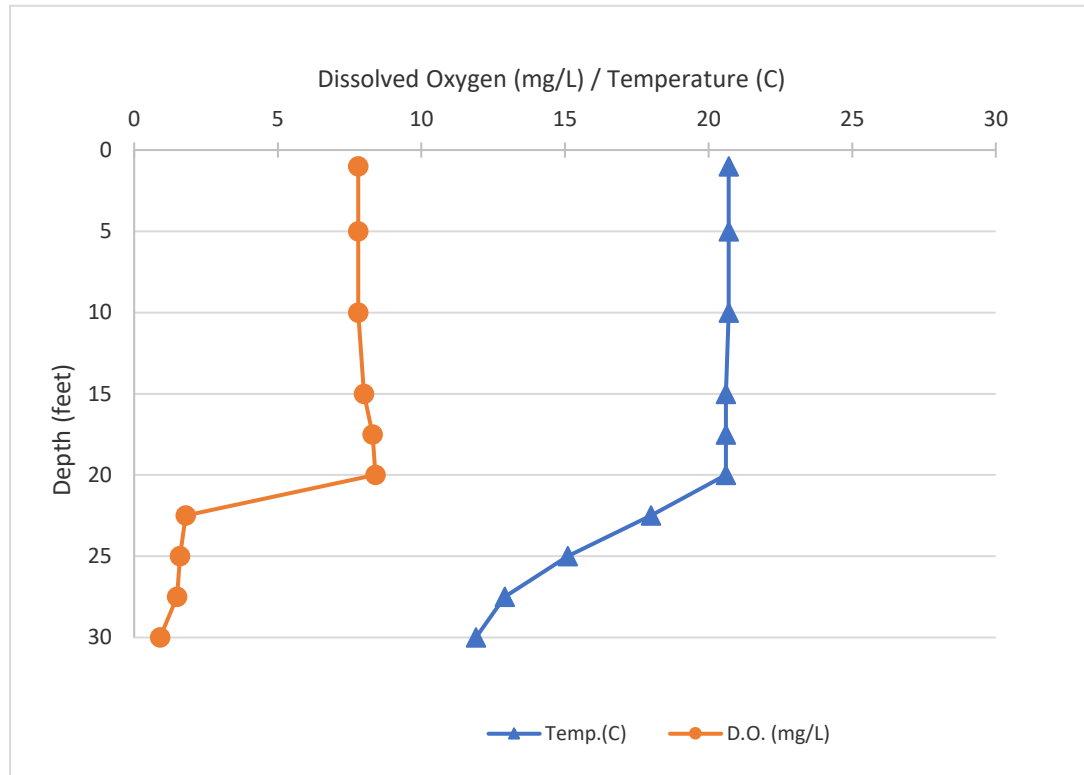
9/24/2022

### Dissolved Oxygen and Temperature Profile

Depth (ft)	Temp.(C)	D.O. (mg/L)
1	20.7	7.8
5	20.7	7.8
10	20.7	7.8
15	20.6	8
17.5	20.6	8.3
20	20.6	8.4
22.5	18	1.8
25	15.1	1.6
27.5	12.9	1.5
30	11.9	0.9
