2022 Data Report for

Corey Lake, St. Joseph County

Site ID: 750142

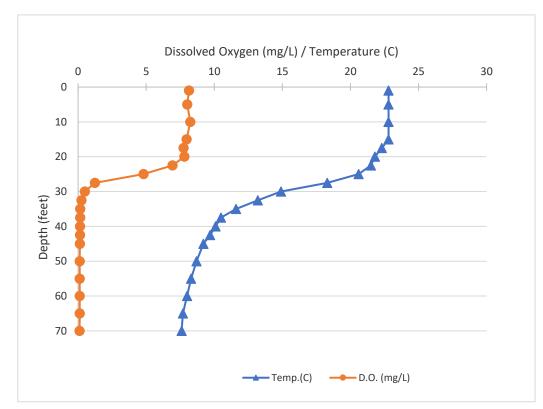
Name: Corey Lake County: St. Joseph Site ID: 750142 Date: 9/17/2019

Depth (ft) Temp.(C) D.O. (mg/L) 22.8 8.14 5 22.8 8.02 10 22.8 8.24 22.8 7.97 15 17.5 22.3 7.74 20 21.8 7.8 22.5 21.5 6.93 25 20.6 4.81 27.5 18.3 1.23 30 14.9 0.5 32.5 13.2 0.25 35 11.6 0.15 37.5 10.5 0.15 40 10.1 0.14 42.5 9.7 0.14 45 9.2 0.13 50 8.7 0.12 55 8.3 0.12 60 8 0.12 65 0.12 7.7 7.6 70 0.11
