2022 Data Report for

Crockery Lake, Ottawa County

Site ID: 700422

Crockery Lake, Ottawa County 2022 CLMP Results

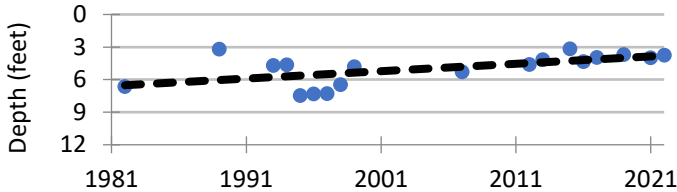
Secchi Disk Transparency (feet)

Year	# Readings	Min	Max	Average	Std. Dev	Carlson TSI
2022	17	2.5	6.0	3.7	1.1	58
2017-2021	53	1.5	7.5	3.7	1.2	58
1982-2016	237	0.3	15.0	5.3	1.9	54
2022 All CLMP Lakes	3178	1.0	63.0	11.6	2.5	43

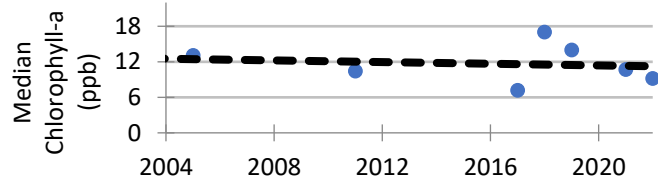
Chlorophyll-a (parts per billion)

Year	# Samples	Min	Max	Median	Std. Dev	Carlson TSI
2022	5	6.9	15.0	9.2	3.3	52
2017-2021	19	5.0	33.0	12.4	6.4	55
2001-2016	23	2.0	100.0	12.4	20.0	55
2022 All CLMP Lakes	687	< 1.0	43.0	3.7	5.3	43

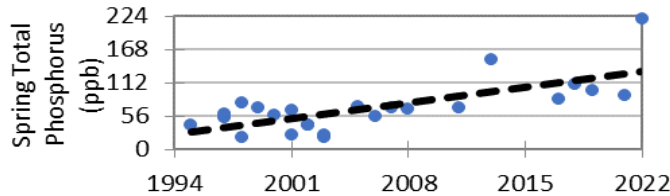
Spring Phosphorus (parts per billion)

Year	# Samples	Min	Max	Average	Std. Dev	Carlson TSI
2022	1	220.0	220.0	220.0	NA	NA
2017-2021	4	85.0	110.0	96.5	10.9	54
1995-2016	19	21.0	150.0	57.2	29.5	45
2022 All CLMP Lakes	220	<5	220.0	20.7	21.3	45

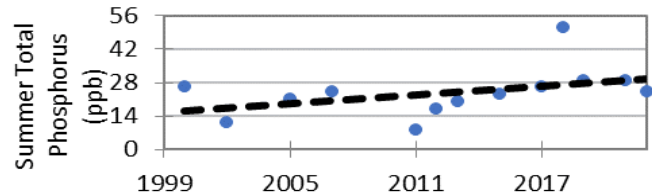
Summer Phosphorus (parts per billion)

Year	# Samples	Min	Max	Average	Std. Dev	Carlson TSI
2022	1	24.0	24.0	24.0	NA	50
2017-2021	4	26.0	51.0	33.8	11.6	54
2000-2016	8	8.0	26.0	18.8	6.4	45
2022 All CLMP Lakes	234	<= 3	150.0	17.4	15.3	45

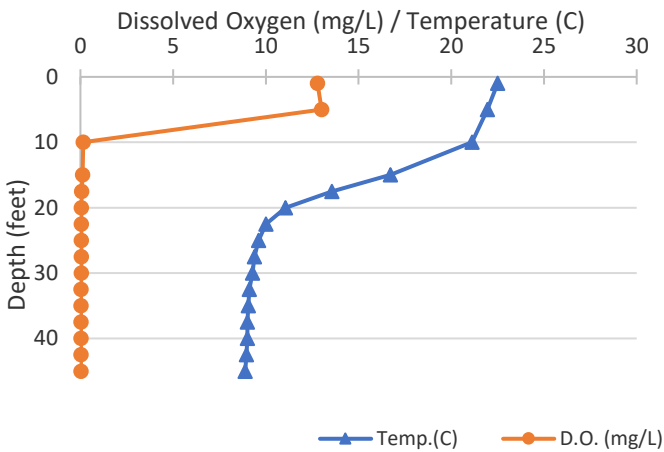
Dissolved Oxygen and Temperature Profile

Due to the high nutrient level, the lake loses dissolved oxygen in the bottom waters in the early summer and this condition persists through the whole monitoring season.

If you enrolled in Dissolved Oxygen/Temperature, the summary page will have a graph of one of the profiles taken during the late summer (typically August or September). If your lake stratifies, we will use a graph showing the earliest time of stratification, because identifying the timing of this condition and the depth at which it occurs is typically the most important use of dissolved oxygen measurements.

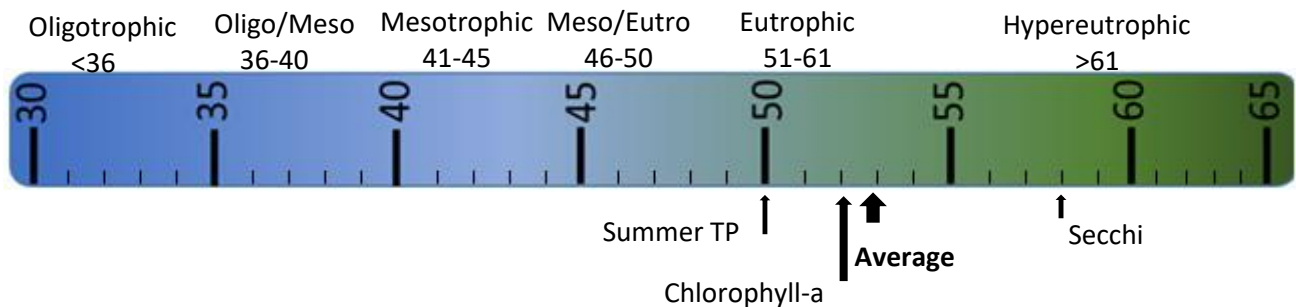
TSI for Crockery Lake in 2022	
Average	53
Secchi Disk	58
Summer TP	50
Chlorophyll-a	52

Oligotrophic: Generally deep and clear lakes with little aquatic plant or algae growth. These lakes maintain sufficient dissolved oxygen in the cool, deep-bottom waters during late summer to support cold water fish, such as trout and whitefish.

Mesotrophic: Lakes that fall between oligotrophic and eutrophic. Mid-ranged amounts of nutrients.

Eutrophic: Highly productive eutrophic lakes are generally shallow, turbid, and support abundant aquatic plant growth. In deep eutrophic lakes, the cool bottom waters usually contain little or no dissolved oxygen. Therefore, these lakes can only support warm water fish, such as bass and pike.

Hypereutrophic: A specialized category of eutrophic lakes. These lakes exhibit extremely high productivity, such as nuisance algae and weed growth.

With an average TSI score of 53 based on 2022 Secchi transparency, chlorophyll-a, and summer total phosphorus data, this lake is rated as a eutrophic lake.

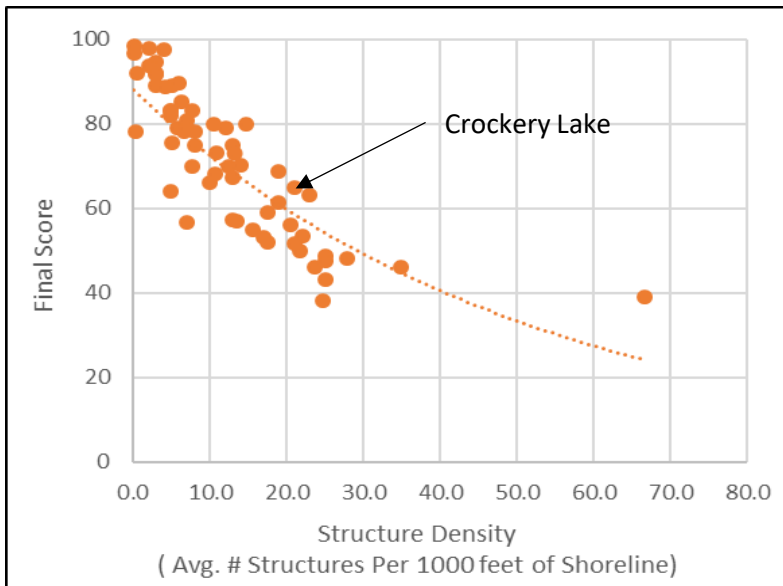
How does your lake compare to others in the program?

Crockery Lake:	
Number of Sections:	8
Number of Structures:	187
Structure Density:	23
Final Score:	63

All 42 Participating Lakes from 2015-2019:	
Avg. Number of Sections:	16
Avg. Number of Structures:	226
Avg. Structure Density:	12.5
Avg. Final Score:	71.1

Overall, the lakeshore habitat of Crockery Lake scored lower when average when compared to other lakes in the program, but probably scored exactly as expected considering the amount of development along the shores.

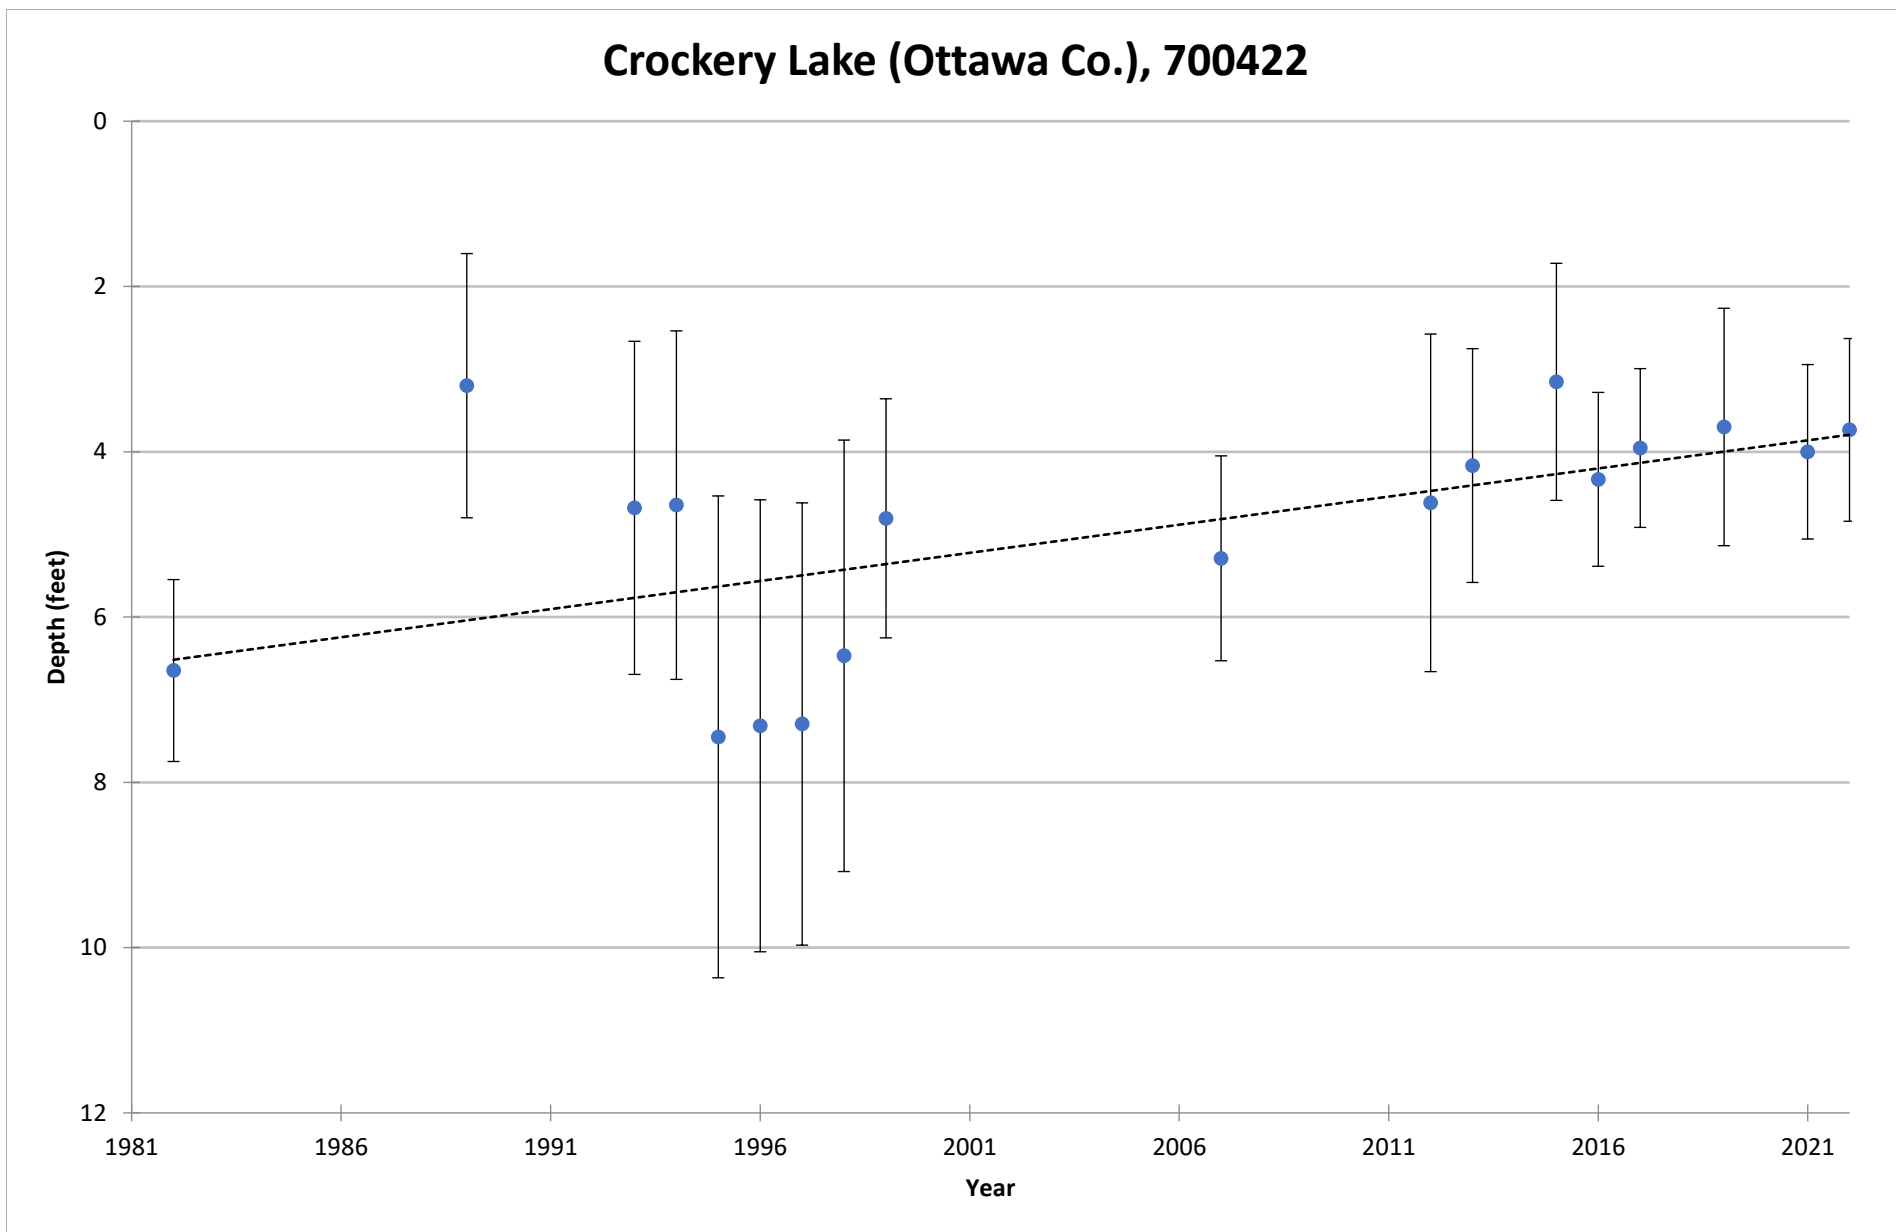
COOPERATIVE LAKES MONITORING PROGRAM
SUMMER MEAN TRANSPARENCY

Crockery Lake (Ottawa Co.), 700422

Vertical bars indicate standard deviation

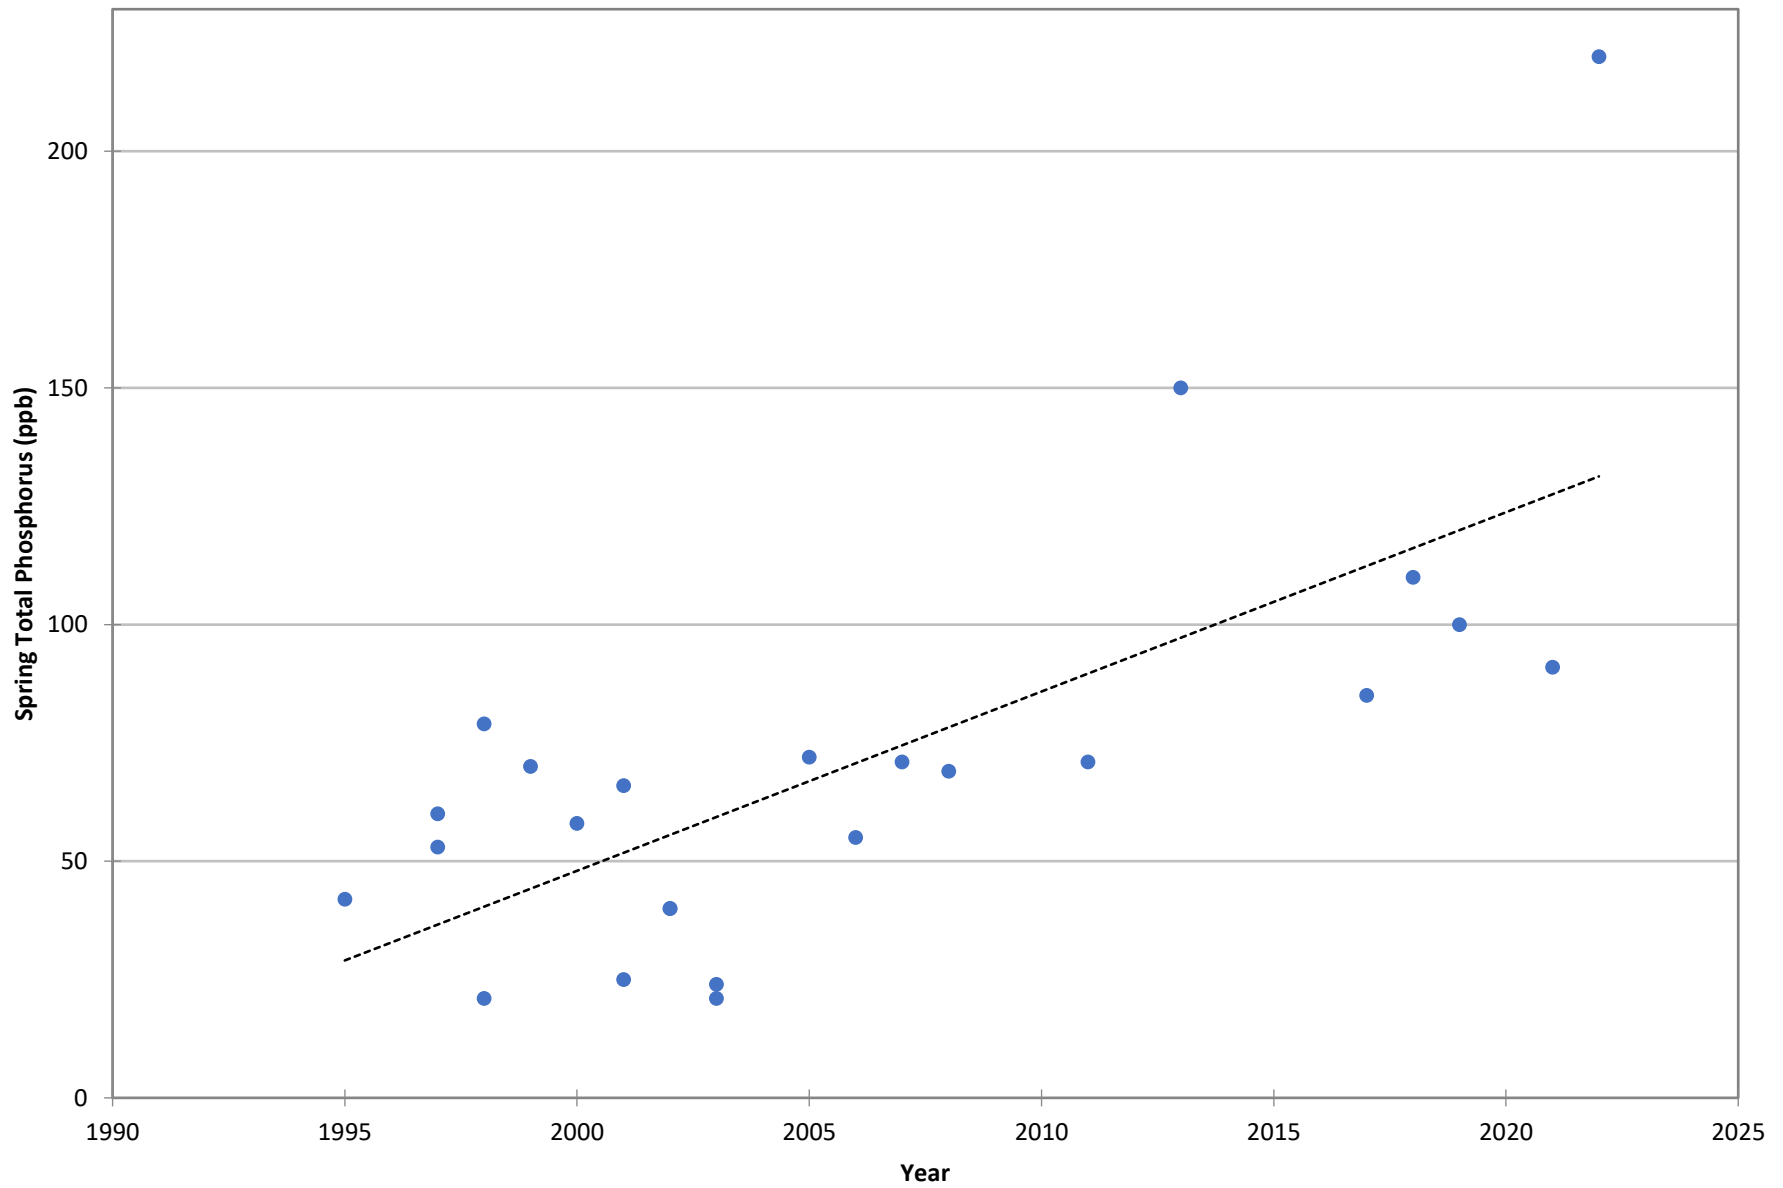
COOPERATIVE LAKES MONITORING PROGRAM
SPRING TOTAL PHOSPHORUS

Crockery Lake (Ottawa Co.), 700422

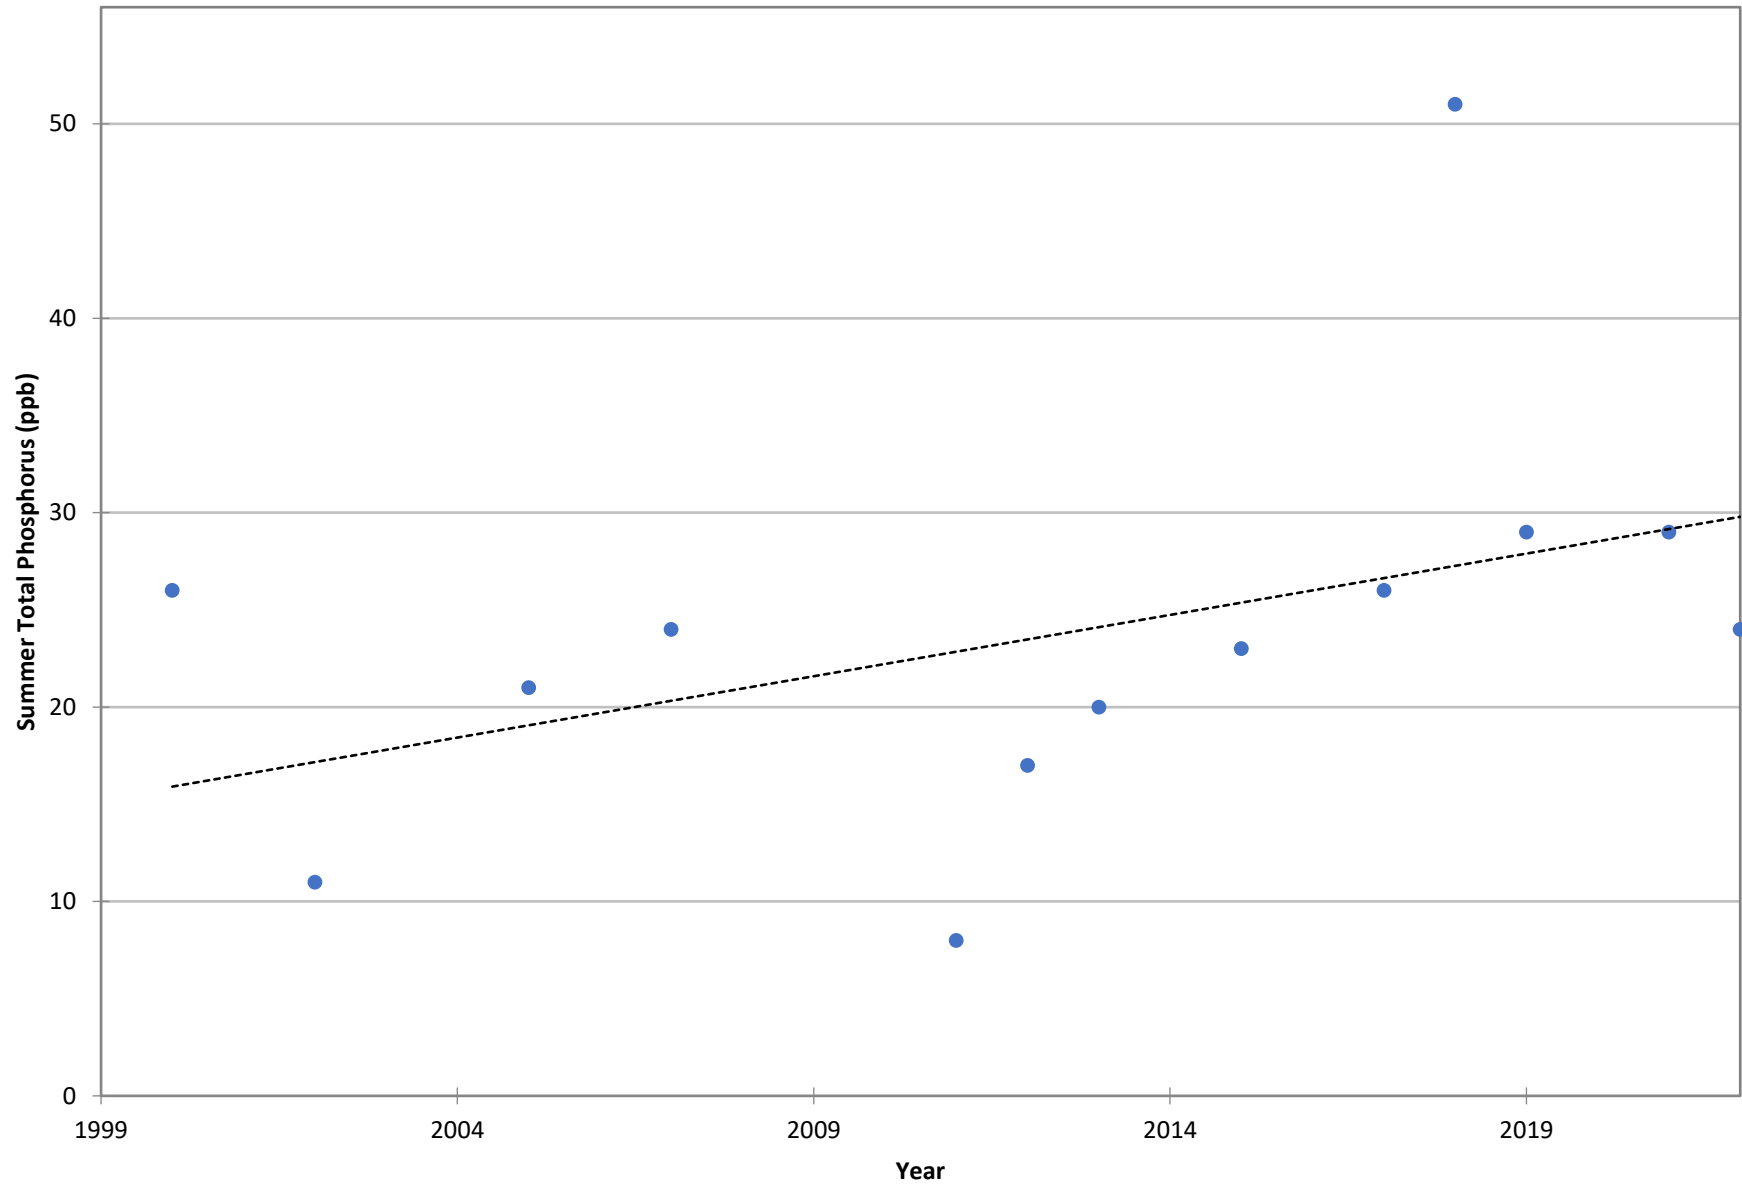
COOPERATIVE LAKES MONITORING PROGRAM
SUMMER TOTAL PHOSPHORUS

Crockery Lake (Ottawa Co.), 700422

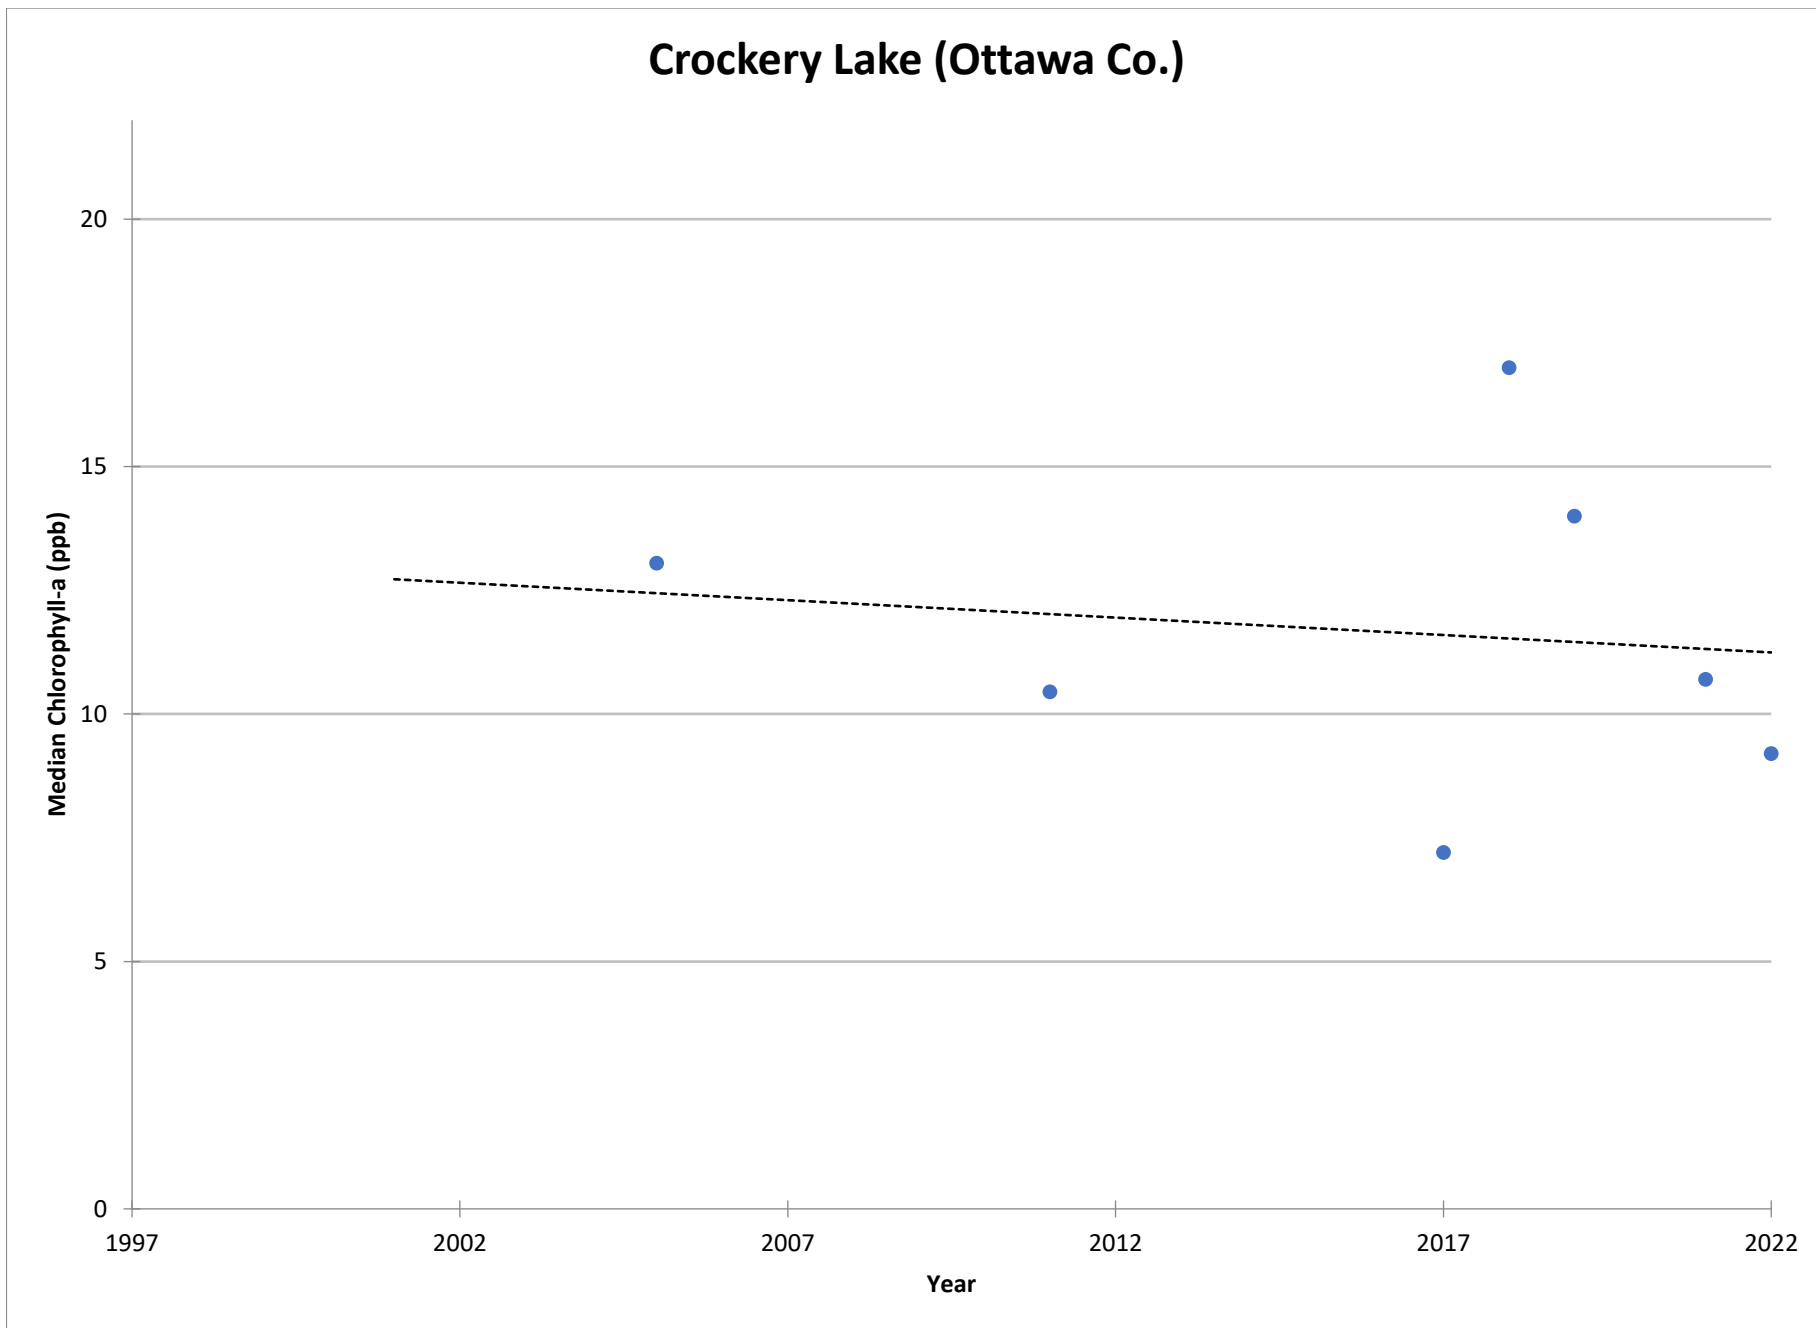
COOPERATIVE LAKES MONITORING PROGRAM
SUMMER MEDIAN CHLOROPHYLL-A

Crockery Lake (Ottawa Co.)

Vertical bars indicate standard deviation

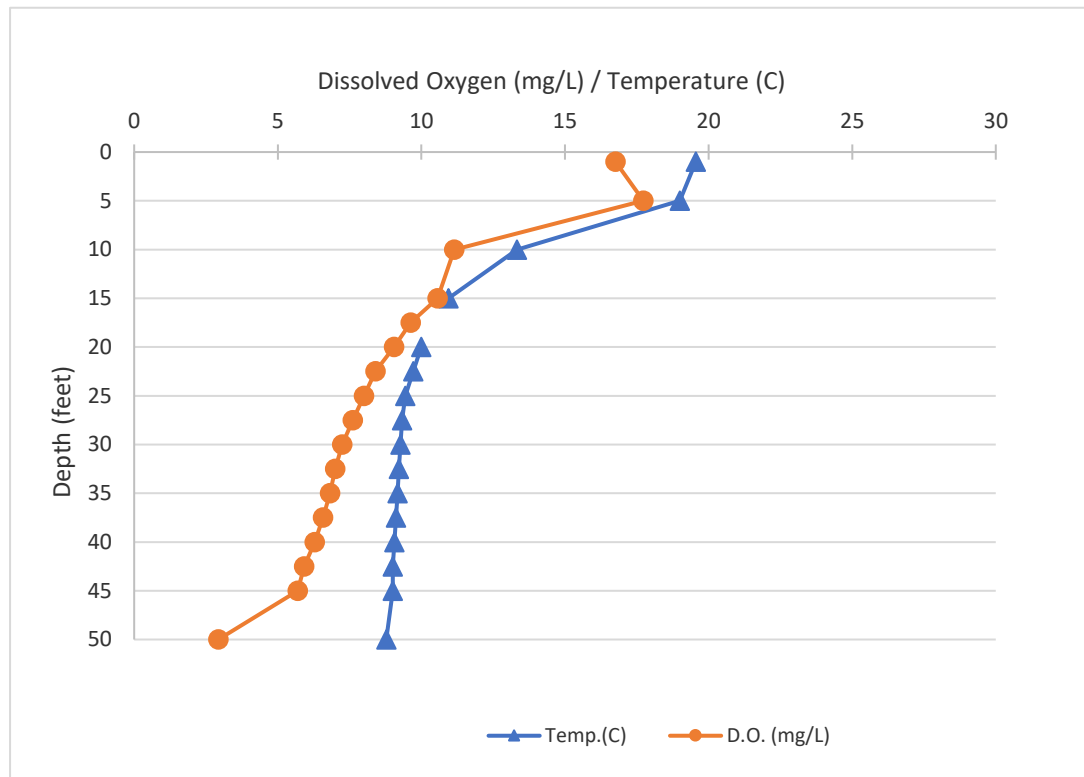
Dissolved Oxygen and Temperature Profile

Name: Crockery Lake
 County: Ottawa
 Site ID: 700422
 Date: 5/15/2022

Depth (ft)	Temp.(C)	D.O. (mg/L)
1	19.5555556	16.76
5	19	17.73
10	13.3333333	11.14
15	10.9444444	10.57
17.5		9.63
20	10	9.05
22.5	9.7222222	8.4
25	9.4444444	8
27.5	9.3333333	7.61
30	9.2777778	7.24
32.5	9.2222222	7
35	9.1666667	6.82
37.5	9.1111111	6.58
40	9.0555556	6.29
42.5	9	5.92
45	9	5.7
50	8.7777778	2.93

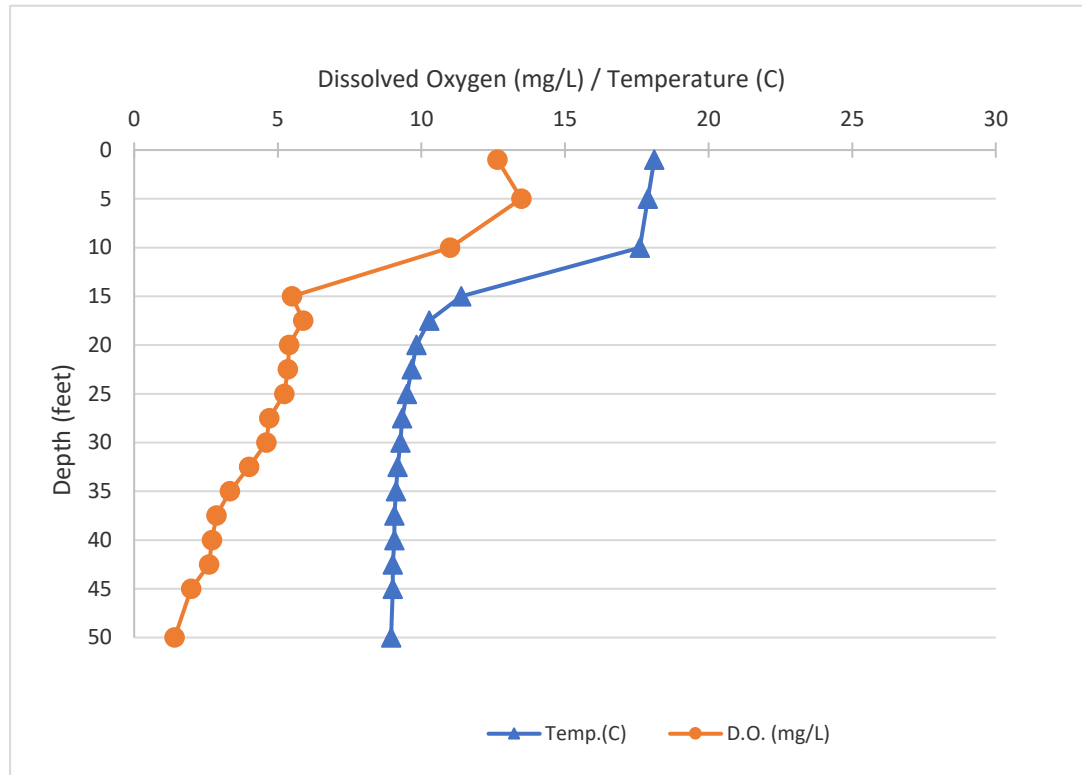
Dissolved Oxygen and Temperature Profile

Name: Crockery Lake
 County: Ottawa
 Site ID: 700422
 Date: 5/24/2022

Depth (ft)	Temp.(C)	D.O. (mg/L)
1	18.11111111	12.65
5	17.8888889	13.48
10	17.61111111	11
15	11.3888889	5.5
17.5	10.2777778	5.89
20	9.83333333	5.4
22.5	9.66666667	5.35
25	9.5	5.23
27.5	9.33333333	4.7
30	9.27777778	4.6
32.5	9.16666667	4
35	9.11111111	3.33
37.5	9.05555556	2.87
40	9.05555556	2.71
42.5	9	2.61
45	9	1.99
50	8.94444444	1.41

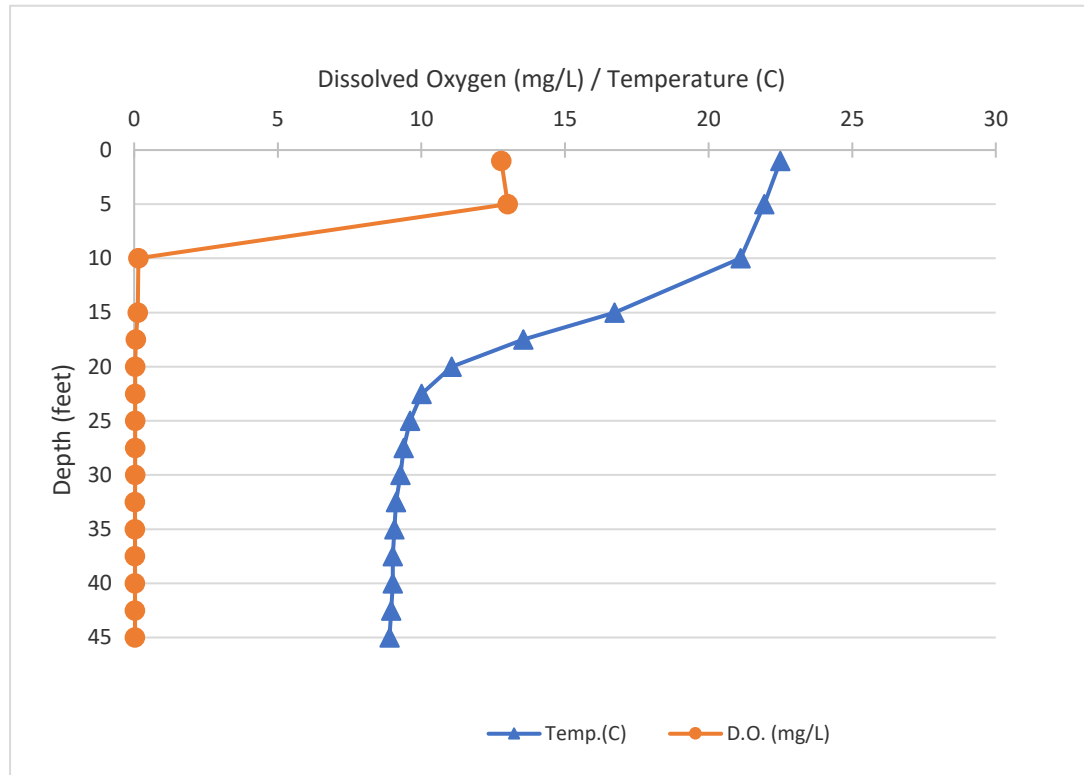
Dissolved Oxygen and Temperature Profile

Name: Crockery Lake
 County: Ottawa
 Site ID: 700422
 Date: 6/13/2022

Depth (ft)	Temp.(C)	D.O. (mg/L)
1	22.5	12.78
5	21.9444444	13.01
10	21.1111111	0.1501
15	16.7222222	0.12
17.5	13.5555556	0.06
20	11.0555556	0.04
22.5	10.0055556	0.04
25	9.61111111	0.04
27.5	9.38888889	0.04
30	9.27777778	0.04
32.5	9.11111111	0.03
35	9.05555556	0.03
37.5	9	0.03
40	9	0.03
42.5	8.94444444	0.03
45	8.88888889	0.03

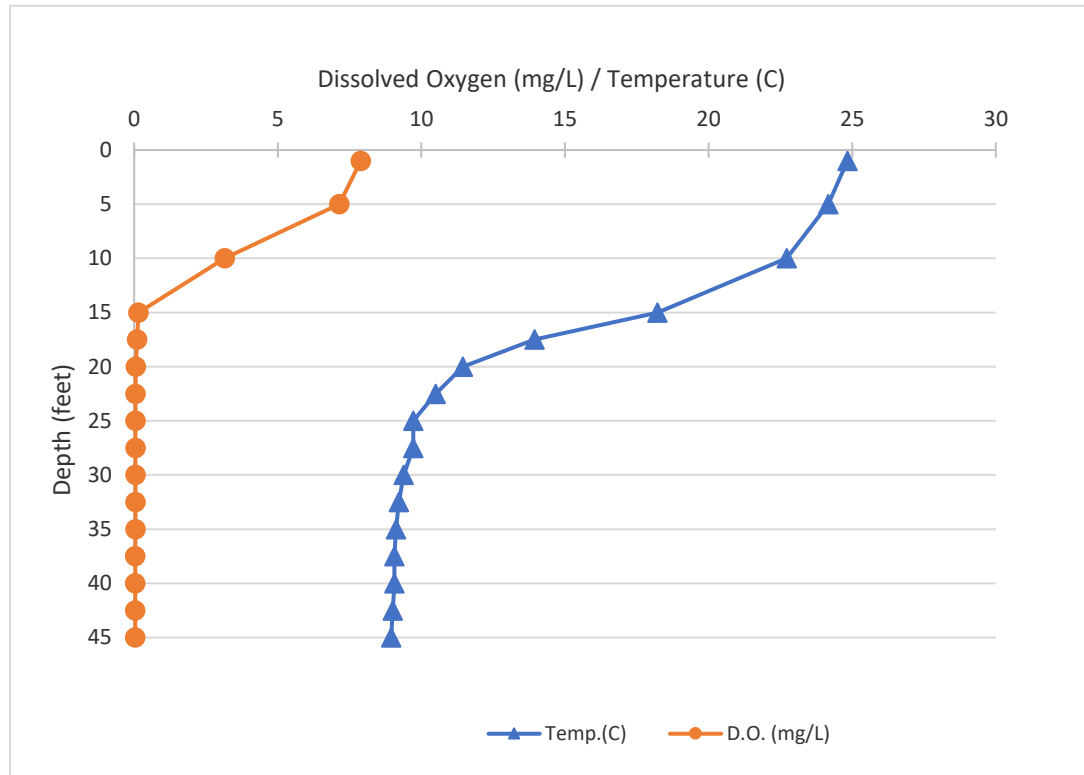
Dissolved Oxygen and Temperature Profile

Name: Crockery Lake
 County: Ottawa
 Site ID: 700422
 Date: 6/20/2022

Depth (ft)	Temp.(C)	D.O. (mg/L)
1	24.8333333	7.89
5	24.1666667	7.14
10	22.7222222	3.15
15	18.2222222	0.15
17.5	13.9444444	0.1
20	11.4444444	0.06
22.5	10.5	0.05
25	9.7222222	0.05
27.5	9.7222222	0.05
30	9.3888889	0.05
32.5	9.2222222	0.05
35	9.1111111	0.05
37.5	9.0555556	0.04
40	9.0555556	0.04
42.5	9	0.04
45	8.9444444	0.04

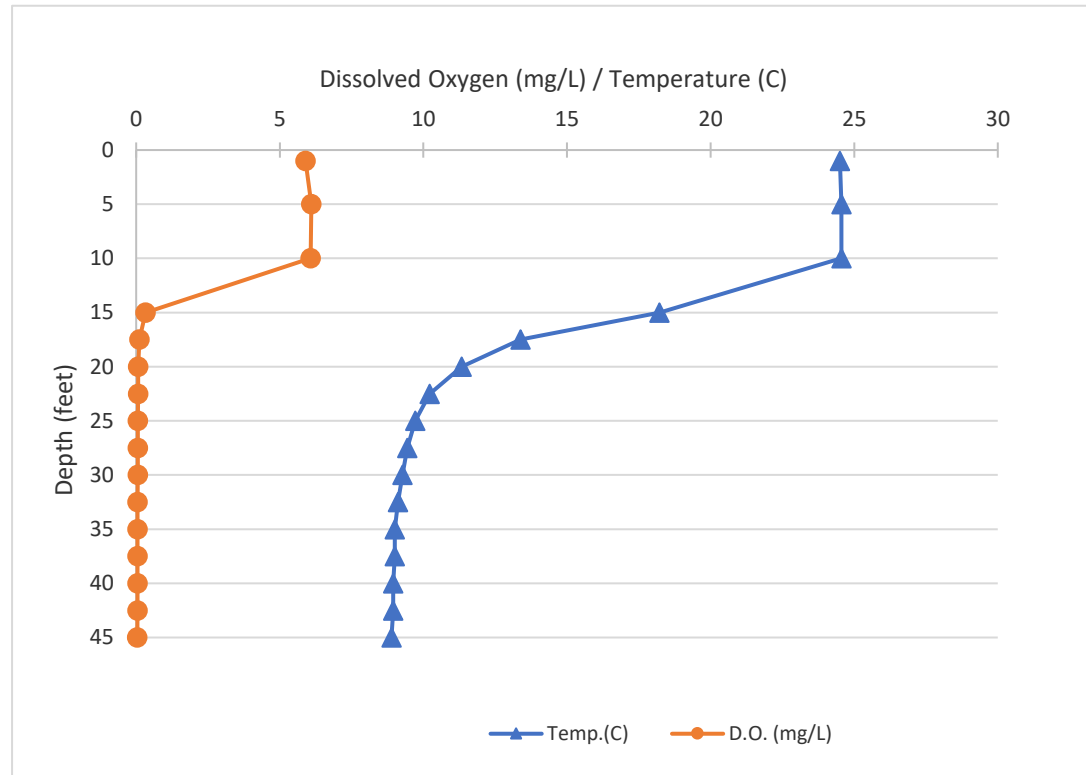
Dissolved Oxygen and Temperature Profile

Name: Crockery Lake
 County: Ottawa
 Site ID: 700422
 Date: 6/27/2022

Depth (ft)	Temp.(C)	D.O. (mg/L)
1	24.5	5.9
5	24.5555556	6.1
10	24.5555556	6.07
15	18.2222222	0.32
17.5	13.3888889	0.11
20	11.3333333	0.07
22.5	10.2222222	0.07
25	9.7222222	0.06
27.5	9.4444444	0.06
30	9.2777778	0.06
32.5	9.1111111	0.05
35	9	0.05
37.5	9	0.05
40	8.9444444	0.05
42.5	8.9444444	0.05
45	8.8888889	0.04

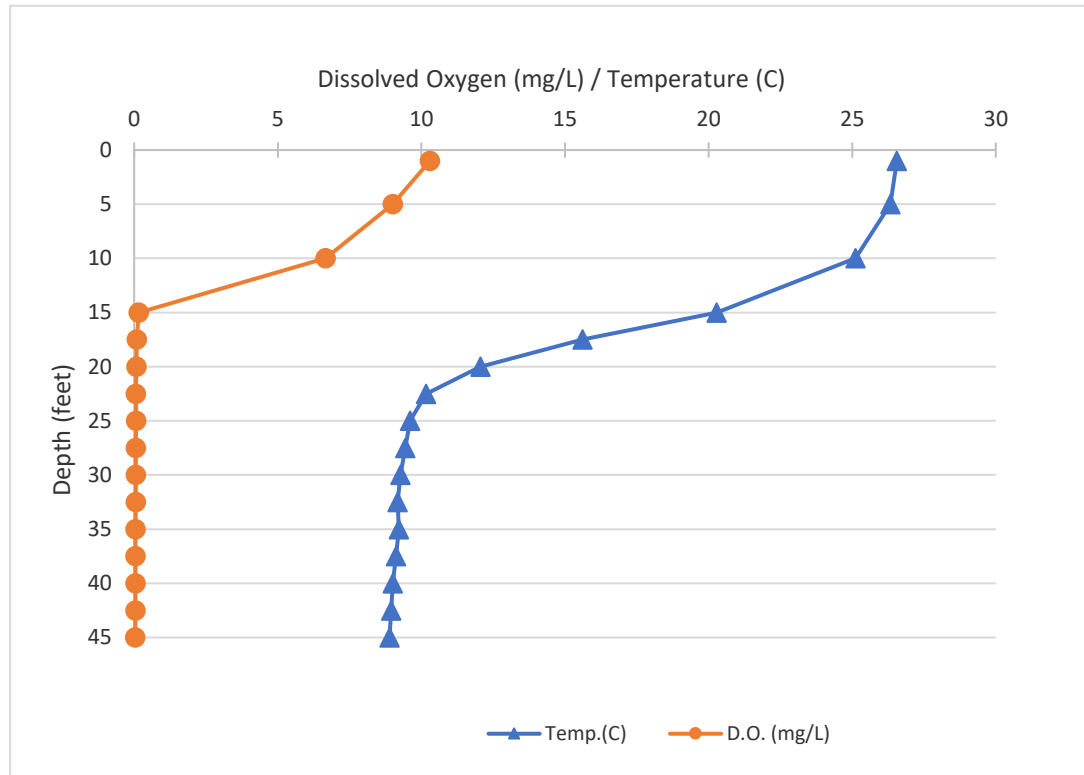
Dissolved Oxygen and Temperature Profile

Name: Crockery Lake
 County: Ottawa
 Site ID: 700422
 Date: 7/5/2022

Depth (ft)	Temp.(C)	D.O. (mg/L)
1	26.5555556	10.3
5	26.3333333	9.01
10	25.1111111	6.67
15	20.2777778	0.16
17.5	15.6111111	0.09
20	12.0555556	0.08
22.5	10.1666667	0.06
25	9.61111111	0.07
27.5	9.44444444	0.06
30	9.27777778	0.06
32.5	9.16666667	0.06
35	9.22222222	0.05
37.5	9.11111111	0.05
40	9	0.05
42.5	8.94444444	0.05
45	8.88888889	0.04

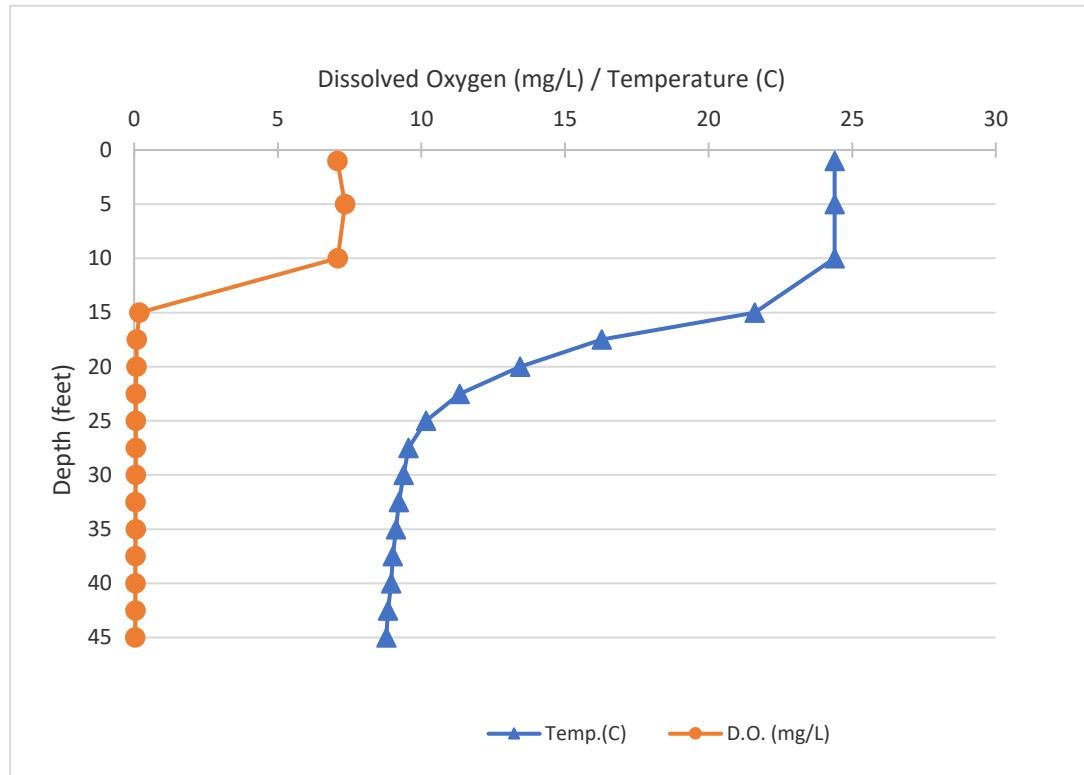
Dissolved Oxygen and Temperature Profile

Name: Crockery Lake
 County: Ottawa
 Site ID: 700422
 Date: 7/12/2022

Depth (ft)	Temp.(C)	D.O. (mg/L)
1	24.3888889	7.08
5	24.3888889	7.34
10	24.3888889	7.09
15	21.6111111	0.18
17.5	16.2777778	0.09
20	13.4444444	0.08
22.5	11.3333333	0.06
25	10.1666667	0.06
27.5	9.5555556	0.06
30	9.3888889	0.06
32.5	9.2222222	0.05
35	9.1111111	0.06
37.5	9	0.05
40	8.9444444	0.05
42.5	8.8333333	0.05
45	8.7777778	0.04

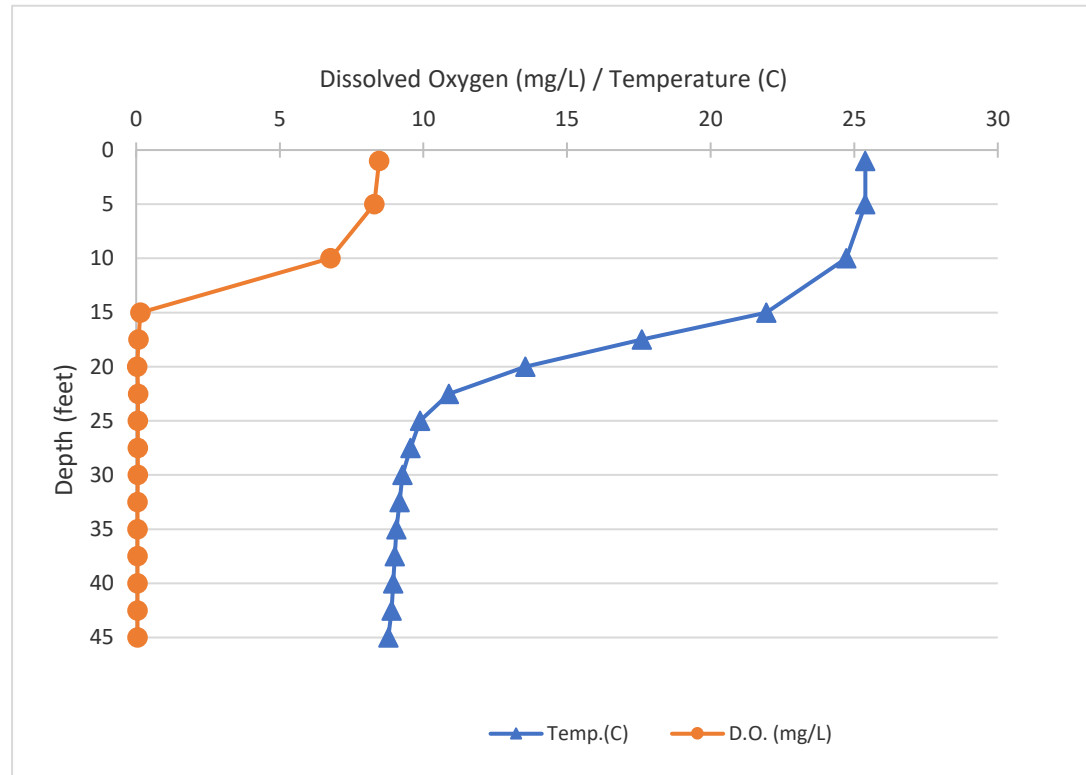
Dissolved Oxygen and Temperature Profile

Name: Crockery Lake
 County: Ottawa
 Site ID: 700422
 Date: 7/18/2022

Depth (ft)	Temp.(C)	D.O. (mg/L)
1	25.3888889	8.46
5	25.3888889	8.29
10	24.7222222	6.76
15	21.9444444	0.15
17.5	17.6111111	0.08
20	13.5555556	0.04
22.5	10.8888889	0.07
25	9.8888889	0.06
27.5	9.5555556	0.06
30	9.2777778	0.06
32.5	9.1666667	0.05
35	9.0555556	0.05
37.5	9	0.05
40	8.9444444	0.05
42.5	8.8888889	0.05
45	8.7777778	0.05

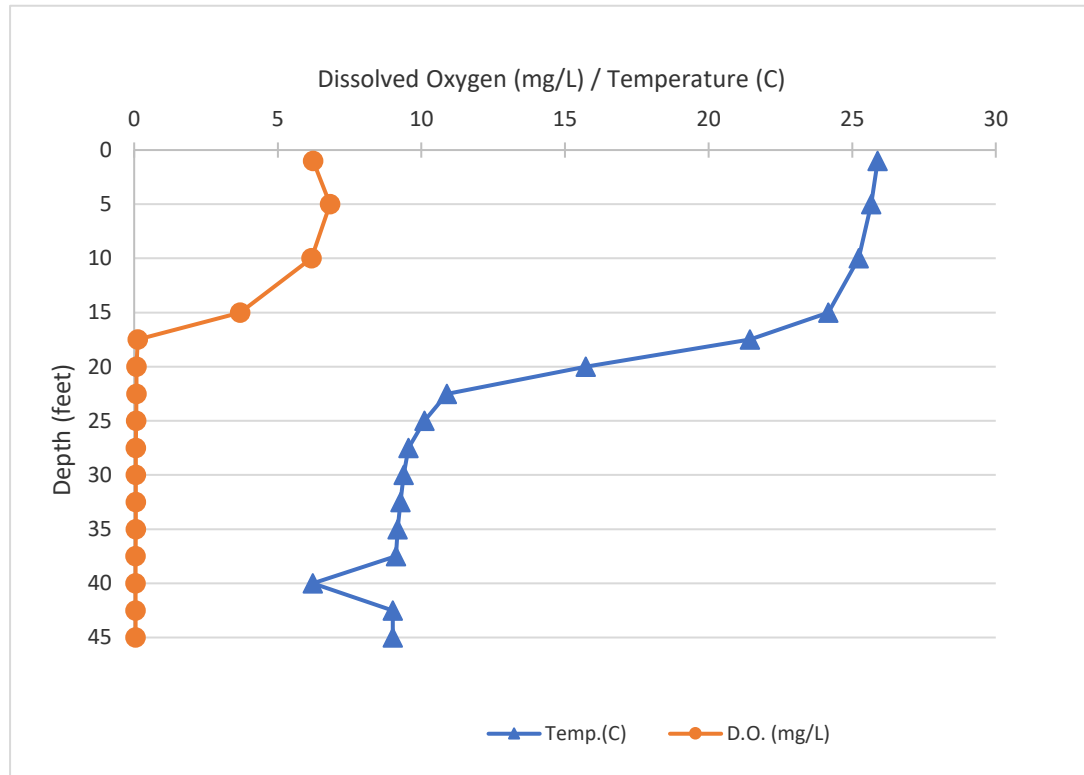
Dissolved Oxygen and Temperature Profile

Name: Crockery Lake
 County: Ottawa
 Site ID: 700422
 Date: 7/25/2022

Depth (ft)	Temp.(C)	D.O. (mg/L)
1	25.8888889	6.23
5	25.6666667	6.82
10	25.2222222	6.17
15	24.1666667	3.69
17.5	21.4444444	0.12
20	15.7222222	0.08
22.5	10.8888889	0.08
25	10.1111111	0.07
27.5	9.55555556	0.06
30	9.38888889	0.06
32.5	9.27777778	0.06
35	9.16666667	0.06
37.5	9.11111111	0.05
40	6.22222222	0.05
42.5	9	0.05
45	9	0.05

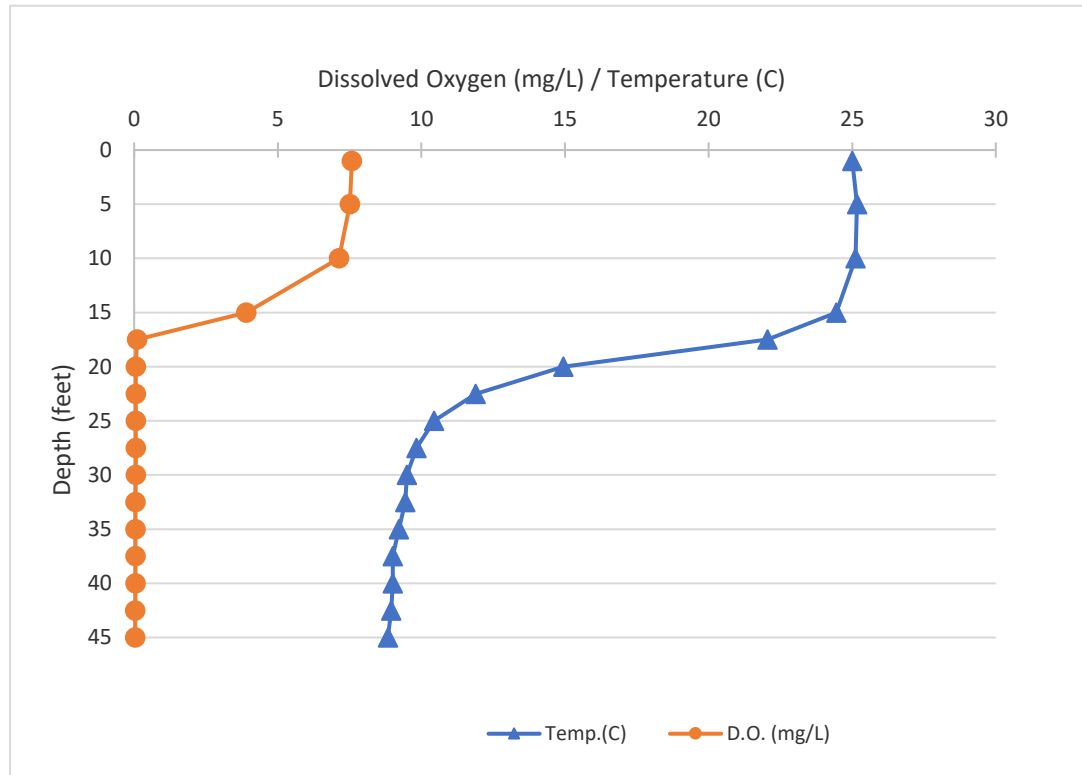
Dissolved Oxygen and Temperature Profile

Name: Crockery Lake
 County: Ottawa
 Site ID: 700422
 Date: 8/2/2022

Depth (ft)	Temp.(C)	D.O. (mg/L)
1	25	7.58
5	25.1666667	7.51
10	25.1111111	7.13
15	24.4444444	3.9
17.5	22.0555556	0.1
20	14.9444444	0.06
22.5	11.8888889	0.06
25	10.4444444	0.06
27.5	9.8333333	0.06
30	9.5	0.06
32.5	9.4444444	0.05
35	9.2222222	0.05
37.5	9	0.05
40	9	0.05
42.5	8.9444444	0.04
45	8.8333333	0.04

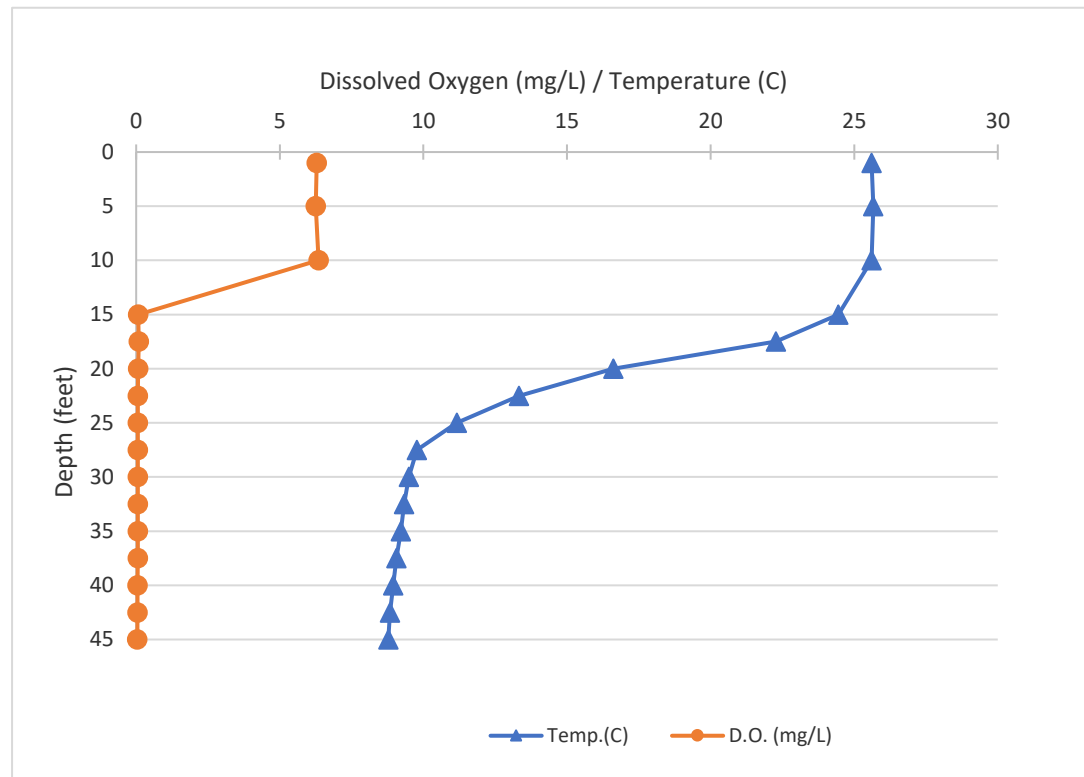
Dissolved Oxygen and Temperature Profile

Name: Crockery Lake
 County: Ottawa
 Site ID: 700422
 Date: 8/9/2022

Depth (ft)	Temp.(C)	D.O. (mg/L)
1	25.61111111	6.29
5	25.66666667	6.25
10	25.61111111	6.35
15	24.44444444	0.067
17.5	22.27777778	0.09
20	16.61111111	0.07
22.5	13.33333333	0.06
25	11.16666667	0.06
27.5	9.77777778	0.06
30	9.5	0.06
32.5	9.33333333	0.06
35	9.22222222	0.06
37.5	9.05555556	0.06
40	8.94444444	0.05
42.5	8.83333333	0.05
45	8.77777778	0.04

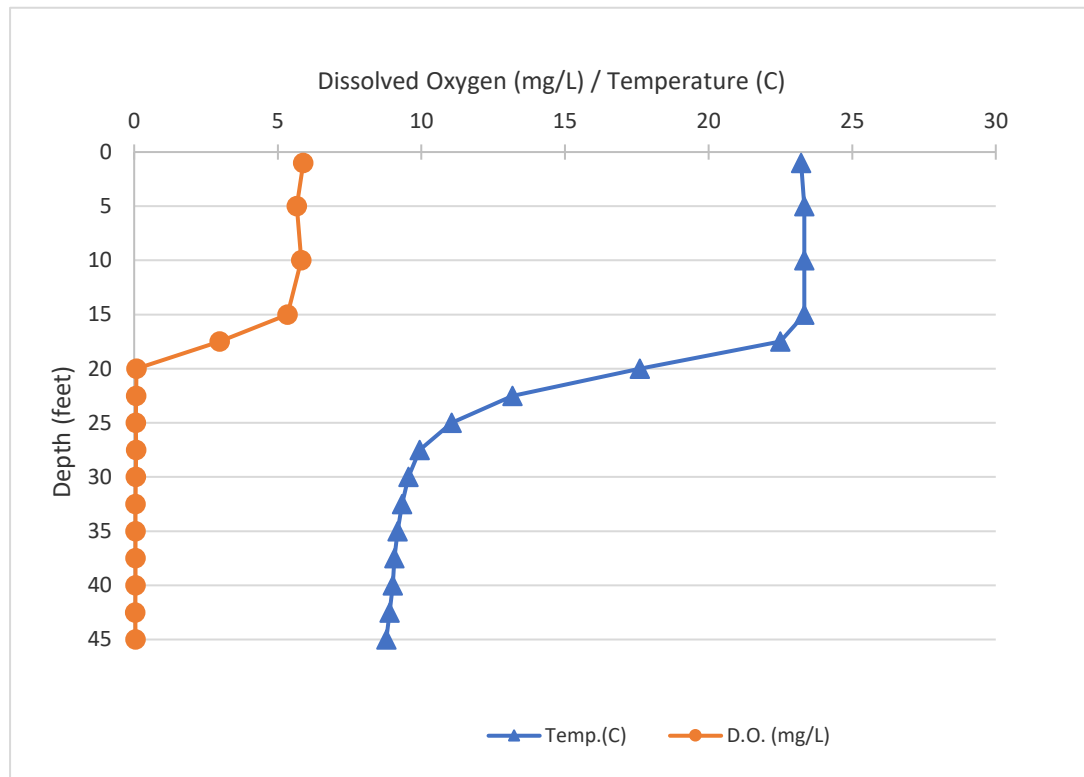
Dissolved Oxygen and Temperature Profile

Name: Crockery Lake
 County: Ottawa
 Site ID: 700422
 Date: 8/15/2022

Depth (ft)	Temp.(C)	D.O. (mg/L)
1	23.2222222	5.89
5	23.3333333	5.66
10	23.3333333	5.82
15	23.3333333	5.34
17.5	22.5	2.98
20	17.6111111	0.08
22.5	13.1666667	0.07
25	11.0555556	0.06
27.5	9.9444444	0.07
30	9.5555556	0.06
32.5	9.3333333	0.05
35	9.1666667	0.05
37.5	9.0555556	0.05
40	9	0.05
42.5	8.8888889	0.04
45	8.7777778	0.05
