2022 Data Report for

Crockery Lake, Ottawa County

Site ID: 700422

Crockery Lake, Ottawa County 2022 CLMP Results

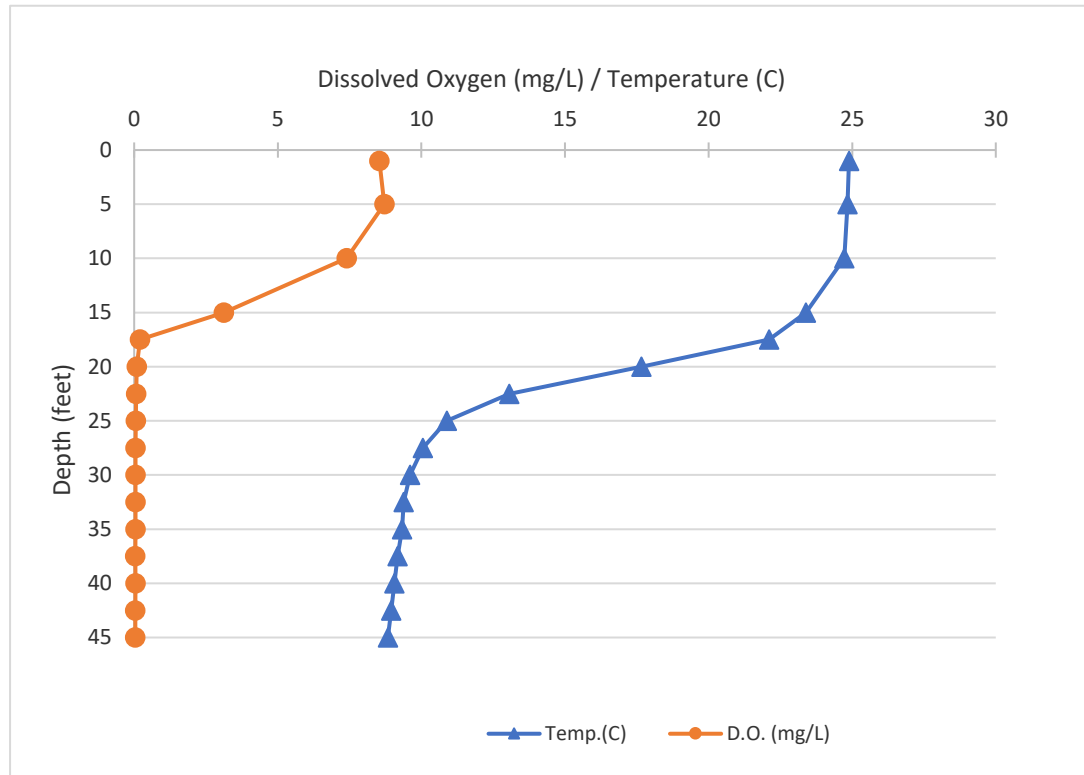
Dissolved Oxygen and Temperature Profile

Name: Crockery Lake
 County: Ottawa
 Site ID: 700422
 Date: 8/22/2022

Depth (ft)	Temp.(C)	D.O. (mg/L)
1	24.8888889	8.54
5	24.8333333	8.71
10	24.7222222	7.4
15	23.3888889	3.12
17.5	22.1111111	0.2
20	17.6666667	0.09
22.5	13.0555556	0.07
25	10.8888889	0.06
27.5	10.0555556	0.05
30	9.611111111	0.05
32.5	9.38888889	0.05
35	9.333333333	0.05
37.5	9.16666667	0.04
40	9.05555556	0.05
42.5	8.944444444	0.04
45	8.833333333	0.04

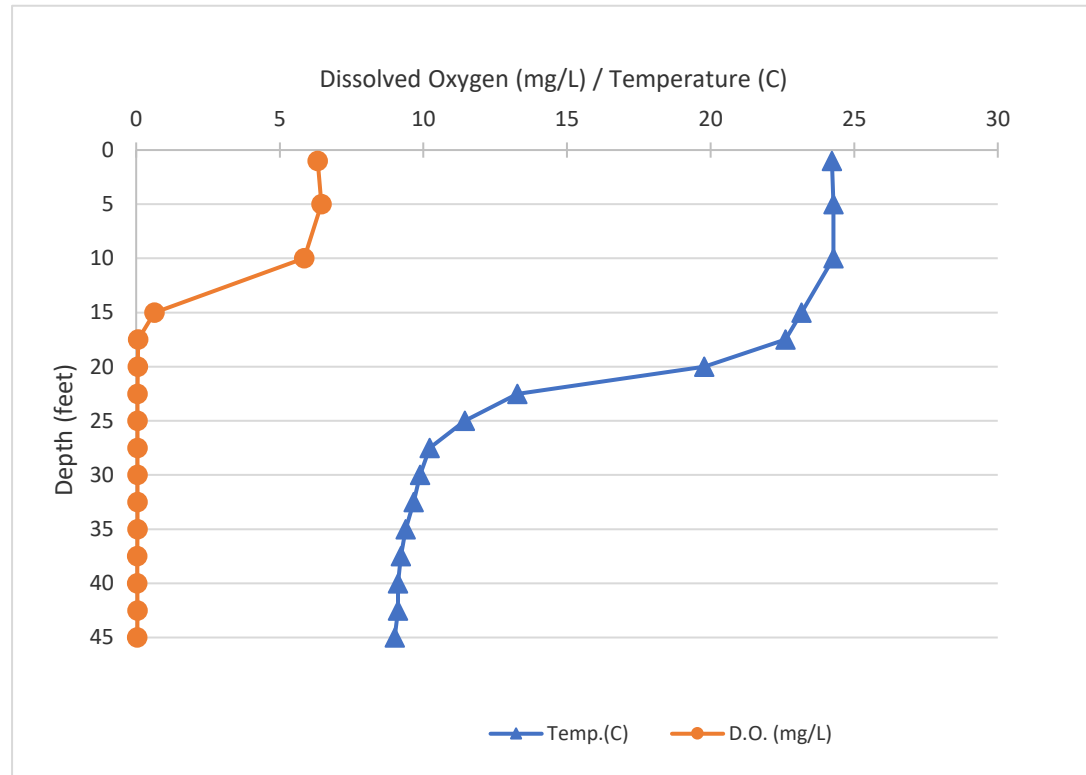
Dissolved Oxygen and Temperature Profile

Name: Crockery Lake
 County: Ottawa
 Site ID: 700422
 Date: 8/29/2022

Depth (ft)	Temp.(C)	D.O. (mg/L)
1	24.2222222	6.32
5	24.2777778	6.45
10	24.2777778	5.85
15	23.1666667	0.64
17.5	22.6111111	0.07
20	19.7777778	0.06
22.5	13.2777778	0.05
25	11.4444444	0.05
27.5	10.2222222	0.05
30	9.8888889	0.05
32.5	9.6666667	0.05
35	9.3888889	0.05
37.5	9.2222222	0.04
40	9.1111111	0.04
42.5	9.1111111	0.05
45	9	0.04

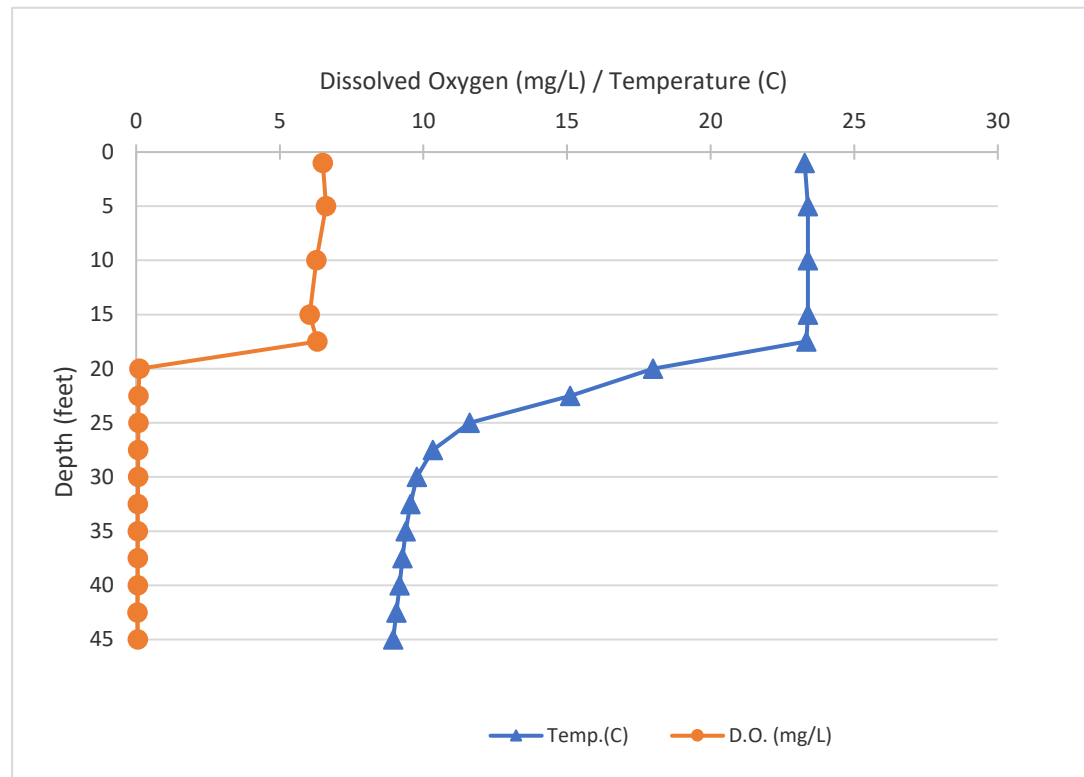
Dissolved Oxygen and Temperature Profile

Name: Crockery Lake
 County: Ottawa
 Site ID: 700422
 Date: 9/5/2022

Depth (ft)	Temp.(C)	D.O. (mg/L)
1	23.2777778	6.5
5	23.3888889	6.61
10	23.3888889	6.27
15	23.3888889	6.04
17.5	23.3333333	6.31
20	18	0.11
22.5	15.1111111	0.08
25	11.6111111	0.08
27.5	10.3333333	0.07
30	9.7777778	0.07
32.5	9.5555556	0.06
35	9.3888889	0.06
37.5	9.2777778	0.06
40	9.1666667	0.06
42.5	9.0555556	0.05
45	8.9444444	0.06
