2016 Trophic & Score the Shore Report 2022 Plant Report for

Hermansville Pond, Menominee County

Site ID: 550218

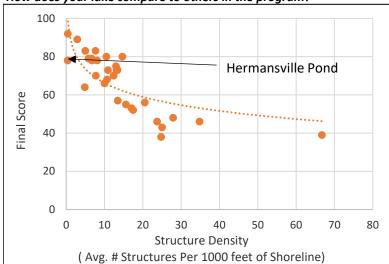
How does your lake compare to others in the program?

Hermansville Pond:		
Number of Sections:	13	
Number of Structures:	5	
Structure Density:	0.4	
Final Score:	78

All 31 Participating Lakes in 2015 and 2016:			
Avg. Number of Sections:	16		
Avg. Number of Structures:	233		
Avg. Structure Density:	14.6		
Avg. Final Score:	66

There is a very tight relationship between Final Score and Structure Density. It will be interesting to see if and how this changes as more lakes go through this scoring process.
