2022 Data Report for Horsehead Lake, Mecosta County

Site ID: 540085

Horsehead Lake, Mecosta County 2022 CLMP Results

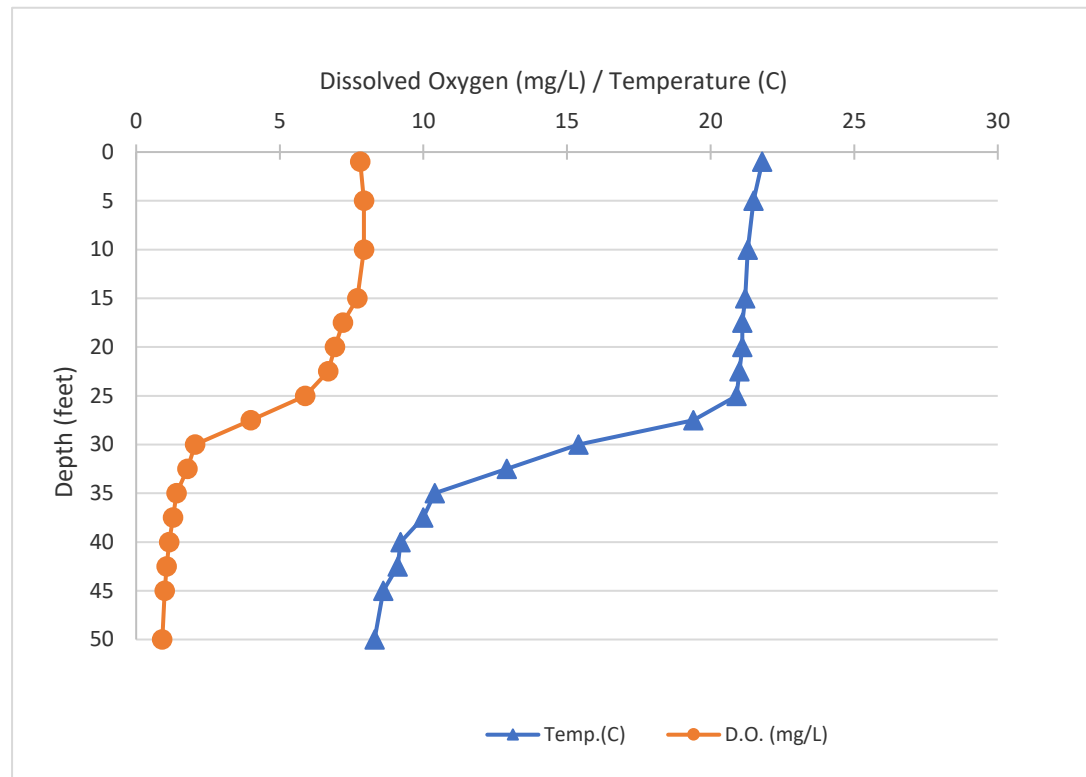
Name: Horsehead Lake
 County: Mecosta
 Site ID: 540085
 Date: 9/15/2022

Dissolved Oxygen and Temperature Profile

Depth (ft)	Temp.(C)	D.O. (mg/L)
1	21.8	7.8
5	21.5	7.93
10	21.3	7.93
15	21.2	7.7
17.5	21.1	7.2
20	21.1	6.92
22.5	21	6.69
25	20.9	5.89
27.5	19.4	3.99
30	15.4	2.05
32.5	12.9	1.79
35	10.4	1.41
37.5	10	1.28
40	9.2	1.15
42.5	9.1	1.06
45	8.6	0.99
50	8.3	0.91
