2022 Data Report for

Klinger Lake, St. Joseph County

Site ID: 750136

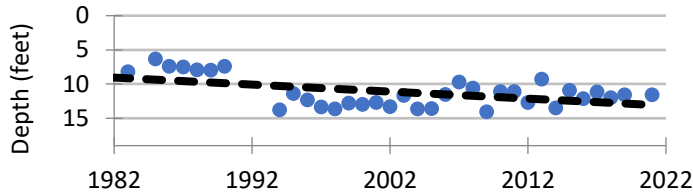
Secchi Disk Transparency (feet)

Year	# Readings	Min	Max	Avg	Std. Dev	Carlson TSI
2021	17	7.5	19.5	11.6	3.9	42
2016-2020	74	5.5	28.5	11.6	4.7	42
1982-2015	502	4.0	32.5	11.1	3.8	43
2022 All CLMP Lakes	3178	1.0	63.0	11.6	2.5	43

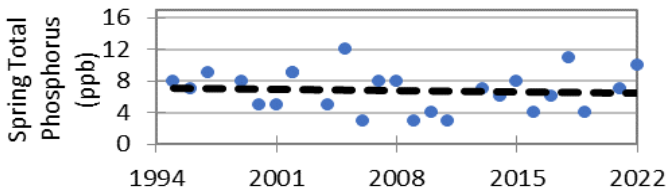
Spring Phosphorus (parts per billion)

Year	# Samples	Min	Max	Avg	Std. Dev
2022	1	10.0	10.0	10.0	NA
2017-2021	4	<5 T	11.0	7.0	2.9
1995-2016	20	<=3 W	12.0	6.6	2.5
2022 All CLMP Lakes	220	<5	220.0	20.7	21.3

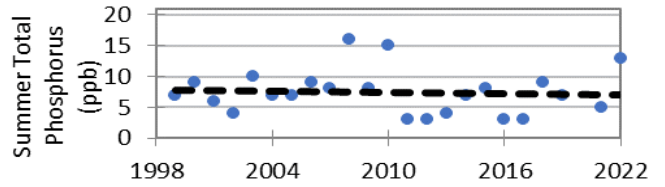
Summer Phosphorus (parts per billion)

Year	# Samples	Min	Max	Avg	Std. Dev	Carlson TSI
2022	1	13.0	13.0	13.0	NA	41
2017-2021	4	<=3 W	9.0	6.0	2.6	29
1999-2016	18	<=3 W	16.0	7.4	3.7	31
2022 All CLMP Lakes	234	<= 3	150.0	17.4	15.3	45

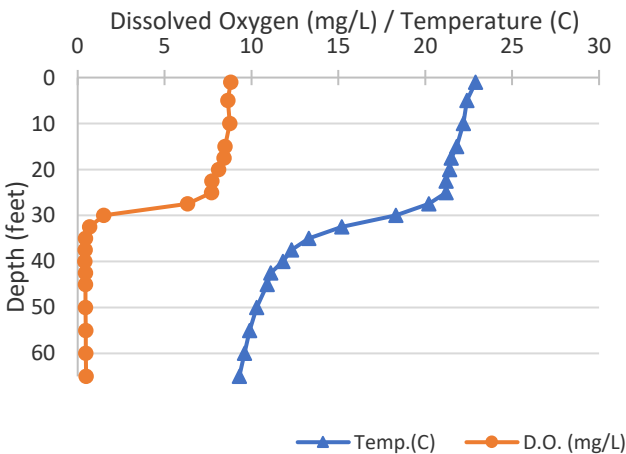
Dissolved Oxygen and Temperature Profile 9/11/2019

The lake keeps some dissolved oxygen in the bottom waters through mid-summer, but by late summer the lake has stratified and the bottom water is devoid of oxygen.

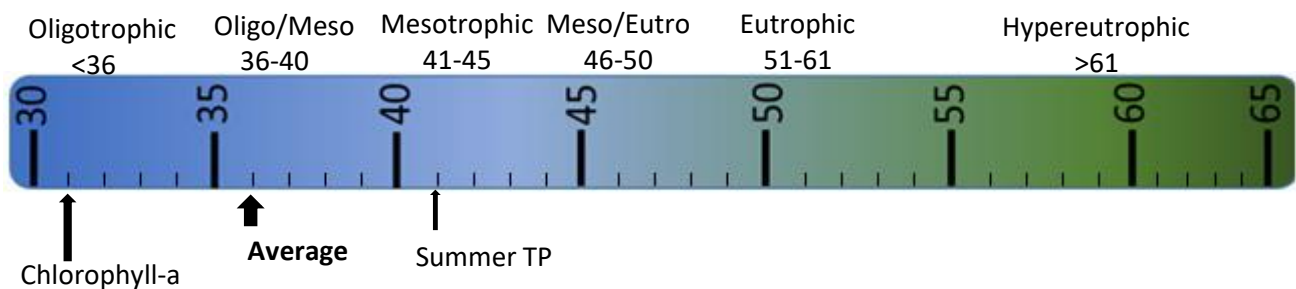
In 1977, limnologist Dr. Robert Carlson developed a numerical scale (0-100) where the numbers indicate the level of nutrient enrichment. Using the proper equations, we can convert results from Summer Total Phosphorus, Secchi Depth, and Chlorophyll-a to this Trophic Status Index (TSI). The TSI numbers are furthermore grouped into general categories (oligotrophic, mesotrophic, eutrophic, and hypereutrophic), to quickly give us a way to understand the general nutrient level of any lake.

TSI for Klinger Lake in 2022	
Average	36
Secchi Disk	
Summer TP	41
Chlorophyll-a	<31

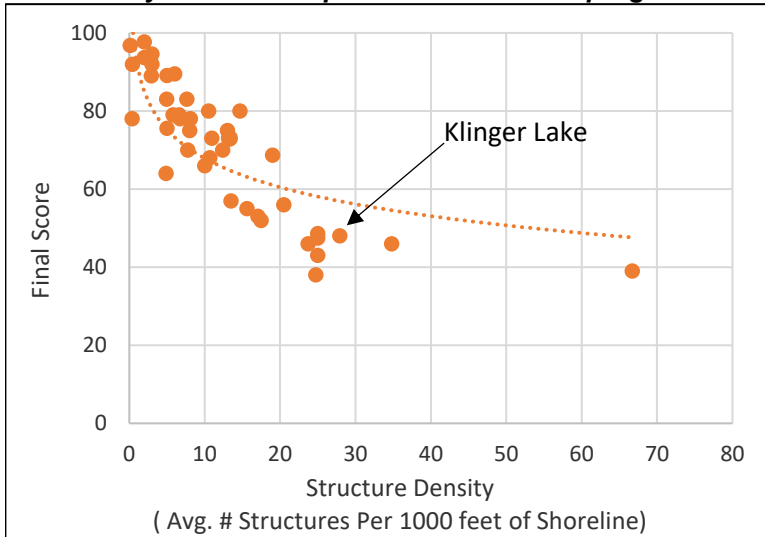
How does your lake compare to others in the program?

Klinger Lake:	
Number of Sections:	25
Number of Structures:	698
Structure Density:	27.9
Final Score:	48

All 42 Participating Lakes from 2015-2018:	
Avg. Number of Sections:	16.3
Avg. Number of Structures:	248.5
Avg. Structure Density:	15.2
Avg. Final Score:	70.5

With a fairly high house and dock density as compared to the other lakes, it would be expected that the quality of the lakeshore habitat would be lower in Klinger Lake. Overall, all of the sections were classified as either poor or fair.

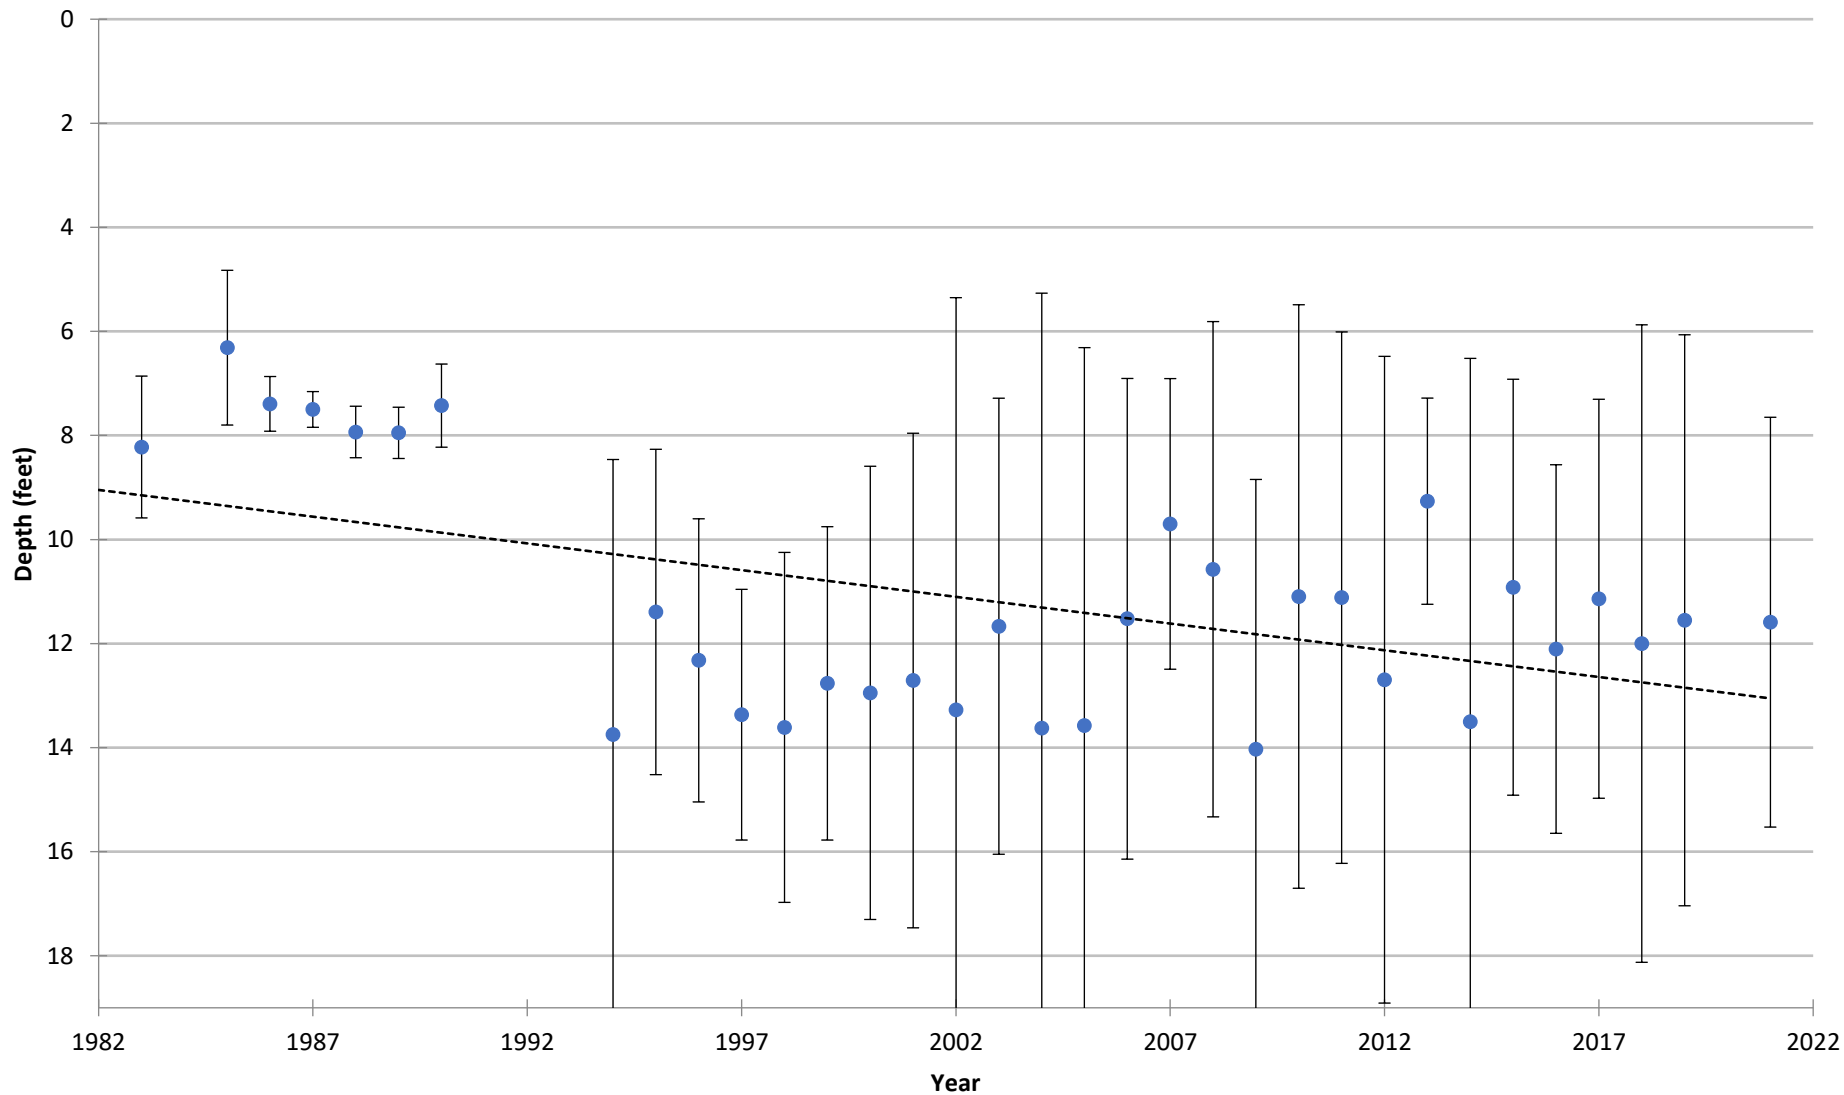
COOPERATIVE LAKES MONITORING PROGRAM
SUMMER MEAN TRANSPARENCY

Vertical bars indicate standard deviation

Long term trends indicate that the trophic status parameters have not changed beyond minor year-to-year variation since monitoring began.

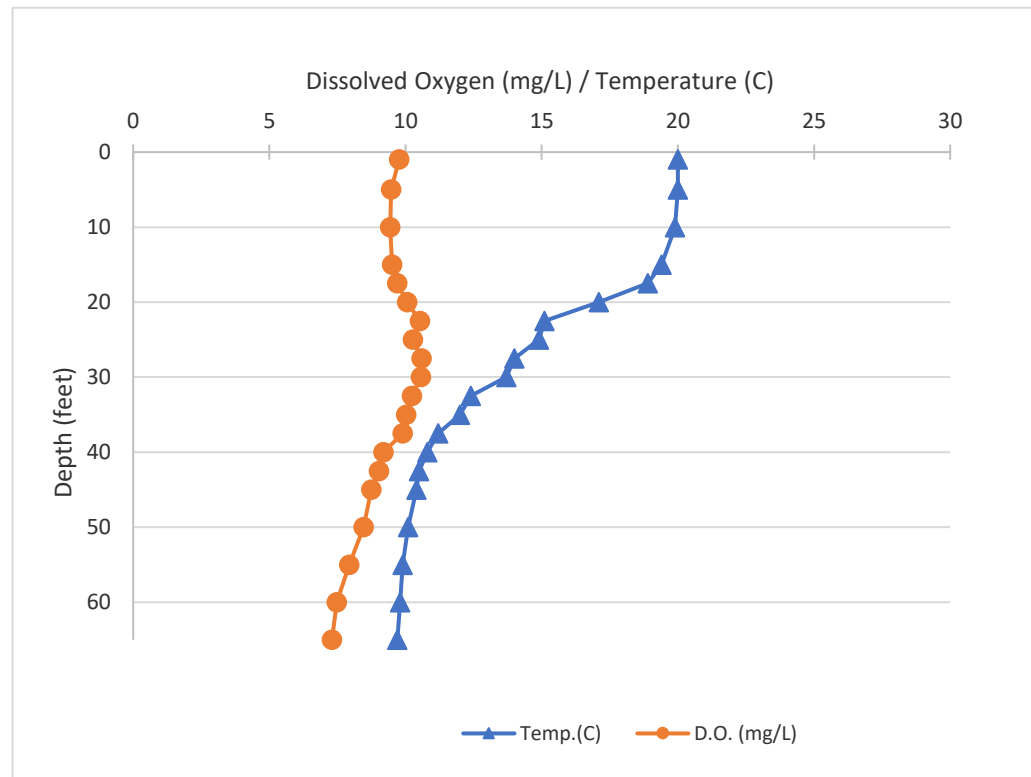
5/29/2019

Dissolved Oxygen and Temperature Profile

Depth (ft)	Temp.(C)	D.O. (mg/L)
1	20	9.76
5	20	9.47
10	19.9	9.44
15	19.4	9.51
17.5	18.9	9.7
20	17.1	10.06
22.5	15.1	10.53
25	14.9	10.27
27.5	14	10.59
30	13.7	10.56
32.5	12.4	10.23
35	12	10.03
37.5	11.2	9.9
40	10.8	9.19
42.5	10.5	9.03
45	10.4	8.74
50	10.1	8.46
55	9.9	7.93
60	9.8	7.47
65	9.7	7.3

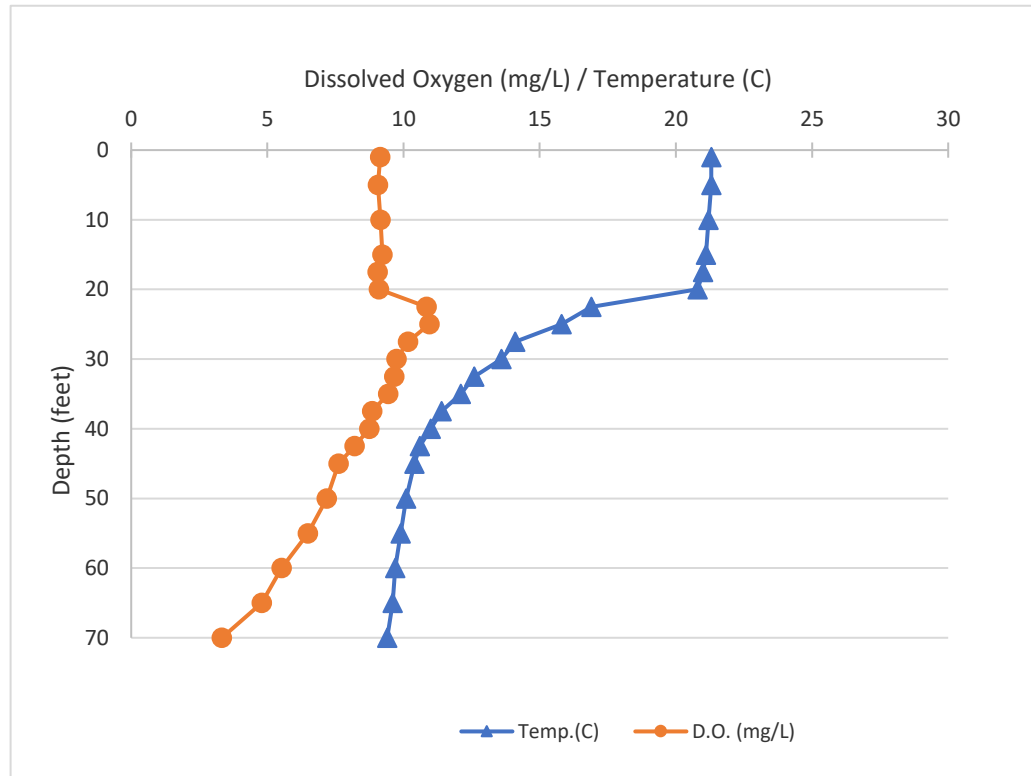
6/11/2019

Dissolved Oxygen and Temperature Profile

Depth (ft)	Temp.(C)	D.O. (mg/L)
1	21.3	9.14
5	21.3	9.06
10	21.2	9.16
15	21.1	9.23
17.5	21	9.05
20	20.8	9.1
22.5	16.9	10.85
25	15.8	10.95
27.5	14.1	10.16
30	13.6	9.74
32.5	12.6	9.66
35	12.1	9.44
37.5	11.4	8.85
40	11	8.74
42.5	10.6	8.2
45	10.4	7.62
50	10.1	7.18
55	9.9	6.49
60	9.7	5.52
65	9.6	4.8
70	9.4	3.33

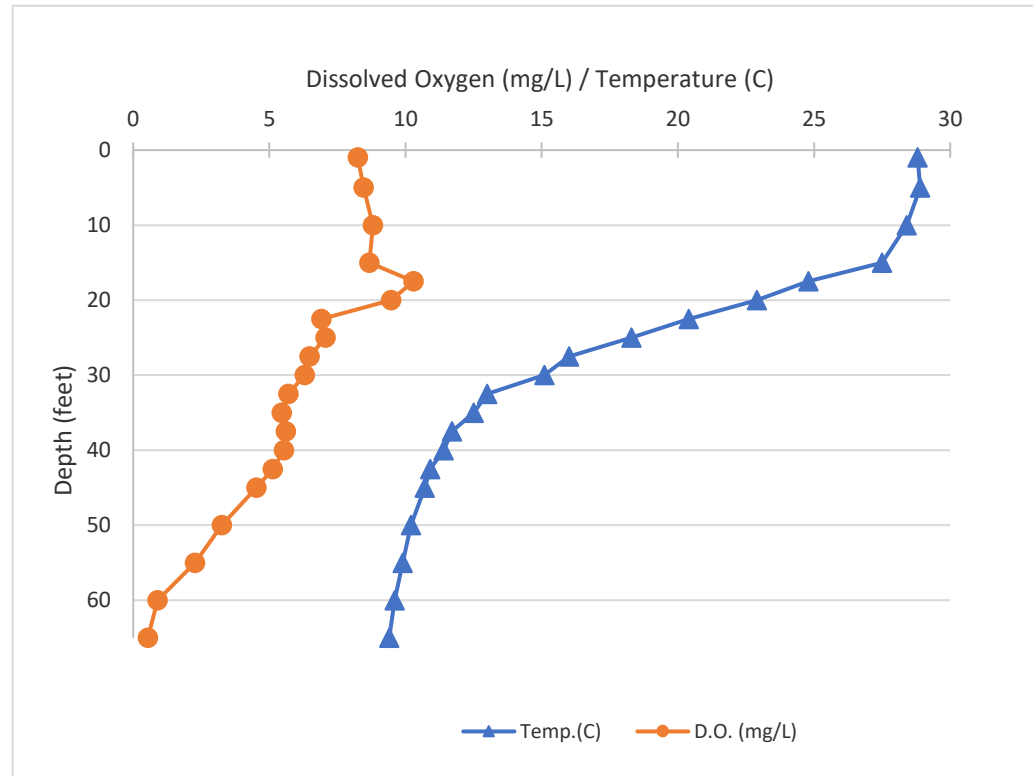
7/18/2019

Dissolved Oxygen and Temperature Profile

Depth (ft)	Temp.(C)	D.O. (mg/L)
1	28.8	8.25
5	28.9	8.46
10	28.4	8.8
15	27.5	8.67
17.5	24.8	10.29
20	22.9	9.47
22.5	20.4	6.91
25	18.3	7.06
27.5	16	6.48
30	15.1	6.3
32.5	13	5.7
35	12.5	5.45
37.5	11.7	5.61
40	11.4	5.53
42.5	10.9	5.13
45	10.7	4.53
50	10.2	3.26
55	9.9	2.27
60	9.6	0.9
65	9.4	0.54

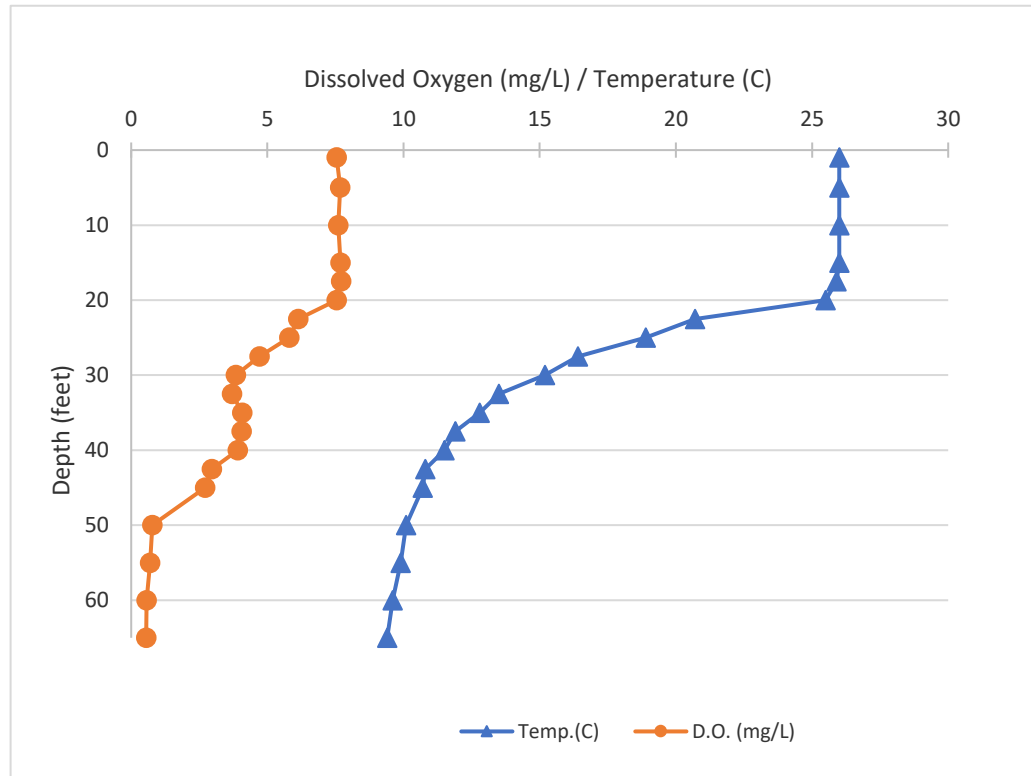
7/31/2019

Dissolved Oxygen and Temperature Profile

Depth (ft)	Temp.(C)	D.O. (mg/L)
1	26	7.55
5	26	7.67
10	26	7.6
15	26	7.69
17.5	25.9	7.71
20	25.5	7.54
22.5	20.7	6.14
25	18.9	5.8
27.5	16.4	4.71
30	15.2	3.84
32.5	13.5	3.7
35	12.8	4.08
37.5	11.9	4.06
40	11.5	3.91
42.5	10.8	2.96
45	10.7	2.71
50	10.1	0.78
55	9.9	0.69
60	9.6	0.56
65	9.4	0.55

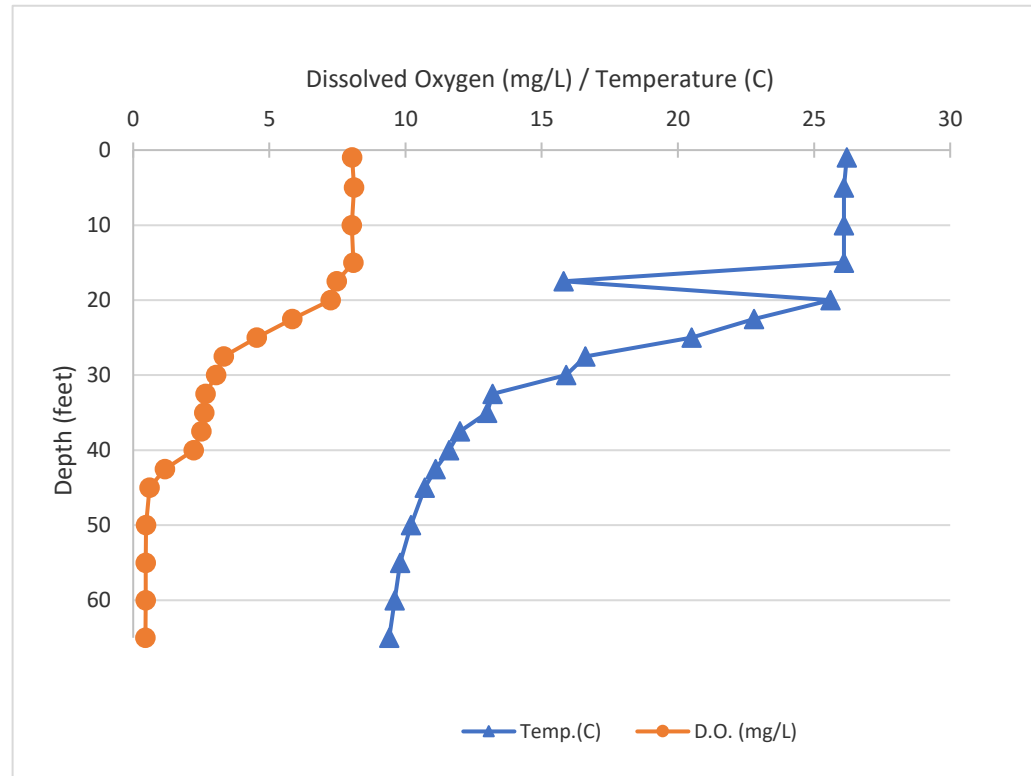
8/14/2019

Dissolved Oxygen and Temperature Profile

Depth (ft)	Temp.(C)	D.O. (mg/L)
1	26.2	8.04
5	26.1	8.11
10	26.1	8.03
15	26.1	8.08
17.5	15.8	7.48
20	25.6	7.25
22.5	22.8	5.84
25	20.5	4.54
27.5	16.6	3.33
30	15.9	3.05
32.5	13.2	2.66
35	13	2.61
37.5	12	2.5
40	11.6	2.22
42.5	11.1	1.17
45	10.7	0.6
50	10.2	0.47
55	9.8	0.46
60	9.6	0.46
65	9.4	0.45

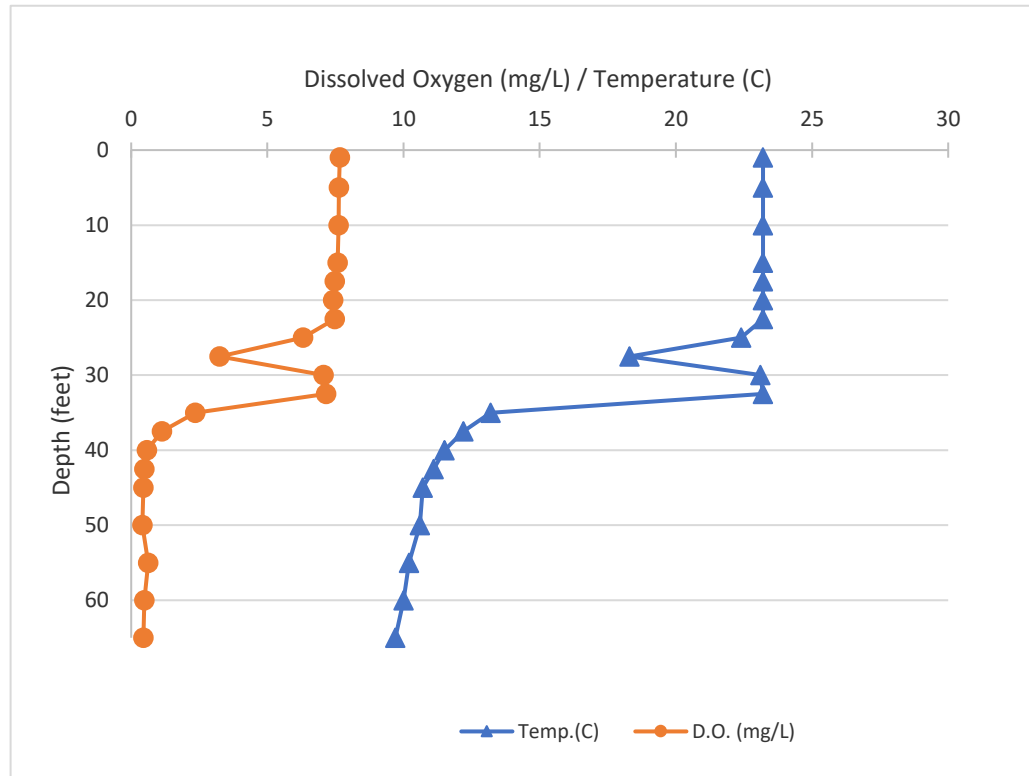
8/28/2019

Dissolved Oxygen and Temperature Profile

Depth (ft)	Temp.(C)	D.O. (mg/L)
1	23.2	7.66
5	23.2	7.63
10	23.2	7.62
15	23.2	7.58
17.5	23.2	7.47
20	23.2	7.41
22.5	23.2	7.48
25	22.4	6.31
27.5	18.3	3.25
30	23.1	7.06
32.5	23.2	7.16
35	13.2	2.35
37.5	12.2	1.13
40	11.5	0.58
42.5	11.1	0.48
45	10.7	0.45
50	10.6	0.41
55	10.2	0.62
60	10	0.48
65	9.7	0.45

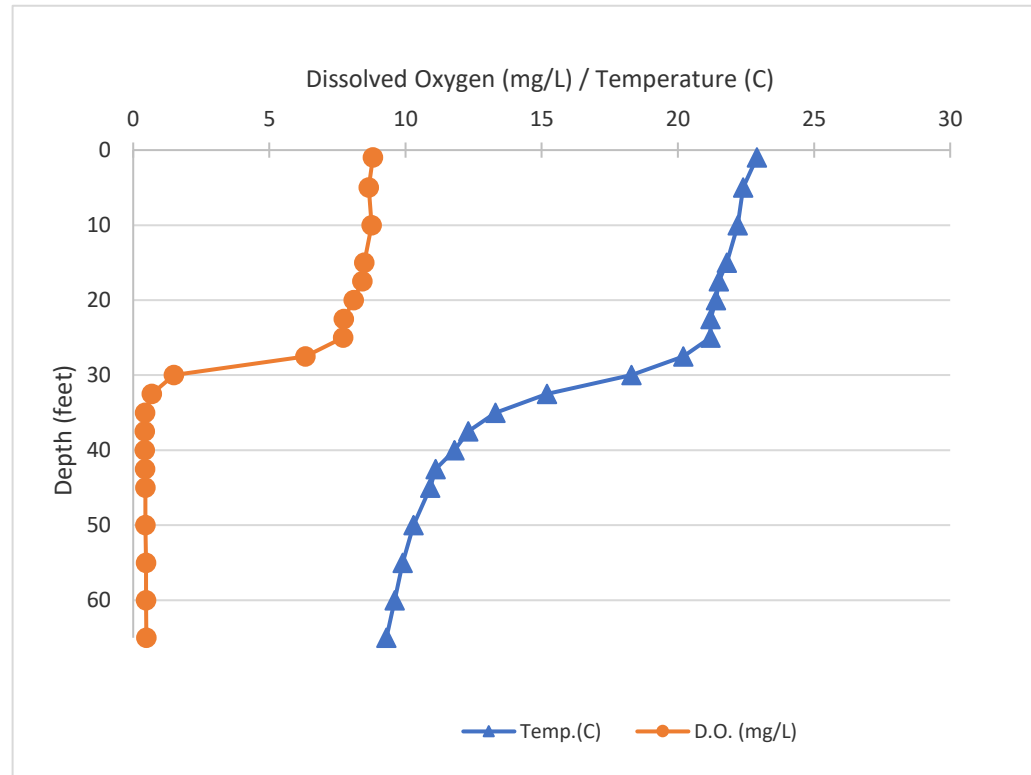
9/11/2019

Dissolved Oxygen and Temperature Profile

Depth (ft)	Temp.(C)	D.O. (mg/L)
1	22.9	8.8
5	22.4	8.65
10	22.2	8.76
15	21.8	8.48
17.5	21.5	8.42
20	21.4	8.1
22.5	21.2	7.73
25	21.2	7.71
27.5	20.2	6.32
30	18.3	1.49
32.5	15.2	0.68
35	13.3	0.44
37.5	12.3	0.43
40	11.8	0.42
42.5	11.1	0.44
45	10.9	0.45
50	10.3	0.45
55	9.9	0.47
60	9.6	0.47
65	9.3	0.48
