2022 Data Report for

Maceday Lake, Oakland County

Site ID: 630415

Maceday Lake, Oakland County 2022 CLMP Results

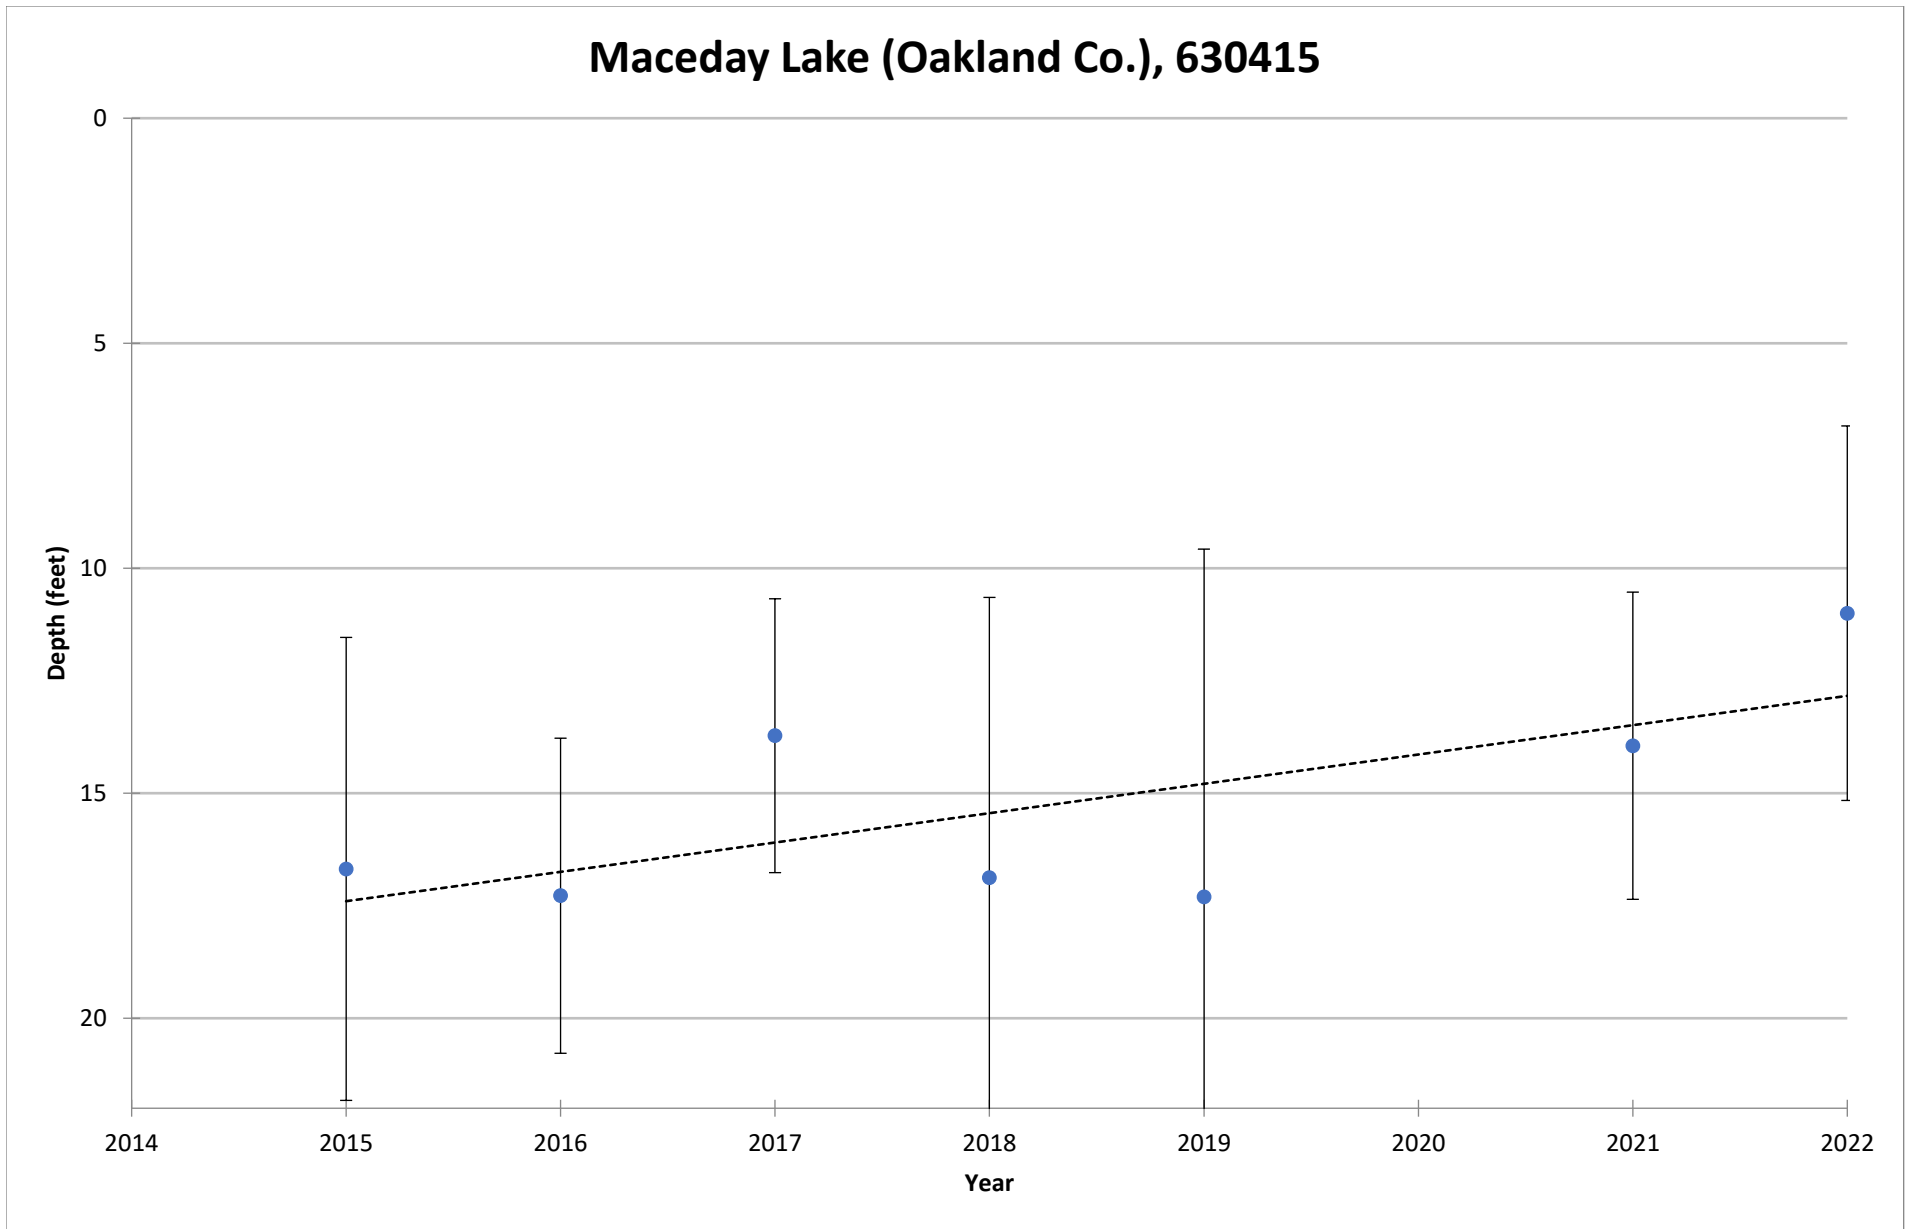
COOPERATIVE LAKES MONITORING PROGRAM
SUMMER MEAN TRANSPARENCY

Maceday Lake (Oakland Co.), 630415

Vertical bars indicate standard deviation

Long term monitoring shows slight upward slopes on all the parameters and an increase in average TSI score over time. These results indicate a slow movement toward higher nutrient levels in this lake.

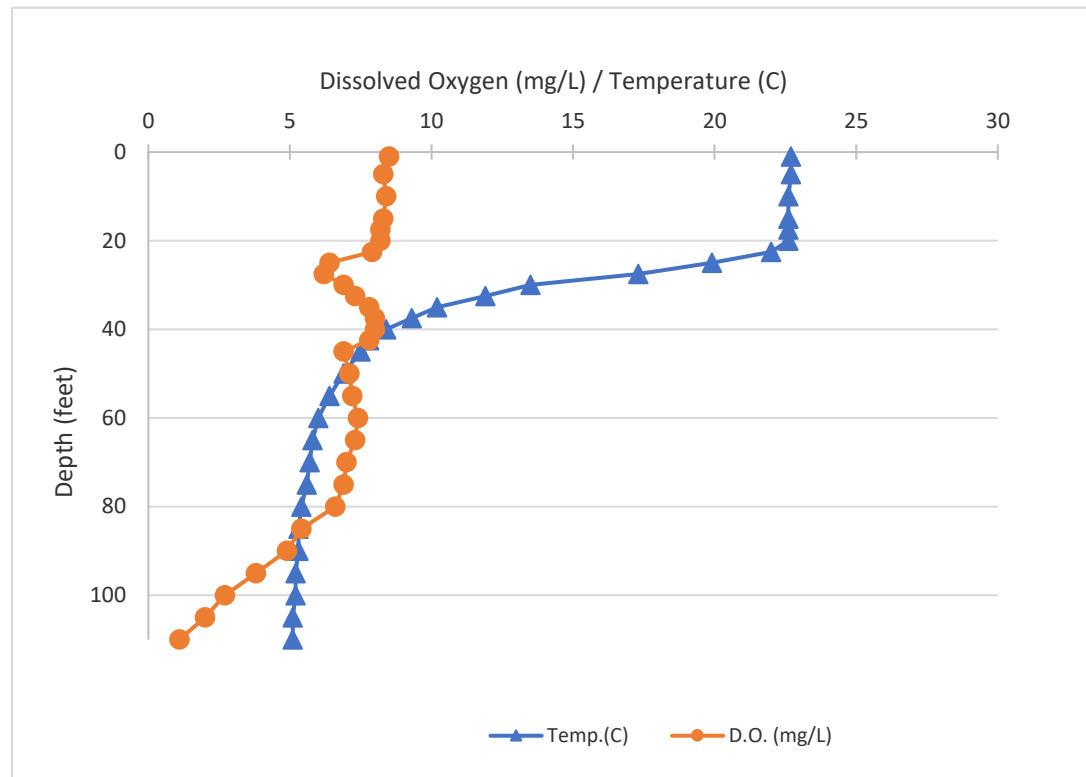
Name: Maceday Lake
 County: Oakland
 Site ID: 630415
 Date: 9/13/2022

Depth (ft)	Temp.(C)	D.O. (mg/L)
1	22.7	8.5
5	22.7	8.3
10	22.6	8.4
15	22.6	8.3
17.5	22.6	8.2
20	22.6	8.2
22.5	22	7.9
25	19.9	6.4
27.5	17.3	6.2
30	13.5	6.9
32.5	11.9	7.3
35	10.2	7.8
37.5	9.3	8
40	8.4	8
42.5	7.8	7.8
45	7.5	6.9
50	6.9	7.1
55	6.4	7.2
60	6	7.4
65	5.8	7.3
70	5.7	7
75	5.6	6.9
80	5.4	6.6
85	5.3	5.4
90	5.3	4.9
95	5.2	3.8
100	5.2	2.7
105	5.1	2
110	5.1	1.1

The low level of nutrients in the lake results in dissolved oxygen being available throughout the water column for most of the summer. Only by the end of the summer/early fall does the bottom of the lake become anoxic.
