2022 Data Report for

Big Maggie Lake, Iron County

Site ID: 360173

Big Maggie Lake, Iron County 2022 CLMP Results

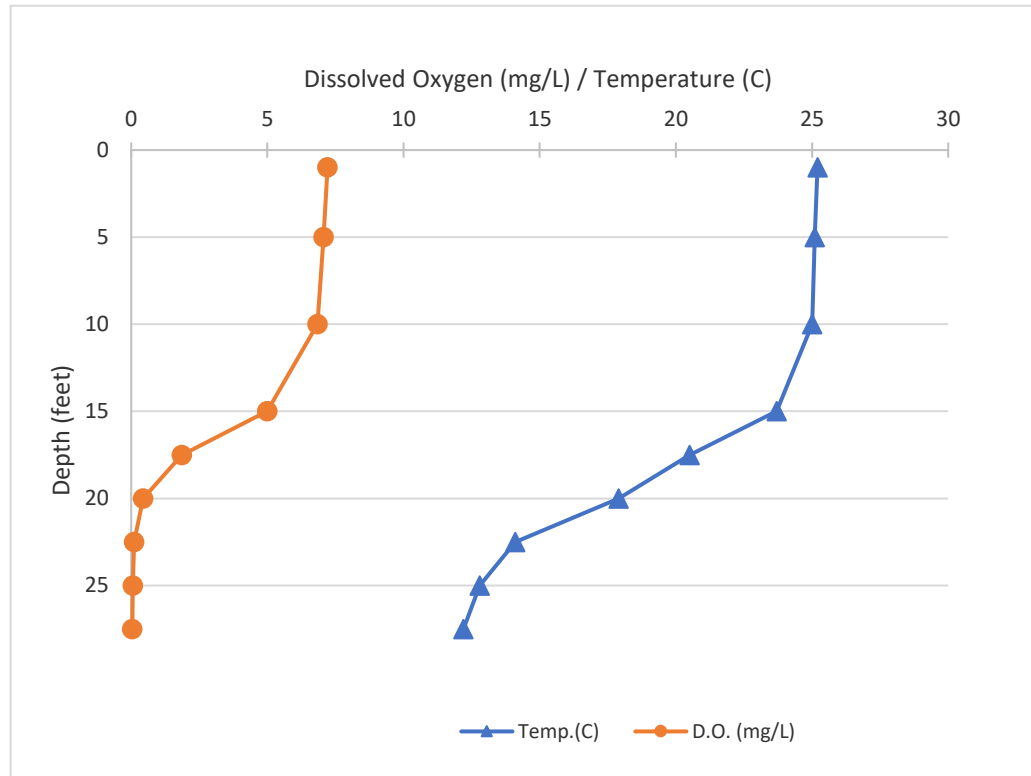
Name: Big Maggie Lake
County: Iron
Site ID: 360173
Date: 8/10/2016

Dissolved Oxygen and Temperature Profile

Depth (ft)	Temp.(C)	D.O. (mg/L)
1	25.2	7.21
5	25.1	7.06
10	25	6.84
15	23.7	5
17.5	20.5	1.86
20	17.9	0.44
22.5	14.1	0.11
25	12.8	0.06
27.5	12.2	0.04

The lake keeps some dissolved oxygen in the bottom waters through spring and early-summer, but by mid- to late-summer the lake has stratified and the bottom water is devoid of oxygen.
