2022 Data Report
for
Painter Lake, Cass County

Site ID: 140108

Painter Lake, Cass County 2022 CLMP Results

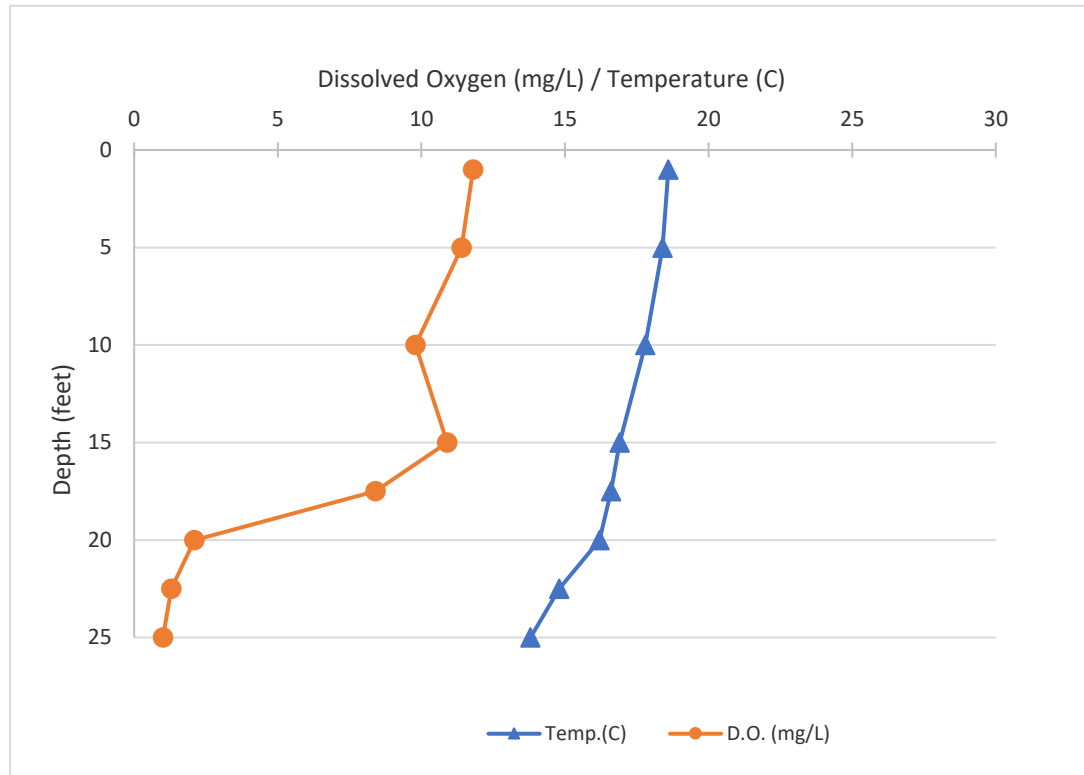
Name: Painter Lake
County: Cass
Site ID: 140108
Date: 9/24/2022

Dissolved Oxygen and Temperature Profile
