2022 Data Report for

Pentwater Lake, Oceana County

Site ID: 640089

Pentwater Lake, Oceana County 2022 CLMP Results

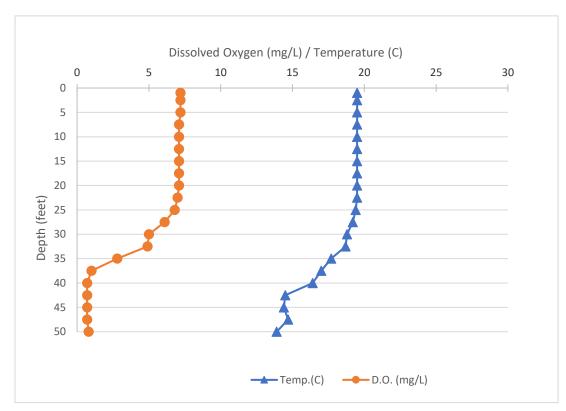
County: Oceana Site ID: 640089 Date: 9/7/2010

Depth (ft) Temp.(C) D.O. (mg/L) 7.2 19.5 2.5 19.5 7.2 5 19.5 7.2 7.5 19.5 7.1 19.5 7.1 10 19.5 7.1 12.5 15 19.5 7.1 17.5 19.5 7.1 20 19.5 7.1 19.5 7 22.5 25 19.4 6.8 27.5 19.2 6.1 30 18.8 5 32.5 4.9 18.7 35 17.7 2.8 37.5 17 1 40 0.7 16.4 42.5 14.5 0.7 45 14.4 0.7 47.5 14.7 0.7 50 13.9 8.0
