2016 Trophic & Score the Shore Report 2022 Plant Report Resort Lake, Menominee County

Site ID: 550197

Resort Lake, Menominee County 2016 CLMP Results

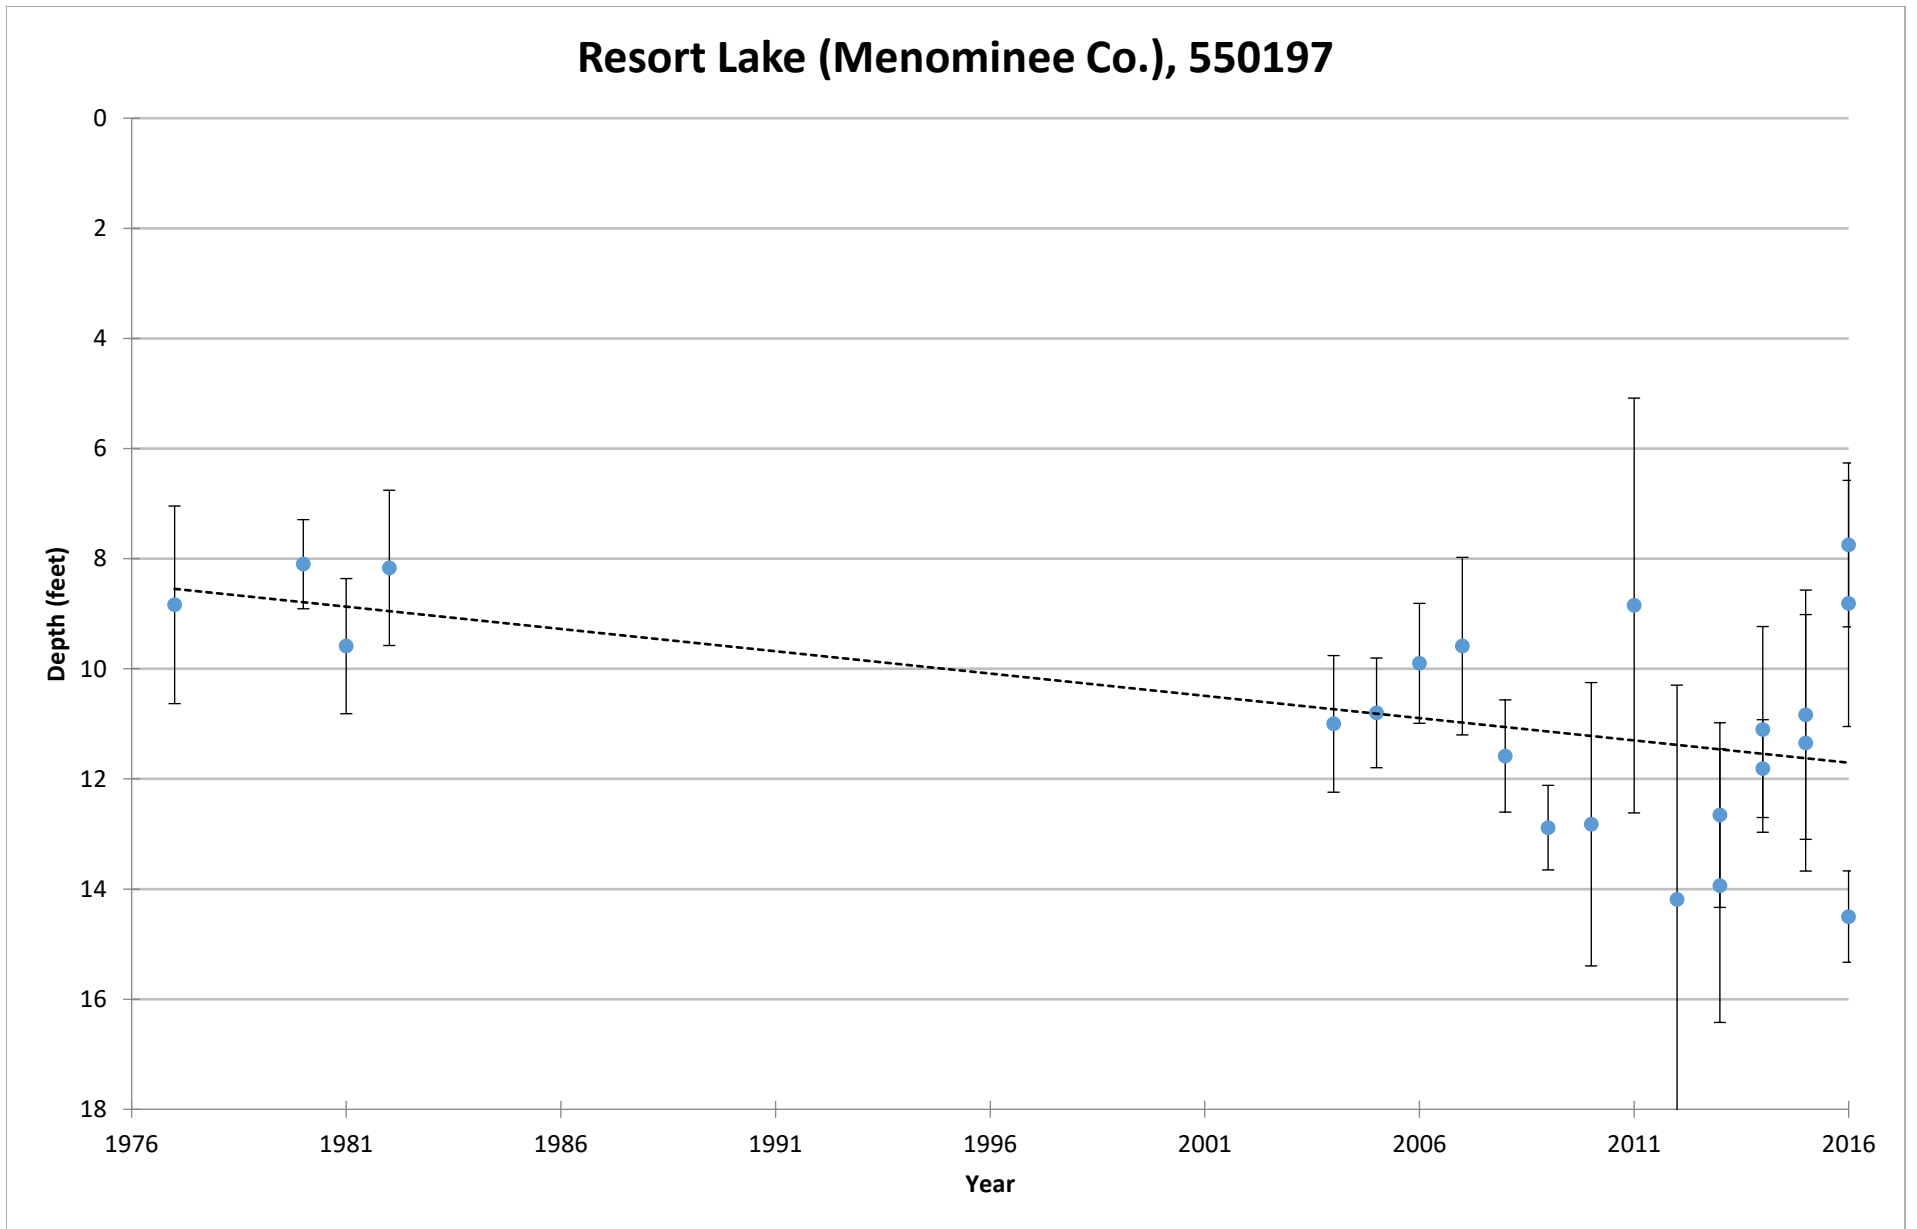
Resort Lake (Menominee Co.), 550197

COOPERATIVE LAKES MONITORING PROGRAM
SUMMER MEAN TRANSPARENCY

Vertical bars indicate standard deviation
