2022 Data Report for

Rose Lake, Osceola County

Site ID: 670058

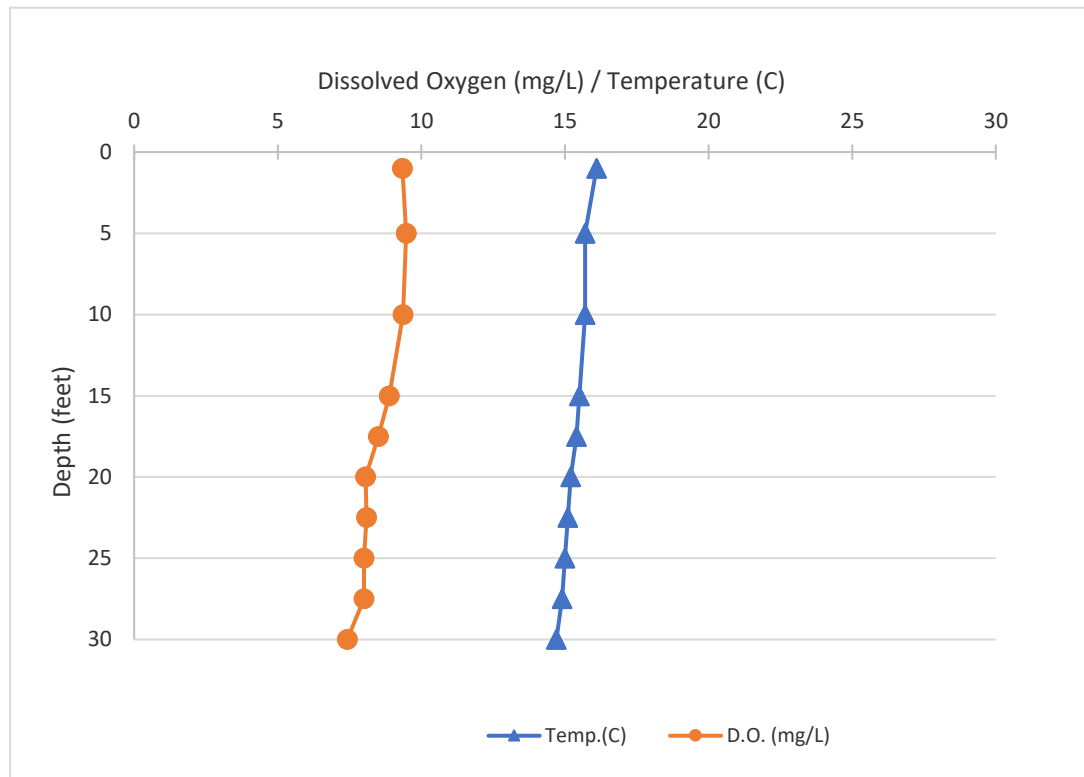
10/1/2022

Depth (ft)	Temp.(C)	D.O. (mg/L)
1	16.1	9.34
1	16.1	9.34
5	15.7	9.47
5	15.7	9.47
10	15.7	9.36
10	15.7	9.36
15	15.5	8.88
15	15.5	8.88
17.5	15.4	8.5
17.5	15.4	8.5
20	15.2	8.06
20	15.2	8.06
22.5	15.1	8.09
22.5	15.1	8.09
25	15	8
25	15	8
27.5	14.9	8
27.5	14.9	8
30	14.7	7.42
30	14.7	7.42
