2022 Data Report for Lake Victoria, Clinton County

Site ID: 190184

Lake Victoria, Clinton County 2022 CLMP Results

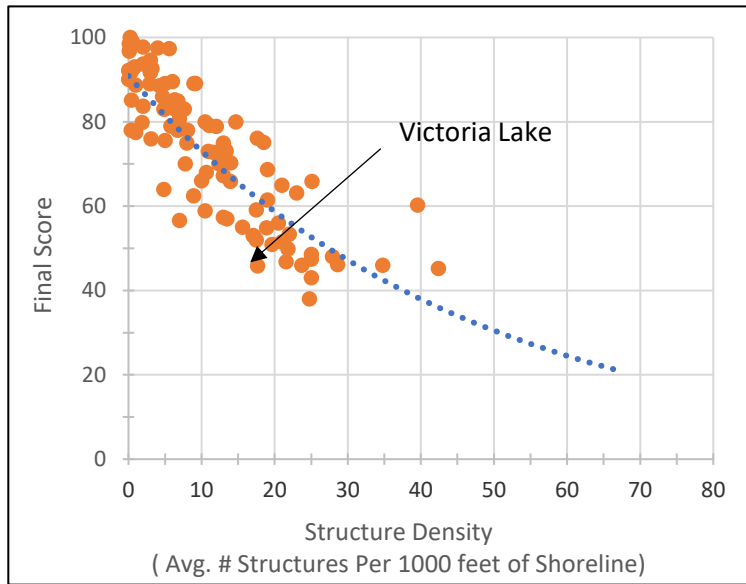
Lake Victoria	
Number of Sections:	14
Number of Structures:	247
Structure Density:	17.6
Final Score:	45.9

Note about graph to the left: The dotted line sets your average expectation of the score of your lake. If your lake is lower than the dotted line, then your shoreline health is lower than average compared to lakes with similar amount of shoreline development. And vice-versa in regards to a lake above the dotted line.

Overall, the lakeshore habitat of Lake Victoria is below average when compared to the other lakes in the program with similar amount of development; some of whom have scores closer to 70 to 80. 50% percent of the lake sections score poor while 50% are rated as Fair.

Of particular concern for Lake Victoria is the riparian habitat, which scored an average of 34, which is considered Poor and not too far removed from the Highly Impacted rating.

Reduce the amount of mowed grass and increase the amount of unmowed native vegetation along the lakeshore to boost this aspect of the shoreline habitat. You can get plenty of ideas for improving shoreline health from the Michigan Natural Shoreline Partnership (<https://www.shorelinepartnership.org/>)
