2022 Data Report for

Oneida Lake, Livingston County

Site ID: 470593

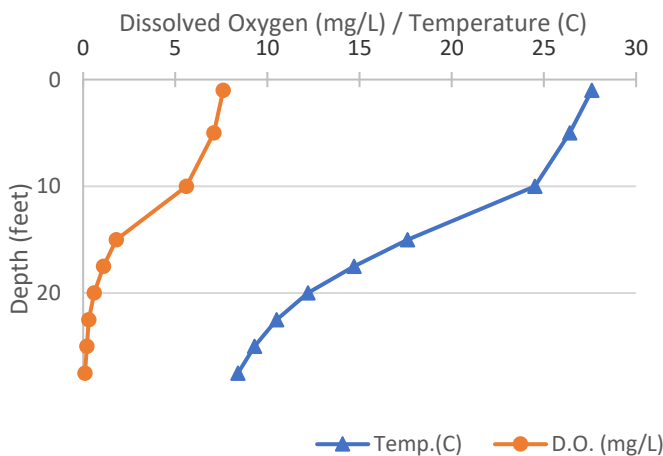
8/10/2022

Dissolved Oxygen and Temperature Profile

The lake loses dissolved oxygen in the bottom waters in early summer, prior to the development of a classic thermocline in mid-summer. By mid-summer, the lake has stratified and the deeper waters are devoid of oxygen. Data indicates that stratification persists through the early fall.

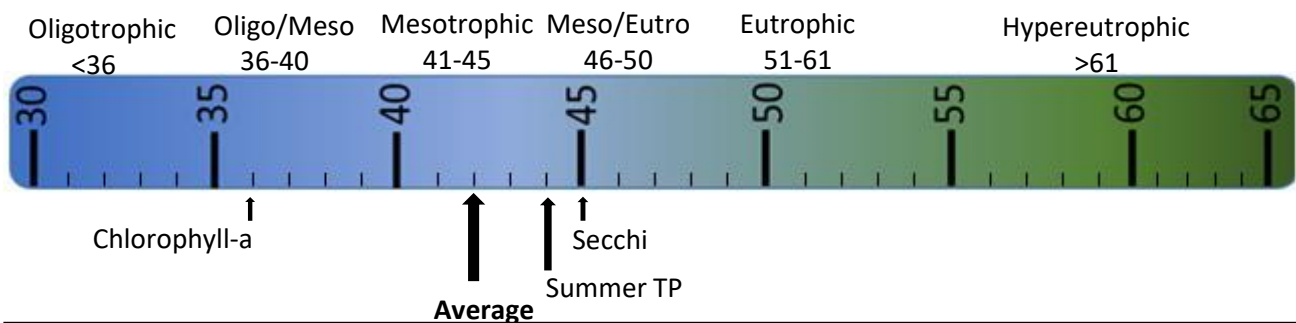
With an average TSI score of 42 based on 2022 Secchi transparency, chlorophyll-a, and summer total phosphorus data, this lake is rated as a mesotrophic lake.

TSI for Oneida Lake in 2022	
Average	42
Secchi Disk	45
Summer TP	44
Chlorophyll-a	36

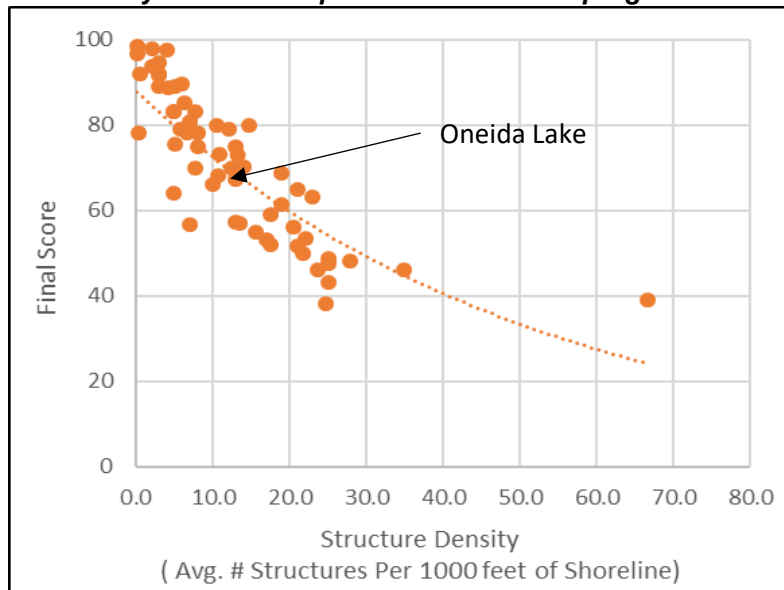
How does your lake compare to others in the program?

Oneida Lake:	
Number of Sections:	7
Number of Structures:	93
Structure Density:	13
Final Score:	67

All 62 Participating Lakes from 2015-2019:	
Avg. Number of Sections:	16
Avg. Number of Structures:	228
Avg. Structure Density:	12.6
Avg. Final Score:	71

Overall, the lakeshore habitat of Oneida Lake right around average when compared to other lakes in the program. All of the 1000 foot sections scored either Fair or Good: 6 fair, and 1 good.

The littoral zone and riparian zone were the weak points in Oneida Lake's habitat (scoring an average of 57 and 56, respectively). To improve the littoral zone score, leave woody debris in place and allow native aquatic vegetation to grow in the shallow waters. Reduce the amount of mowed grass and increase the amount of unmowed native vegetation along the lakeshore to boost the riparian aspect of the shoreline habitat.

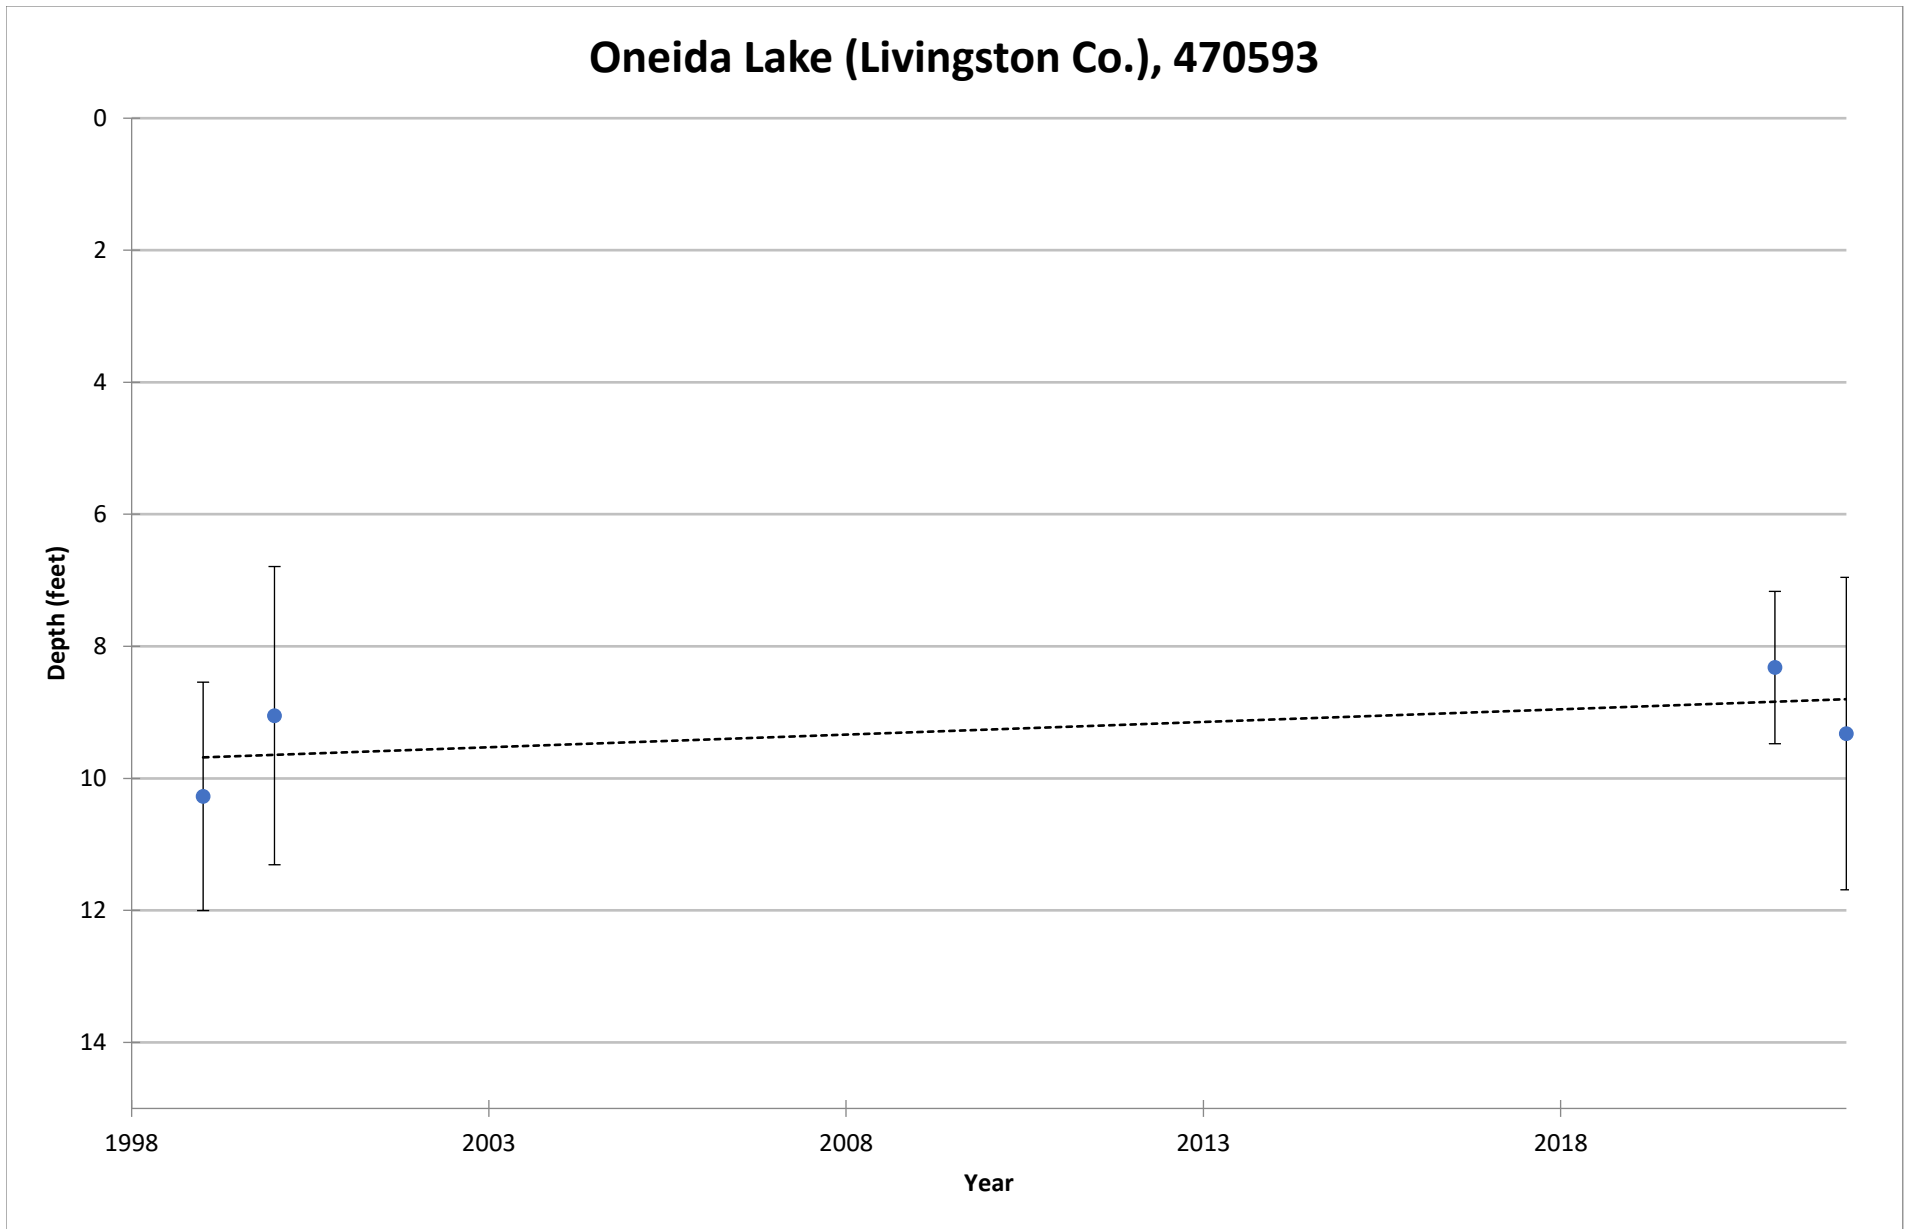
COOPERATIVE LAKES MONITORING PROGRAM
SUMMER MEAN TRANSPARENCY

Oneida Lake (Livingston Co.), 470593

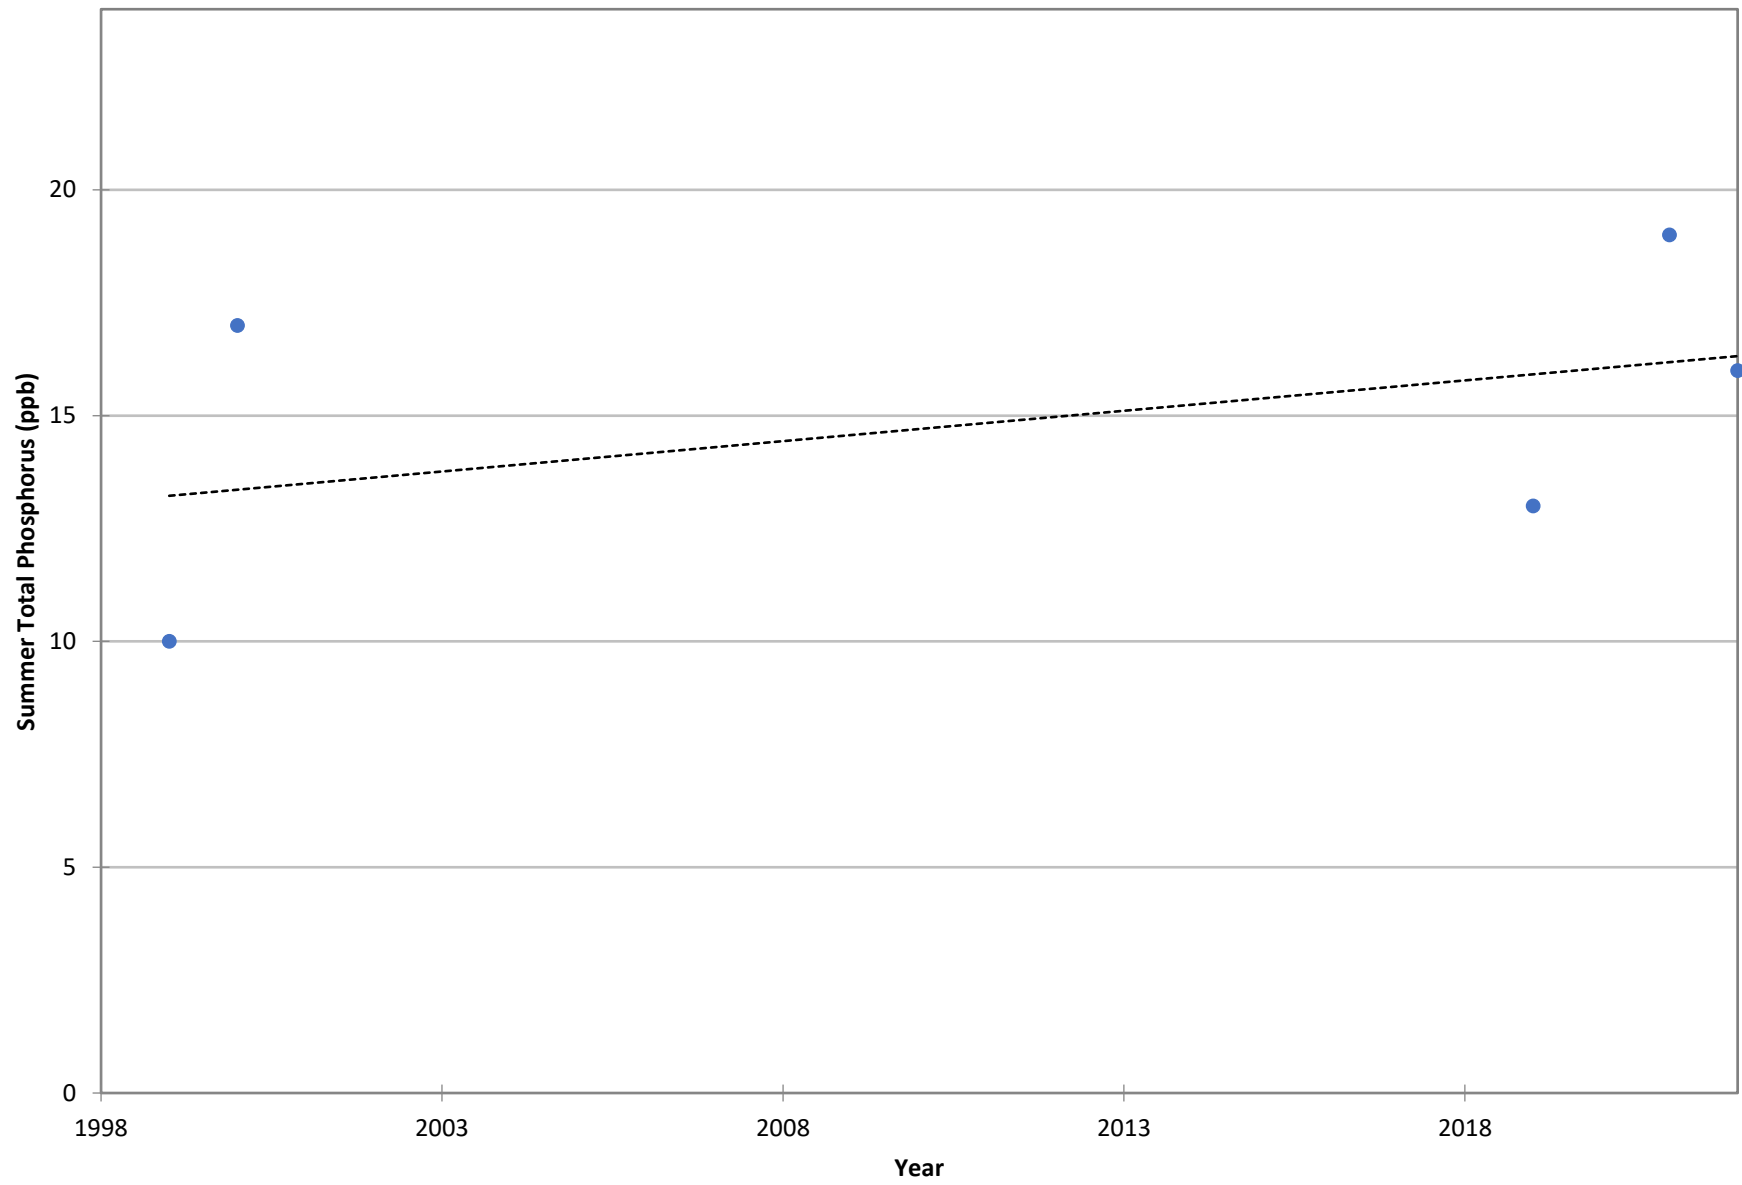
COOPERATIVE LAKES MONITORING PROGRAM
SUMMER TOTAL PHOSPHORUS

Vertical bars indicate standard deviation

Oneida Lake (Livingston Co.), 470593

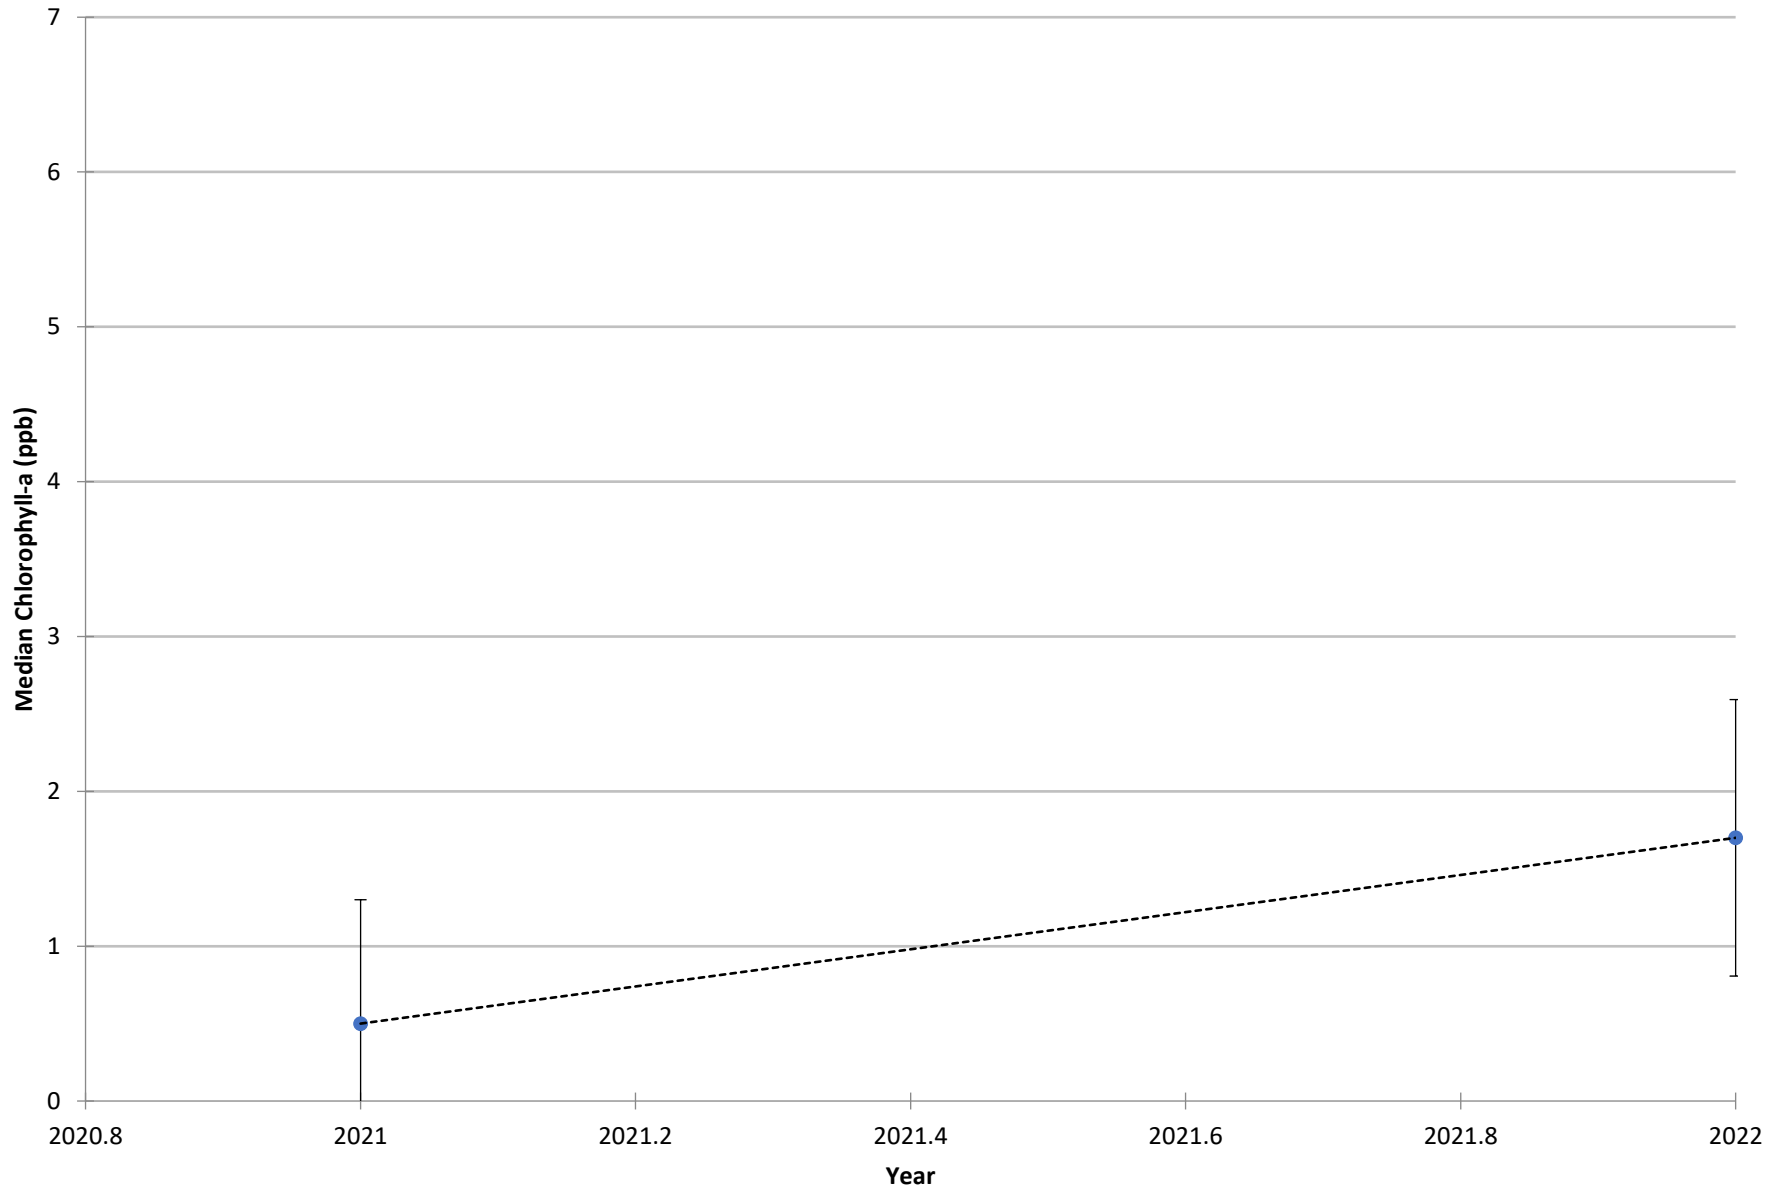
COOPERATIVE LAKES MONITORING PROGRAM
SUMMER MEDIAN CHLOROPHYLL-A

Oneida Lake (Livingston Co.), 1

Vertical bars indicate standard deviation

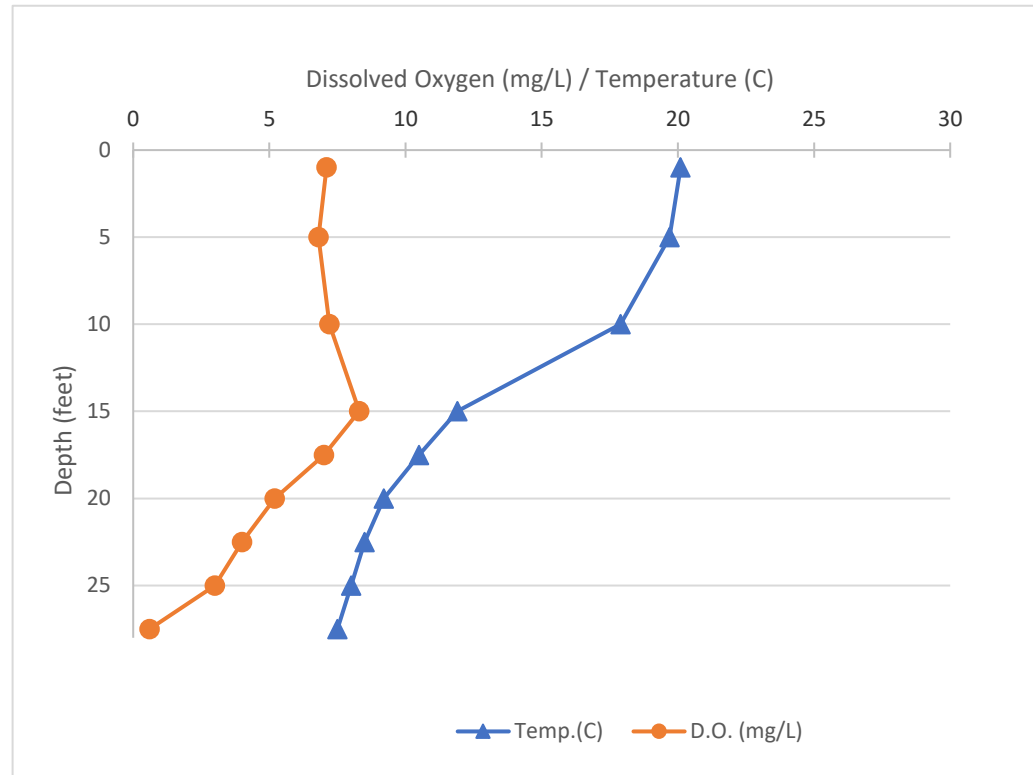
5/28/2022

Dissolved Oxygen and Temperature Profile

Depth (ft)	Temp.(C)	D.O. (mg/L)
1	20.1	7.1
5	19.7	6.8
10	17.9	7.2
15	11.9	8.3
17.5	10.5	7
20	9.2	5.2
22.5	8.5	4
25	8	3
27.5	7.5	0.6

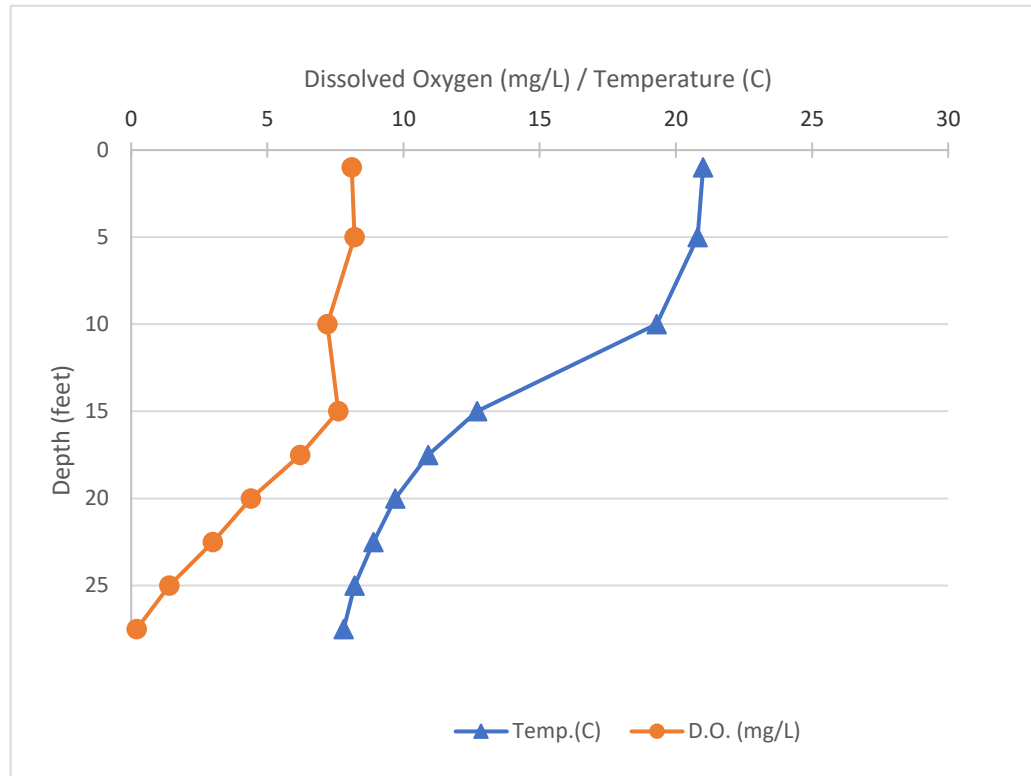
6/11/2022

Dissolved Oxygen and Temperature Profile

Depth (ft)	Temp.(C)	D.O. (mg/L)
1	21	8.1
5	20.8	8.2
10	19.3	7.2
15	12.7	7.6
17.5	10.9	6.2
20	9.7	4.4
22.5	8.9	3
25	8.2	1.4
27.5	7.8	0.2

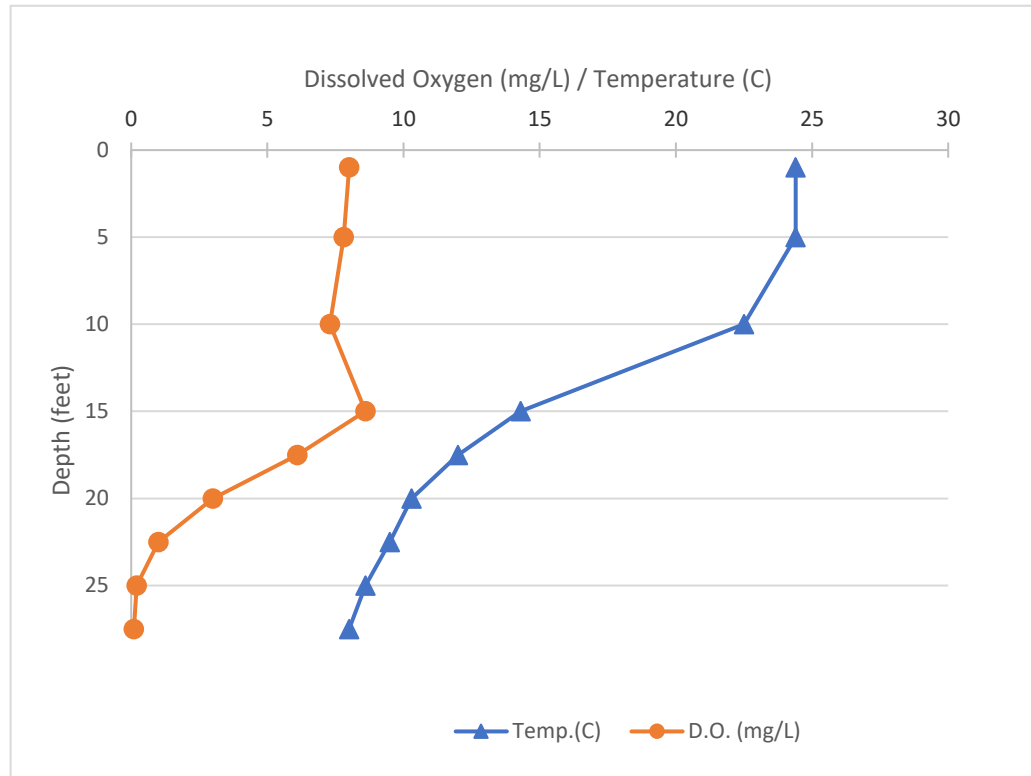
7/2/2022

Dissolved Oxygen and Temperature Profile

Depth (ft)	Temp.(C)	D.O. (mg/L)
1	24.4	8
5	24.4	7.8
10	22.5	7.3
15	14.3	8.6
17.5	12	6.1
20	10.3	3
22.5	9.5	1
25	8.6	0.2
27.5	8	0.1

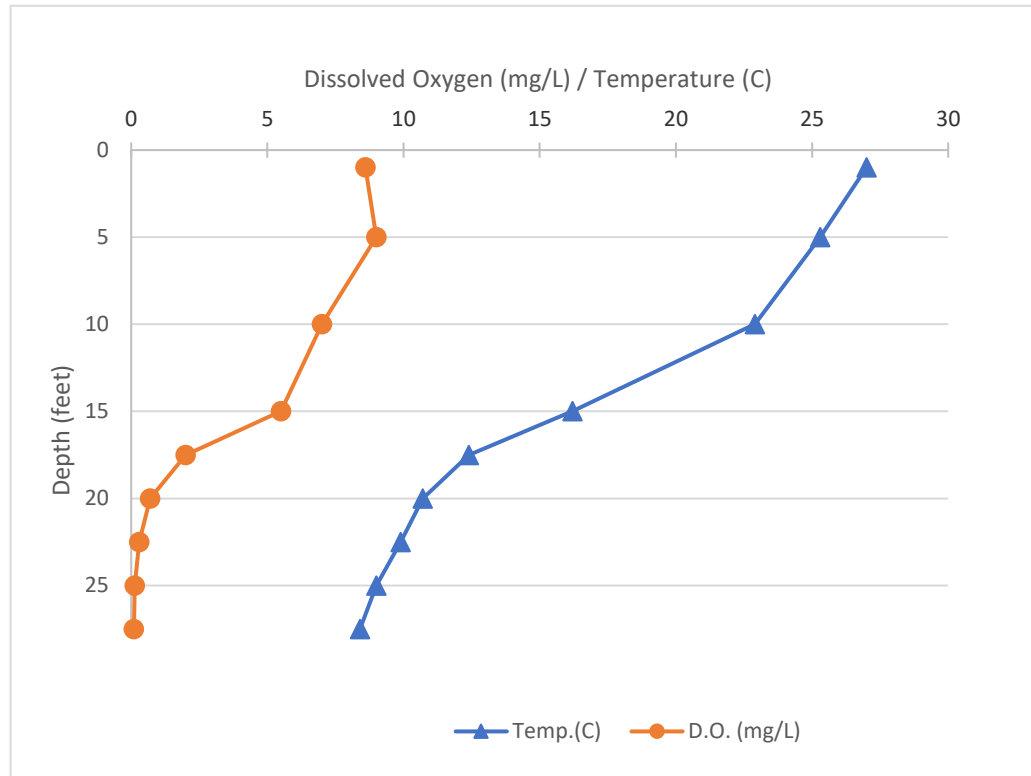
7/17/2022

Dissolved Oxygen and Temperature Profile

Depth (ft)	Temp.(C)	D.O. (mg/L)
1	27	8.6
5	25.3	9
10	22.9	7
15	16.2	5.5
17.5	12.4	2
20	10.7	0.7
22.5	9.9	0.3
25	9	0.13
27.5	8.4	0.1

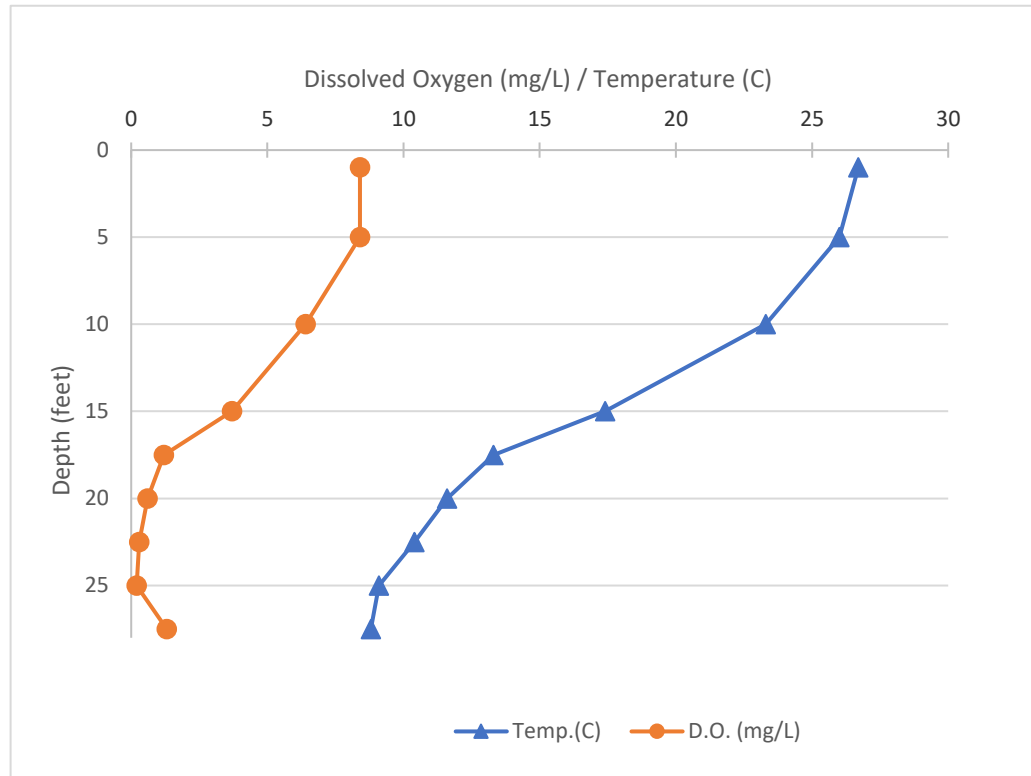
7/31/2022

Dissolved Oxygen and Temperature Profile

Depth (ft)	Temp.(C)	D.O. (mg/L)
1	26.7	8.4
5	26	8.4
10	23.3	6.4
15	17.4	3.7
17.5	13.3	1.2
20	11.6	0.6
22.5	10.4	0.3
25	9.1	0.2
27.5	8.8	1.3

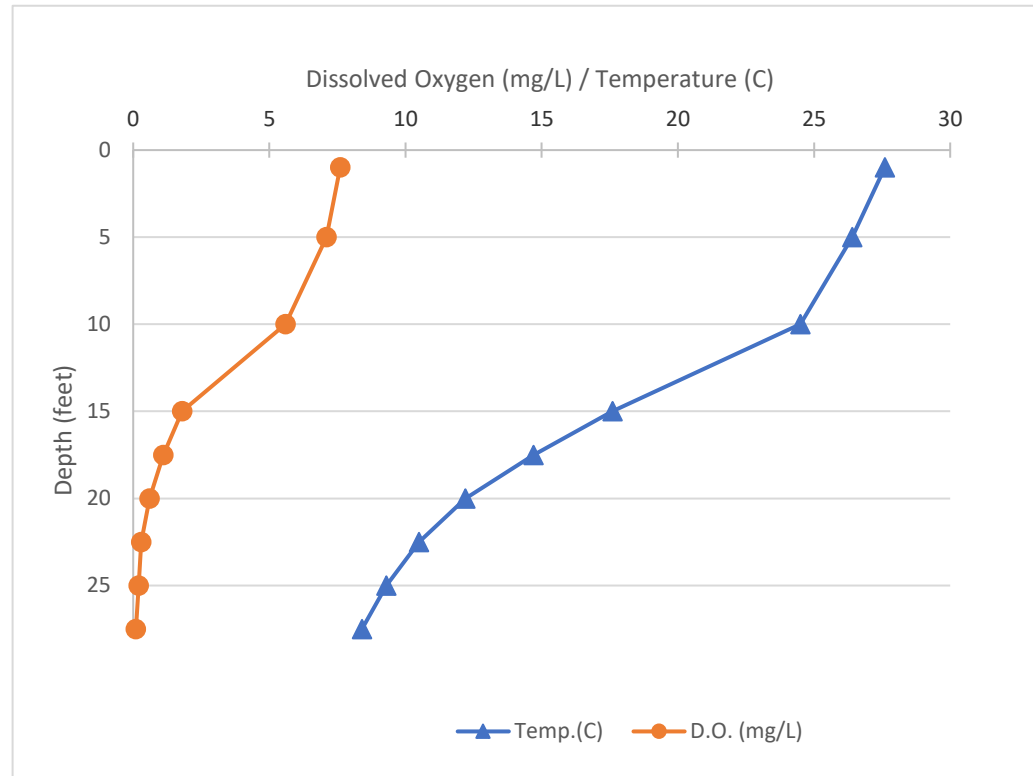
8/10/2022

Dissolved Oxygen and Temperature Profile

Depth (ft)	Temp.(C)	D.O. (mg/L)
1	27.6	7.6
5	26.4	7.1
10	24.5	5.6
15	17.6	1.8
17.5	14.7	1.1
20	12.2	0.6
22.5	10.5	0.3
25	9.3	0.2
27.5	8.4	0.1

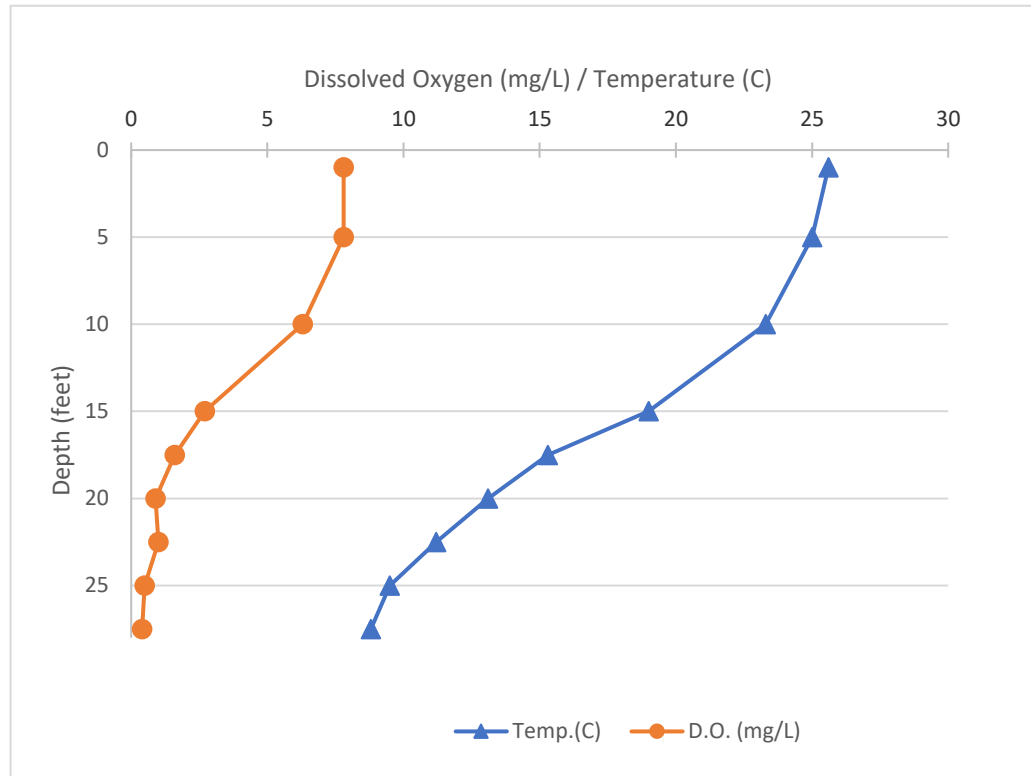
8/28/2022

Dissolved Oxygen and Temperature Profile

Depth (ft)	Temp.(C)	D.O. (mg/L)
1	25.6	7.8
5	25	7.8
10	23.3	6.3
15	19	2.7
17.5	15.3	1.6
20	13.1	0.9
22.5	11.2	1
25	9.5	0.5
27.5	8.8	0.4

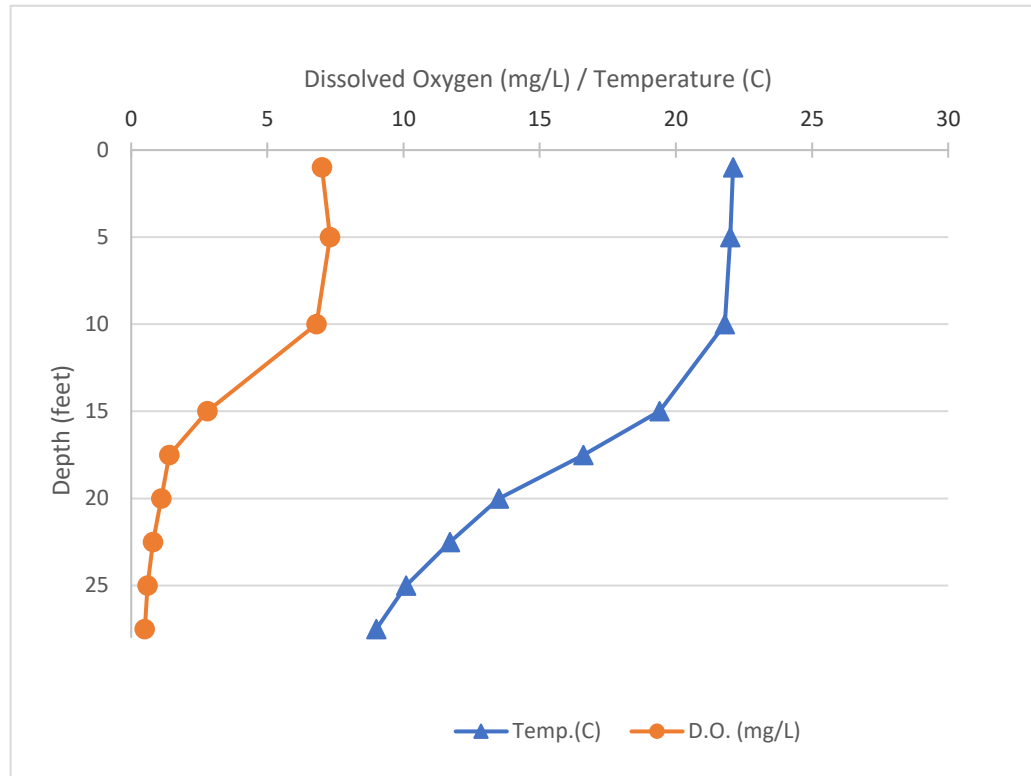
9/16/2022

Dissolved Oxygen and Temperature Profile

Depth (ft)	Temp.(C)	D.O. (mg/L)
1	22.1	7
5	22	7.3
10	21.8	6.8
15	19.4	2.8
17.5	16.6	1.4
20	13.5	1.1
22.5	11.7	0.8
25	10.1	0.6
27.5	9	0.5
