2023 Data Report for

Cedar Lake, Van Buren County

Site ID: 800241

Cedar Lake, Van Buren County 2023 CLMP Results

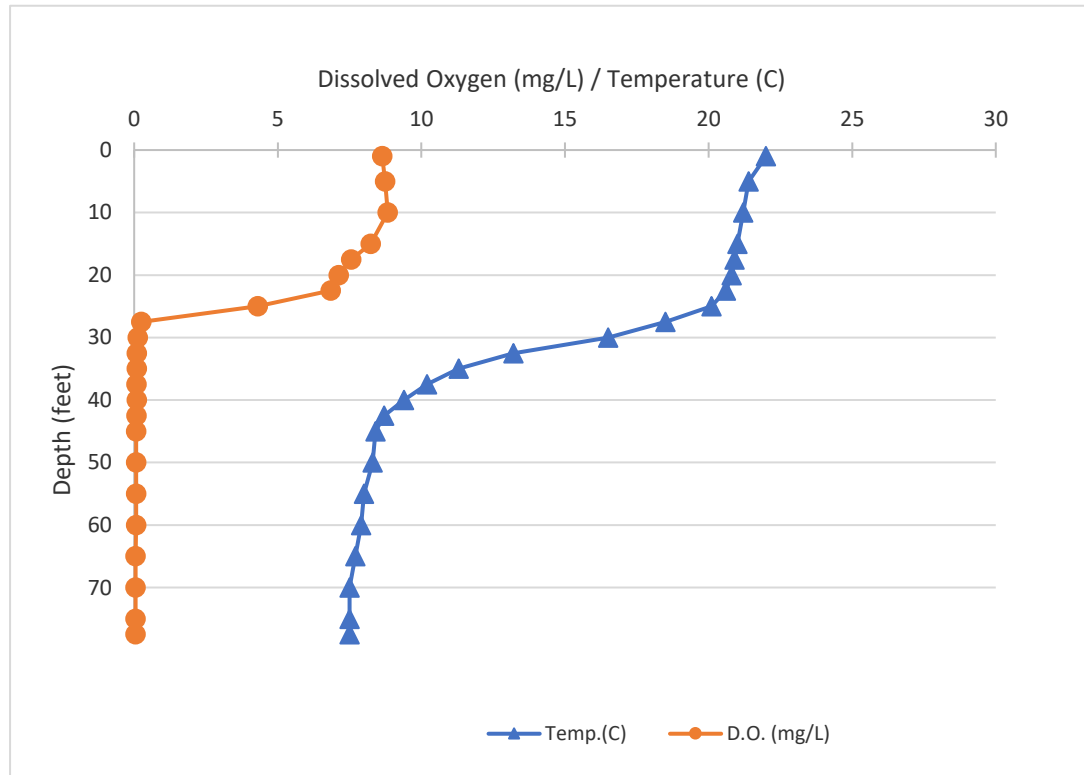
9/20/2008

Dissolved Oxygen and Temperature Profile

Depth (ft)	Temp.(C)	D.O. (mg/L)
1	22	8.64
5	21.4	8.74
10	21.2	8.83
15	21	8.24
17.5	20.9	7.56
20	20.8	7.12
22.5	20.6	6.84
25	20.1	4.3
27.5	18.5	0.25
30	16.5	0.12
32.5	13.2	0.09
35	11.3	0.09
37.5	10.2	0.08
40	9.4	0.09
42.5	8.7	0.08
45	8.4	0.07
50	8.3	0.07
55	8	0.07
60	7.9	0.07
65	7.7	0.05
70	7.5	0.05
75	7.5	0.05
77.5	7.5	0.05
