# 2023 Data Report for

# Klinger Lake, St. Joseph County

Site ID: 750136

# Klinger Lake, St. Joseph County 2023 CLMP Results

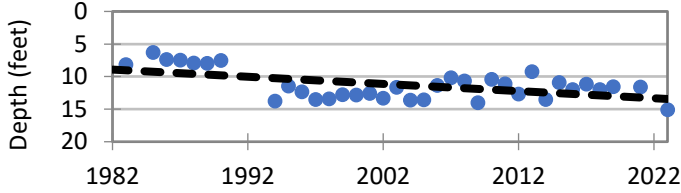
## Secchi Disk Transparency (feet)

Year	# Readings	Min	Max	Average	Std. Dev	Carlson TSI
2023	17	10.0	30.0	15.1	6.0	38
2018-2022	54	5.5	28.5	11.7	5.2	42
1982-2017	530	4.0	32.5	11.1	3.8	43
2023 All CLMP Lakes	2825	0.5	51.0	12.2	2.7	43

Transparency is quite a bit higher since the 1980s.

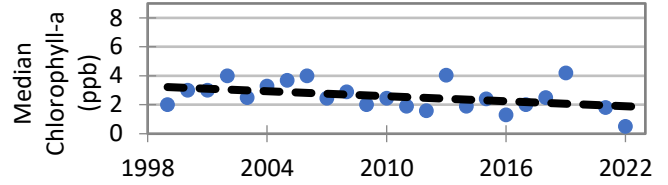
## Chlorophyll-a (parts per billion)

Year	# Samples	Min	Max	Median	Std. Dev	Carlson TSI
2023	2*	<1.0	<1.0			
2018-2022	15	<1.0	5.7	2.5	1.1	40
1999-2017	94	<1.0	5.8	2.5	1.3	39
2023 All CLMP Lakes	687	< 1.0	43.0	3.7	5.3	43

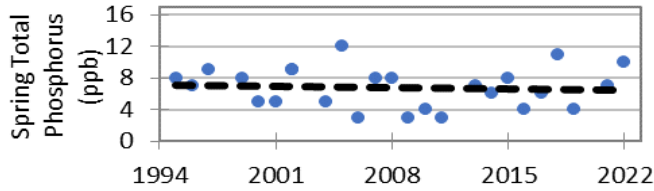
## Spring Phosphorus (parts per billion)

Year	# Samples	Min	Max	Average	Std. Dev
2022	1	10.0	10.0	10.0	NA
2017-2021	4	<5 T	11.0	7.0	2.9
1995-2016	20	<=3 W	12.0	6.6	2.5
2023 All CLMP Lakes	220	<5	220.0	20.7	21.3

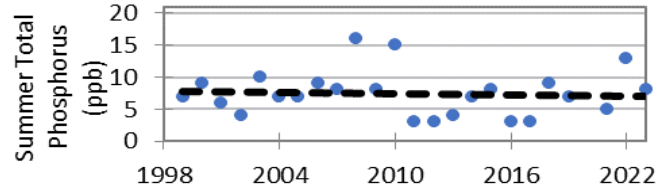
## Summer Phosphorus (parts per billion)

Year	# Samples	Min	Max	Average	Std. Dev	Carlson TSI
2023	1	8.0	8.0	8.0	NA	34
2018-2022	3	5.0	9.0	7.0	2.0	32
1999-2017	19	<=3 W	16.0	7.2	3.7	33
2023 All CLMP Lakes	234	<= 3	150.0	17.4	15.3	45

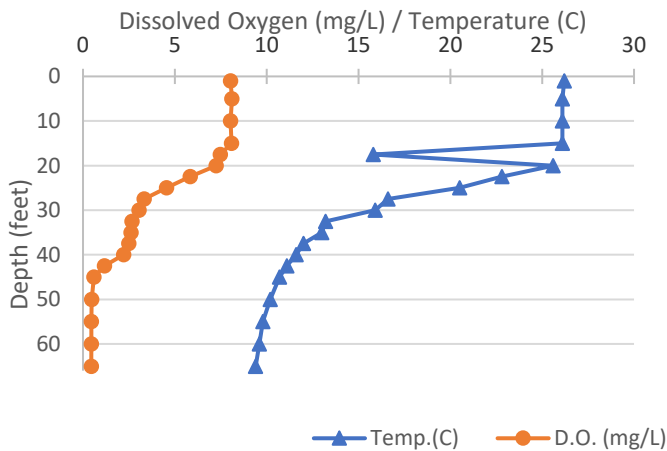
8/14/2019

## Dissolved Oxygen and Temperature Profile

The lake keeps some dissolved oxygen in the bottom waters through early summer, but by mid-summer the lake has stratified and the bottom water is devoid of oxygen.

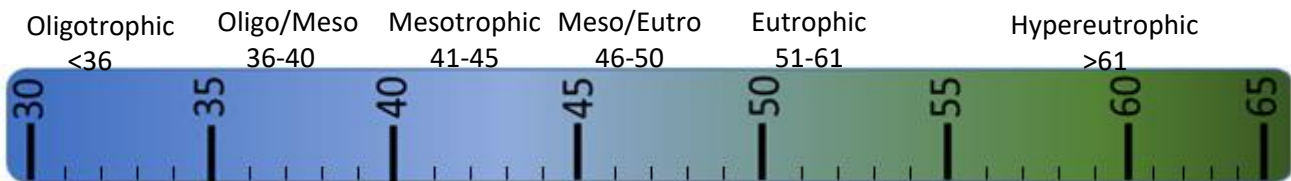
TSI for Klinger Lake in 2023	
Average	36
Secchi Disk	38
Summer TP	34
Chlorophyll-a

^ Average  
 ^ Secchi Transparency  
 ^ Total Phosphorus

With an average TSI score of 36 based on 2023 Secchi transparency and summer total phosphorus data, this lake is rated as oligotrophic.

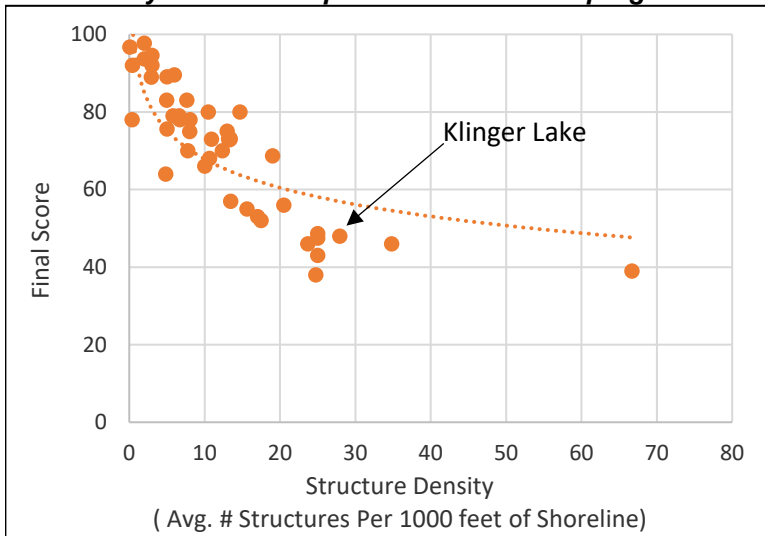
### How does your lake compare to others in the program?

<b>Klinger Lake:</b>	
Number of Sections:	25
Number of Structures:	698
Structure Density:	27.9
Final Score:	48

<b>All 42 Participating Lakes from 2015-2018:</b>	
Avg. Number of Sections:	16.3
Avg. Number of Structures:	248.5
Avg. Structure Density:	15.2
Avg. Final Score:	70.5

With a fairly high house and dock density as compared to the other lakes, it would be expected that the quality of the lakeshore habitat would be lower in Klinger Lake. Overall, all of the sections were classified as either poor or fair.

The weakest point of Klinger Lake assessment was the littoral zone (shallow water near the shore). Increasing aquatic vegetation, allowing fallen trees to remain in the water, and reducing shoreline erosion would be the primary way to boost this score.

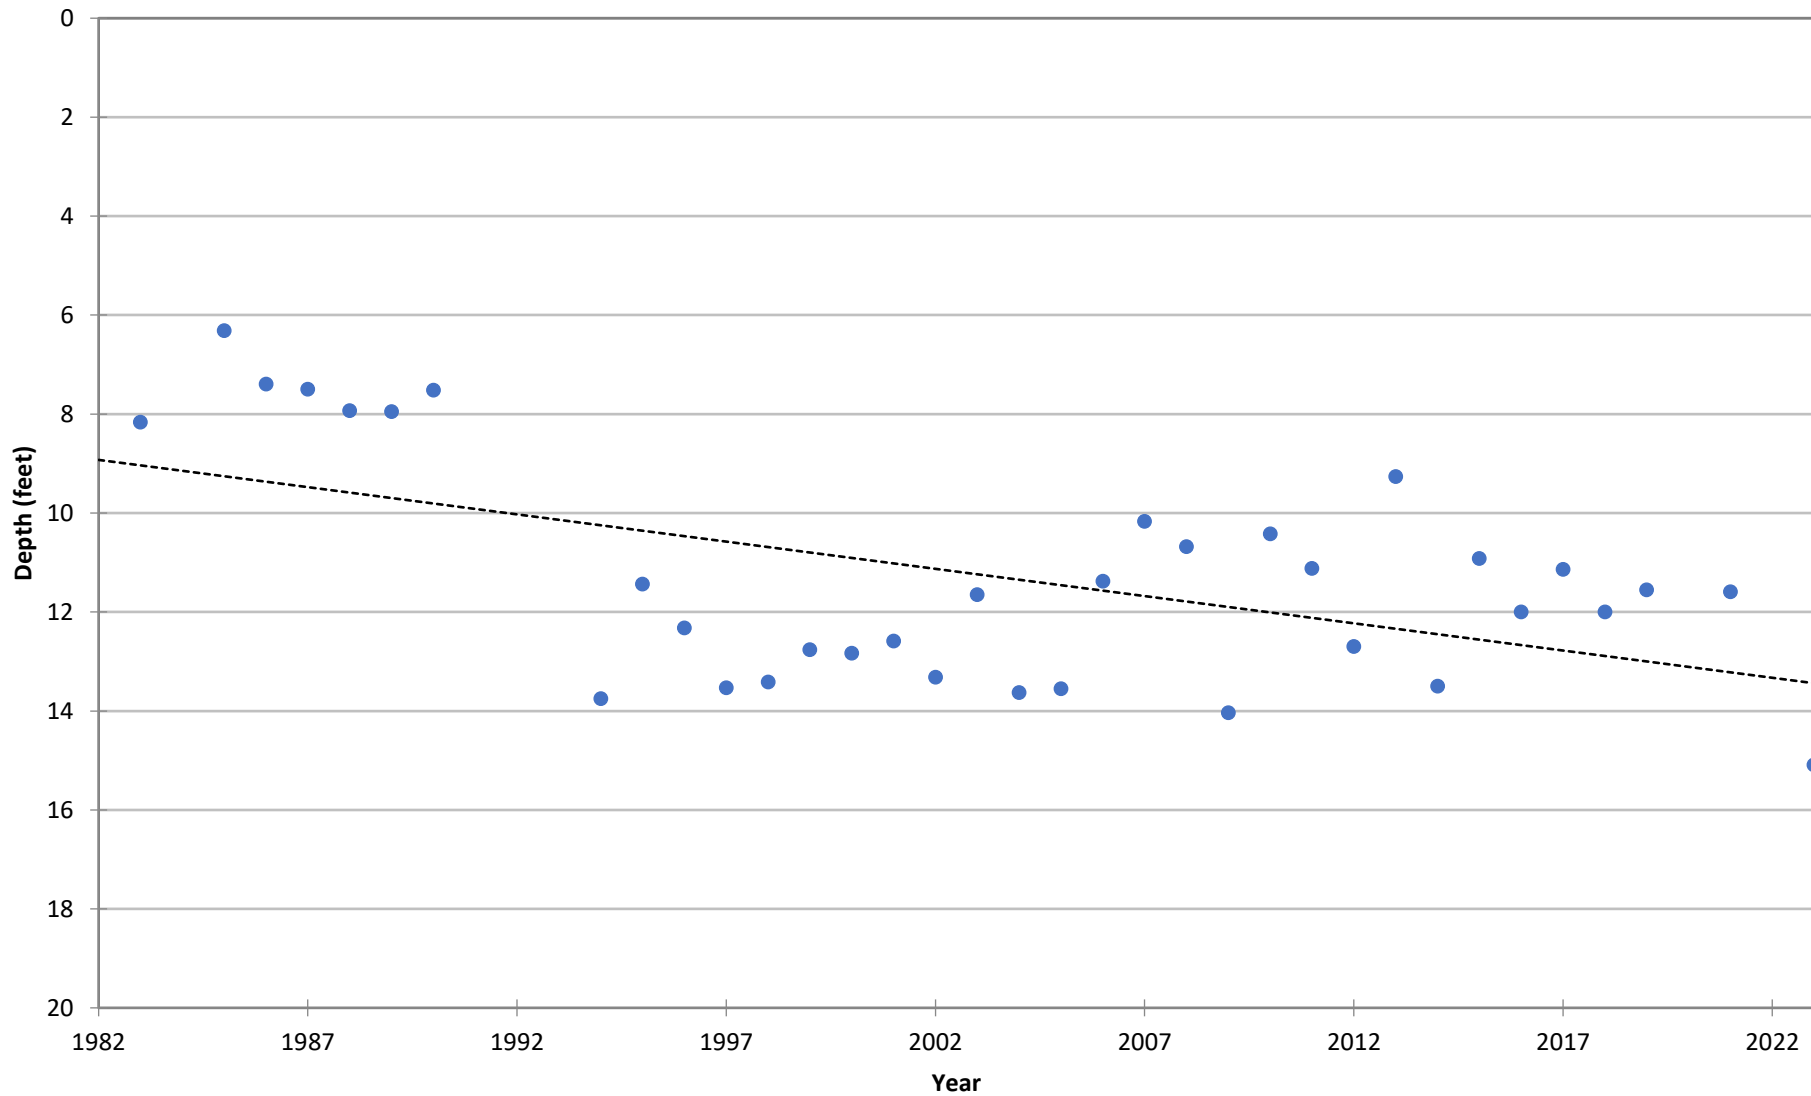
**Klinger Lake (St. Joseph Co.), 750136**

COOPERATIVE LAKES MONITORING PROGRAM  
SUMMER MEAN TRANSPARENCY

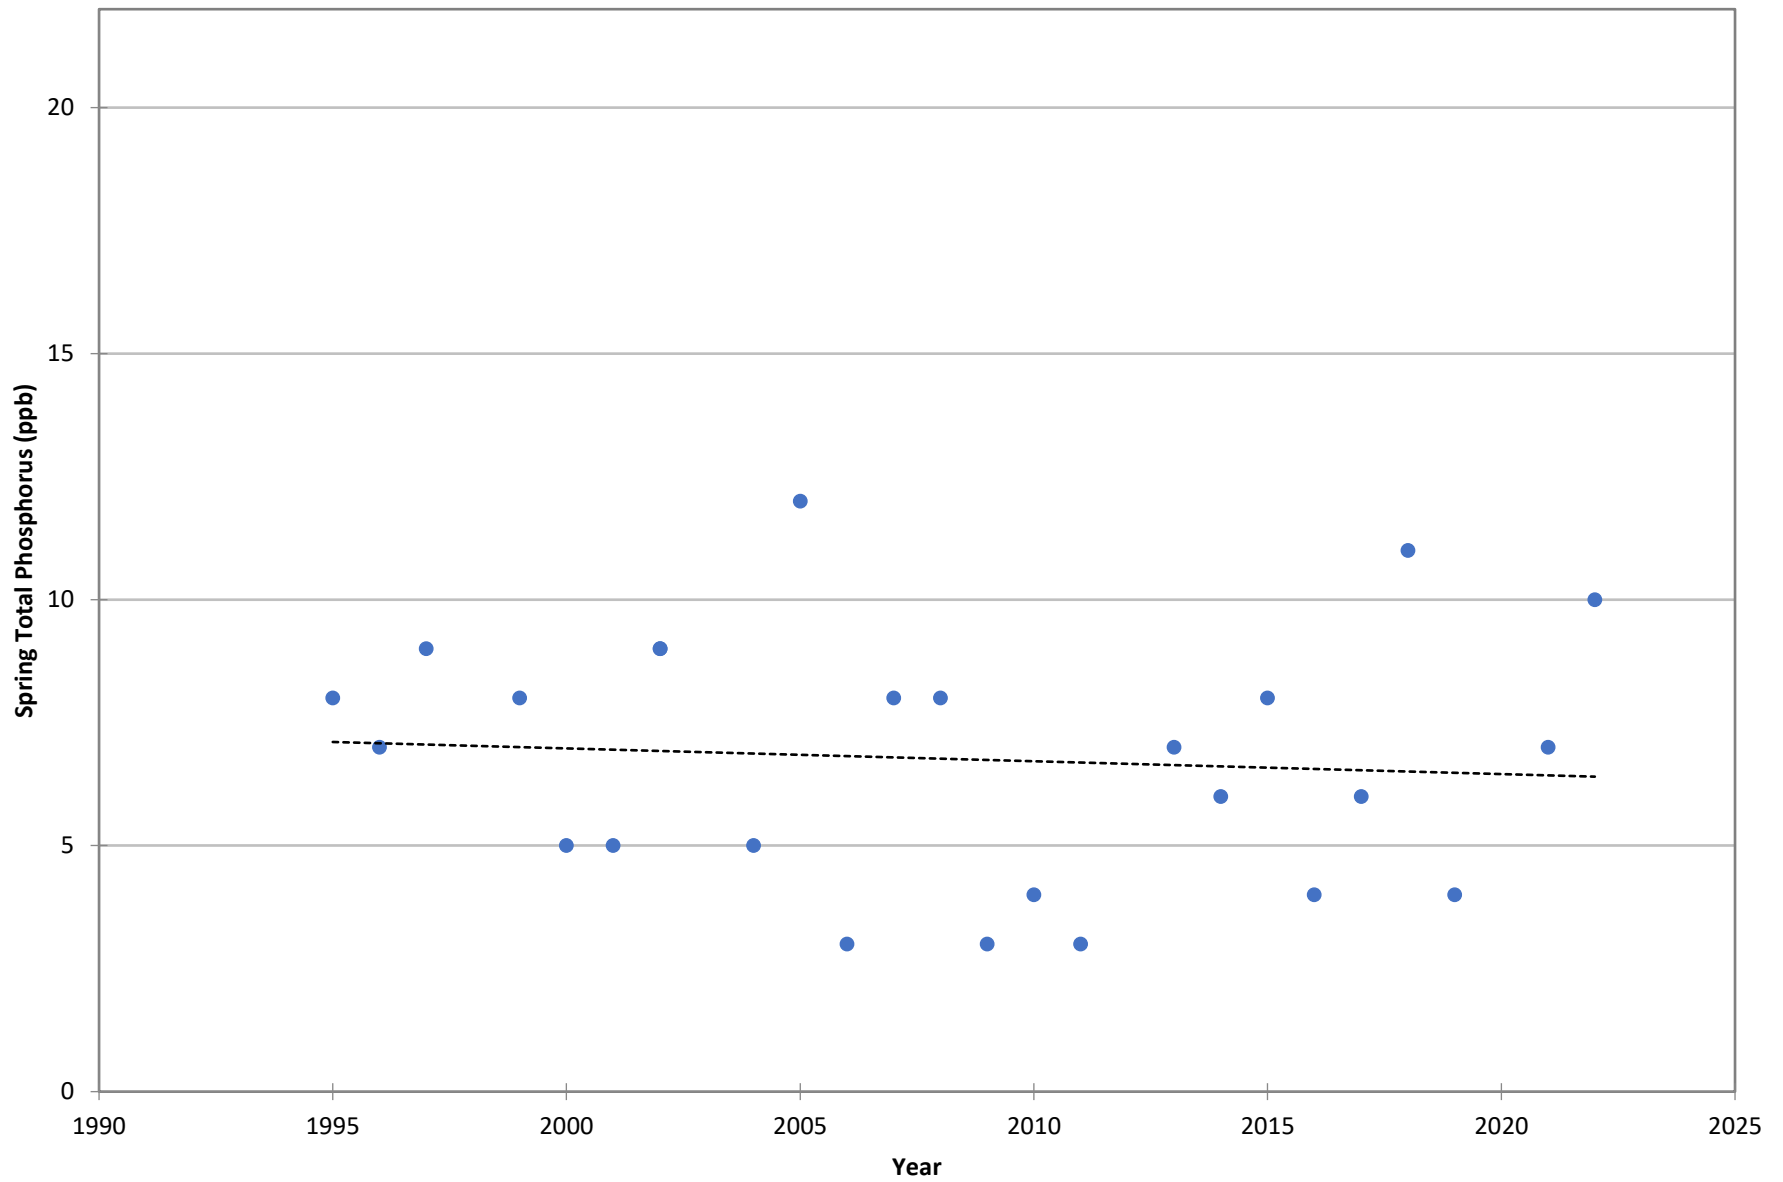
**Klinger Lake (St. Joseph Co.), 750136**

COOPERATIVE LAKES MONITORING PROGRAM  
SPRING TOTAL PHOSPHORUS

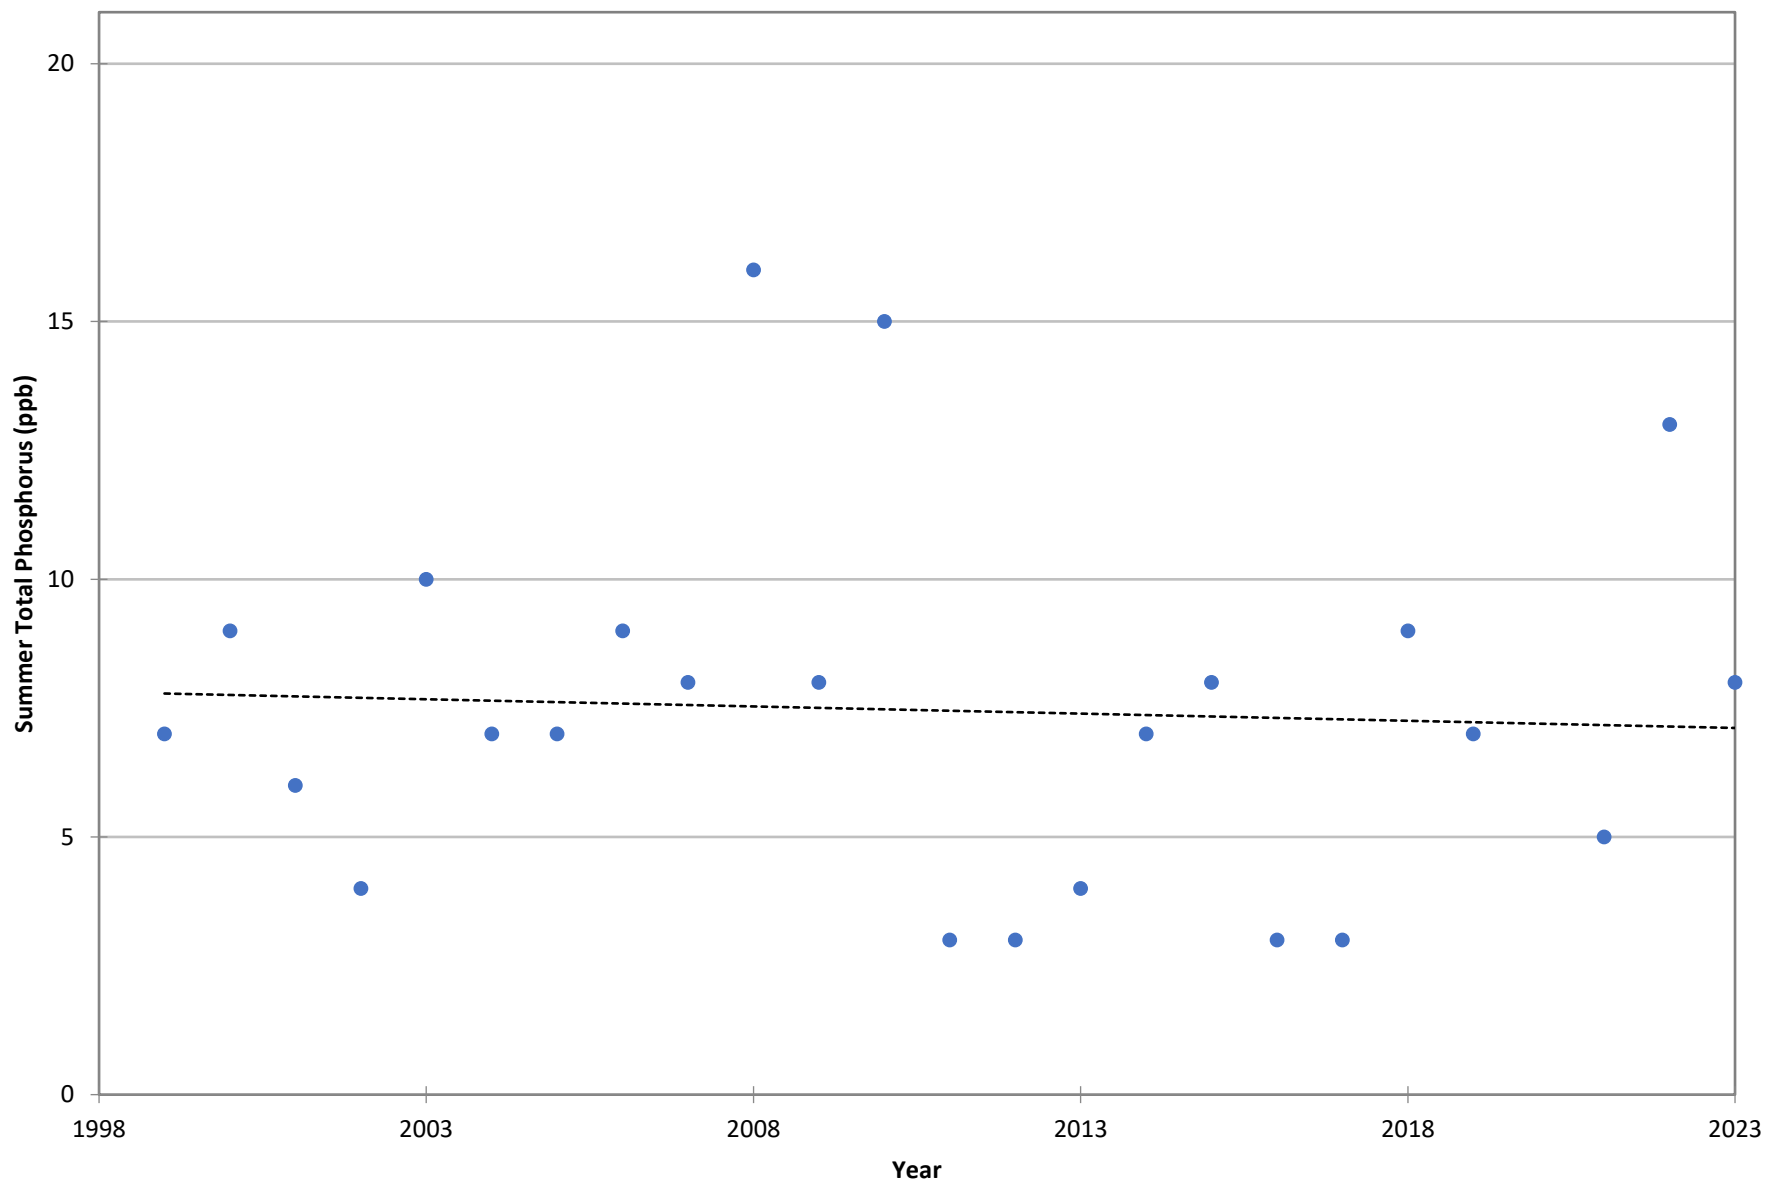
**Klinger Lake (St. Joseph Co.), 750136**

COOPERATIVE LAKES MONITORING PROGRAM  
SUMMER TOTAL PHOSPHORUS

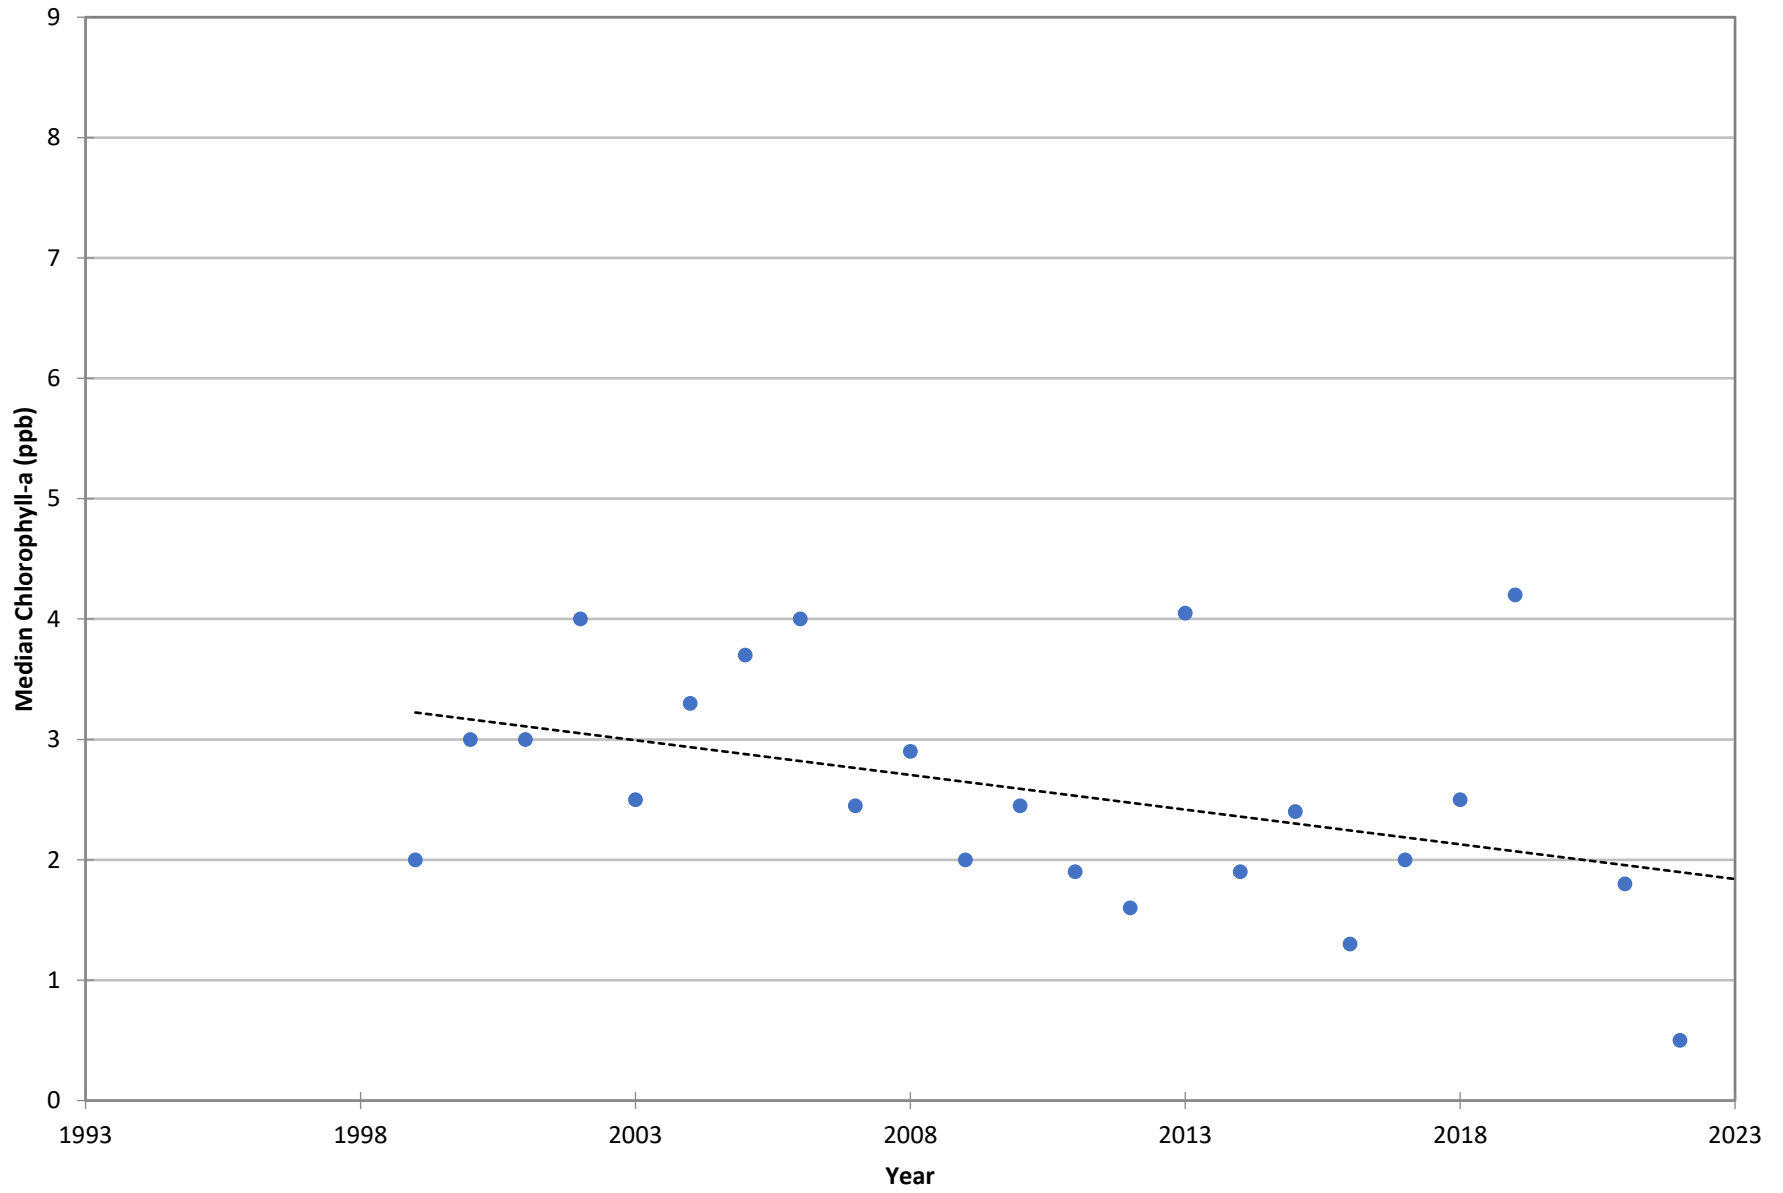
**Klinger Lake (St. Joseph Co.), 750136**

COOPERATIVE LAKES MONITORING PROGRAM  
SUMMER MEDIAN CHLOROPHYLL-A

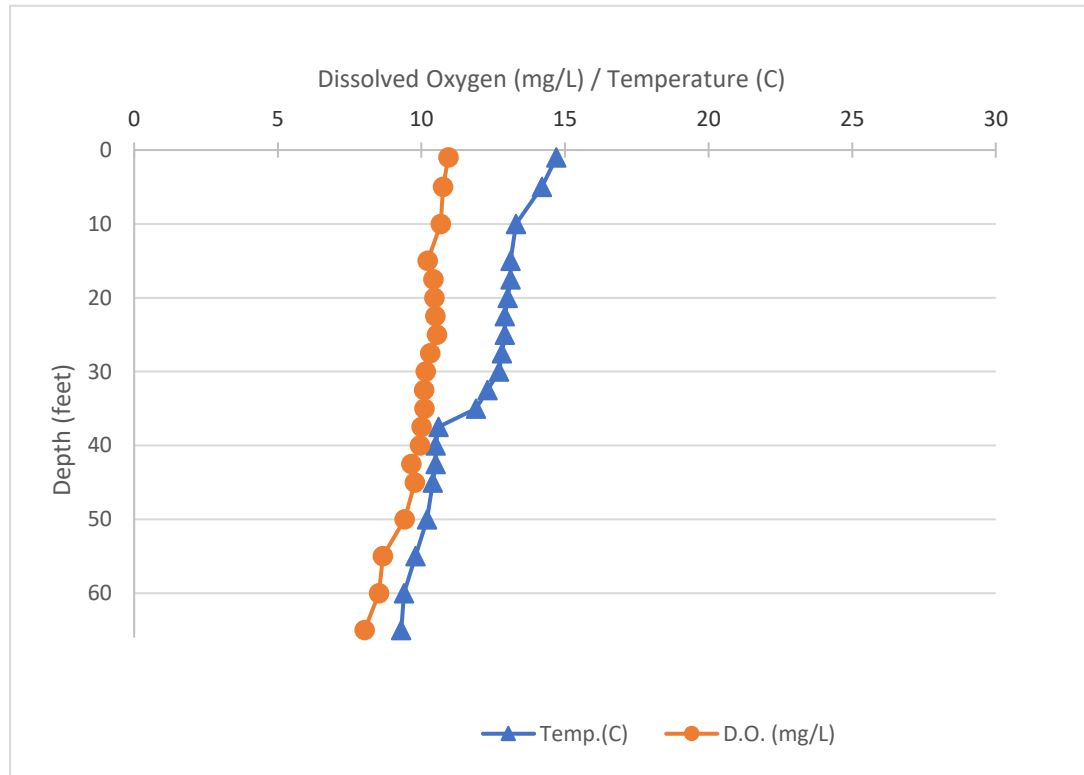
5/15/2019

### Dissolved Oxygen and Temperature Profile

Depth (ft)	Temp.(C)	D.O. (mg/L)
1	14.7	10.94
5	14.2	10.75
10	13.3	10.68
15	13.1	10.22
17.5	13.1	10.42
20	13	10.45
22.5	12.9	10.49
25	12.9	10.54
27.5	12.8	10.31
30	12.7	10.15
32.5	12.3	10.1
35	11.9	10.11
37.5	10.6	10.01
40	10.5	9.95
42.5	10.5	9.65
45	10.4	9.77
50	10.2	9.42
55	9.8	8.66
60	9.4	8.53
65	9.3	8.02

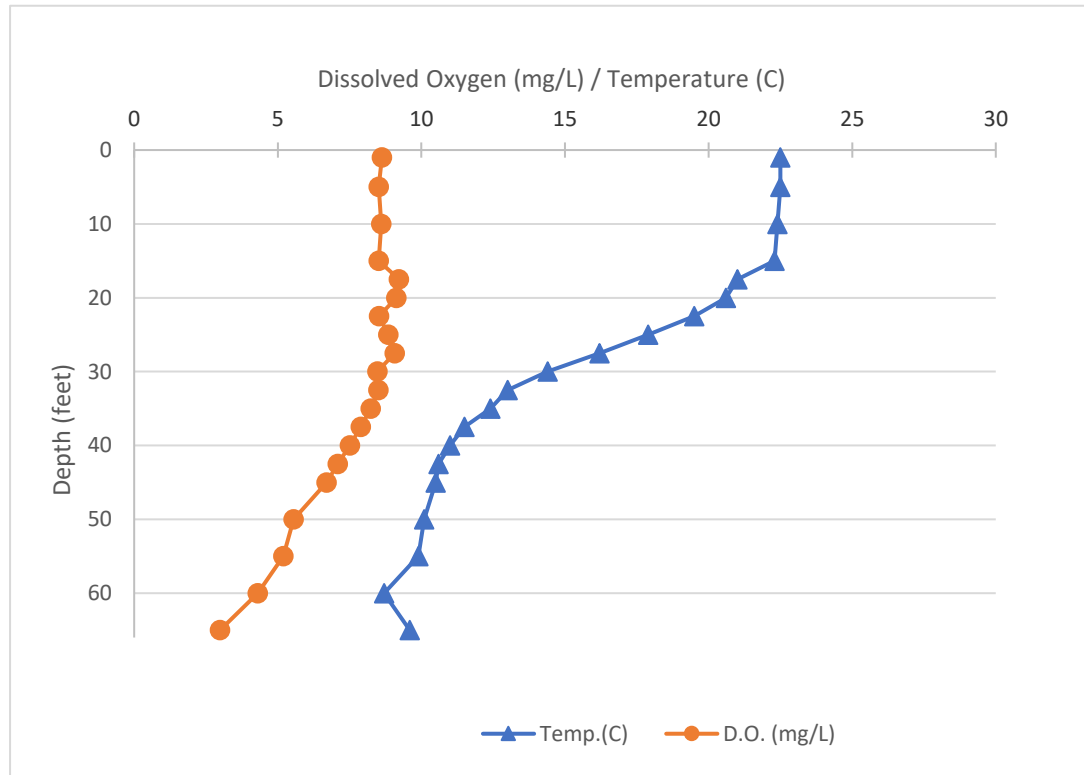
5/25/2019

### Dissolved Oxygen and Temperature Profile

Depth (ft)	Temp.(C)	D.O. (mg/L)
1	22.5	8.63
5	22.5	8.51
10	22.4	8.6
15	22.3	8.52
17.5	21	9.22
20	20.6	9.13
22.5	19.5	8.53
25	17.9	8.85
27.5	16.2	9.07
30	14.4	8.47
32.5	13	8.5
35	12.4	8.24
37.5	11.5	7.89
40	11	7.51
42.5	10.6	7.09
45	10.5	6.7
50	10.1	5.55
55	9.9	5.2
60	8.7	4.3
65	9.6	2.99

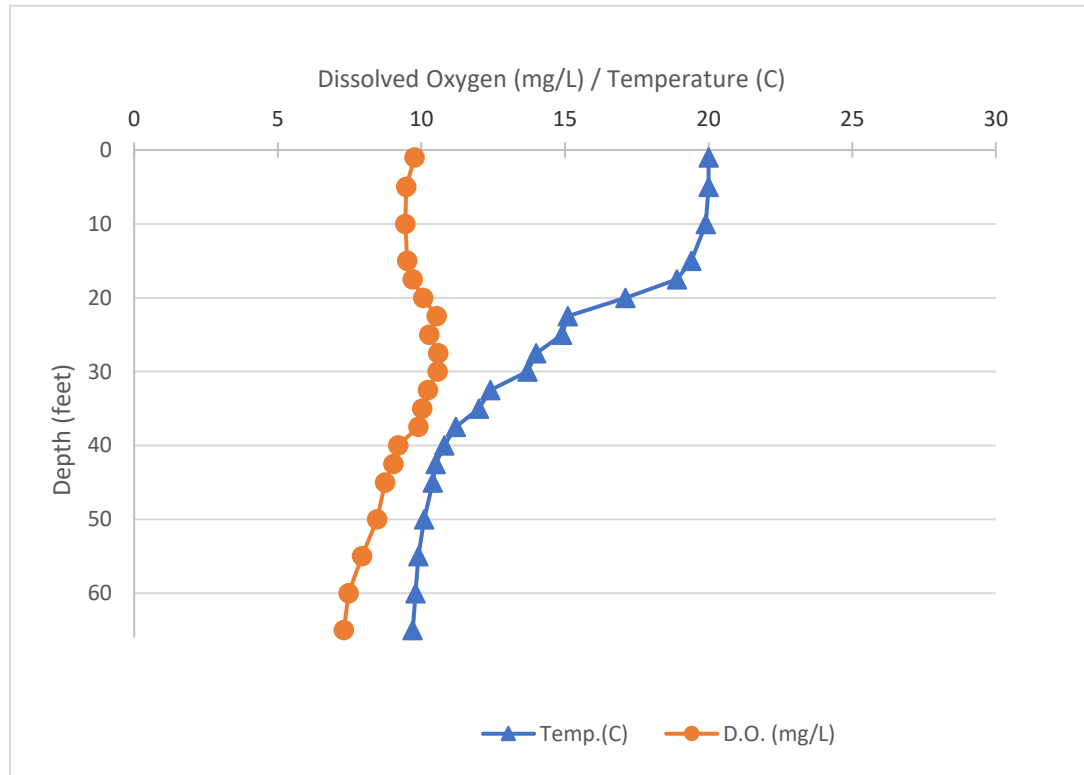
5/29/2019

### Dissolved Oxygen and Temperature Profile

Depth (ft)	Temp.(C)	D.O. (mg/L)
1	20	9.76
5	20	9.47
10	19.9	9.44
15	19.4	9.51
17.5	18.9	9.7
20	17.1	10.06
22.5	15.1	10.53
25	14.9	10.27
27.5	14	10.59
30	13.7	10.56
32.5	12.4	10.23
35	12	10.03
37.5	11.2	9.9
40	10.8	9.19
42.5	10.5	9.03
45	10.4	8.74
50	10.1	8.46
55	9.9	7.93
60	9.8	7.47
65	9.7	7.3

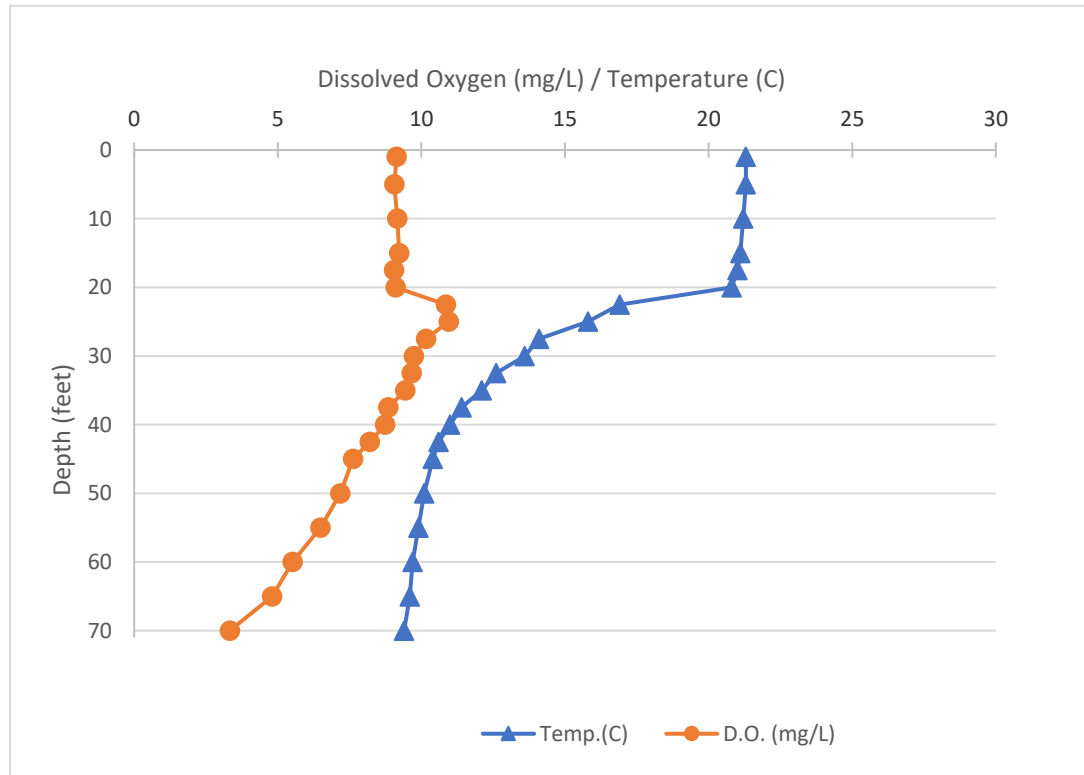
6/11/2019

### Dissolved Oxygen and Temperature Profile

Depth (ft)	Temp.(C)	D.O. (mg/L)
1	21.3	9.14
5	21.3	9.06
10	21.2	9.16
15	21.1	9.23
17.5	21	9.05
20	20.8	9.1
22.5	16.9	10.85
25	15.8	10.95
27.5	14.1	10.16
30	13.6	9.74
32.5	12.6	9.66
35	12.1	9.44
37.5	11.4	8.85
40	11	8.74
42.5	10.6	8.2
45	10.4	7.62
50	10.1	7.18
55	9.9	6.49
60	9.7	5.52
65	9.6	4.8
70	9.4	3.33

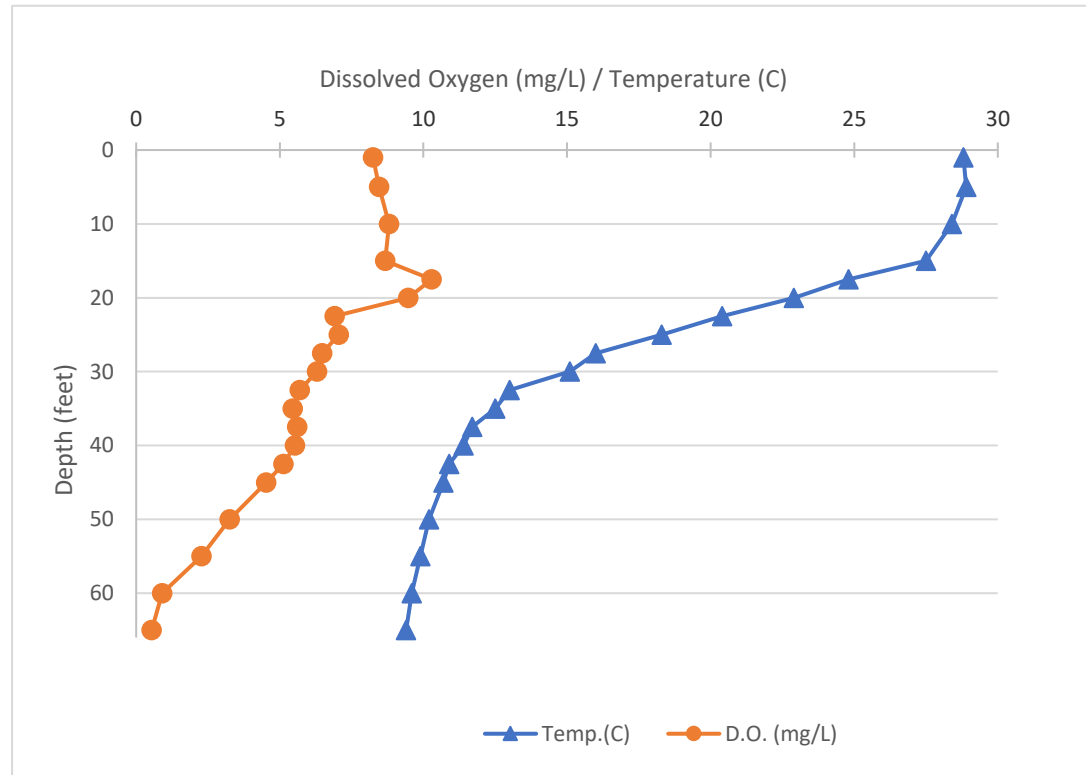
7/18/2019

### Dissolved Oxygen and Temperature Profile

Depth (ft)	Temp.(C)	D.O. (mg/L)
1	28.8	8.25
5	28.9	8.46
10	28.4	8.8
15	27.5	8.67
17.5	24.8	10.29
20	22.9	9.47
22.5	20.4	6.91
25	18.3	7.06
27.5	16	6.48
30	15.1	6.3
32.5	13	5.7
35	12.5	5.45
37.5	11.7	5.61
40	11.4	5.53
42.5	10.9	5.13
45	10.7	4.53
50	10.2	3.26
55	9.9	2.27
60	9.6	0.9
65	9.4	0.54

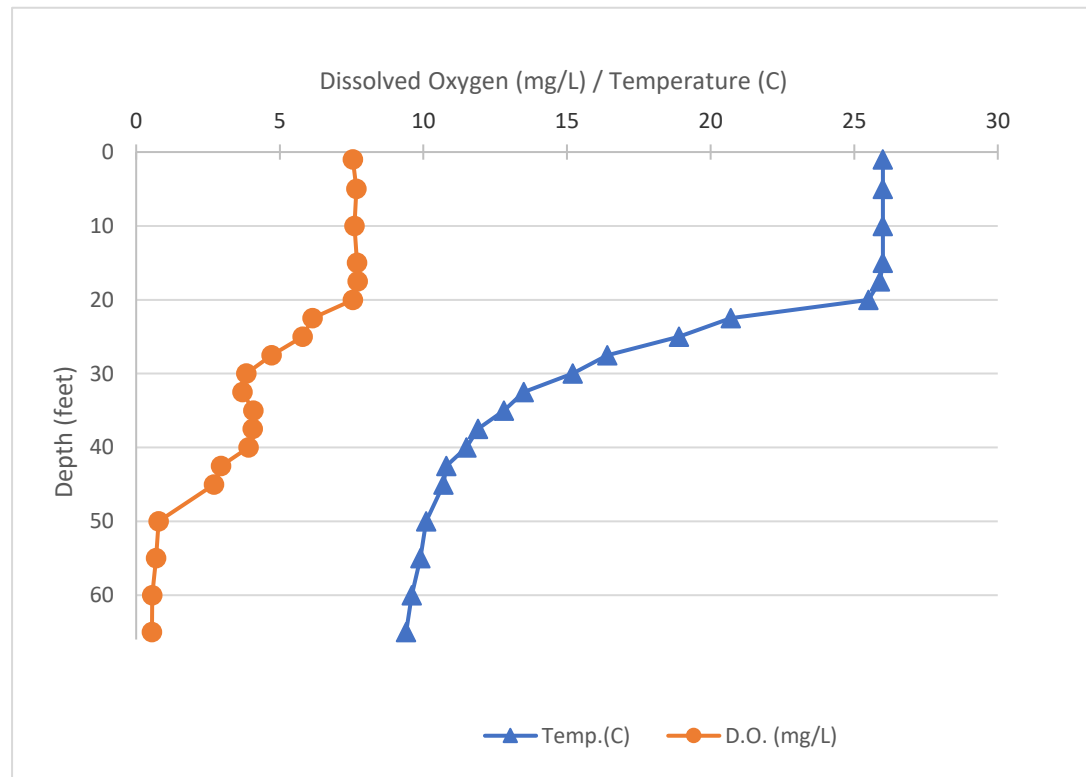
7/31/2019

### Dissolved Oxygen and Temperature Profile

Depth (ft)	Temp.(C)	D.O. (mg/L)
1	26	7.55
5	26	7.67
10	26	7.6
15	26	7.69
17.5	25.9	7.71
20	25.5	7.54
22.5	20.7	6.14
25	18.9	5.8
27.5	16.4	4.71
30	15.2	3.84
32.5	13.5	3.7
35	12.8	4.08
37.5	11.9	4.06
40	11.5	3.91
42.5	10.8	2.96
45	10.7	2.71
50	10.1	0.78
55	9.9	0.69
60	9.6	0.56
65	9.4	0.55

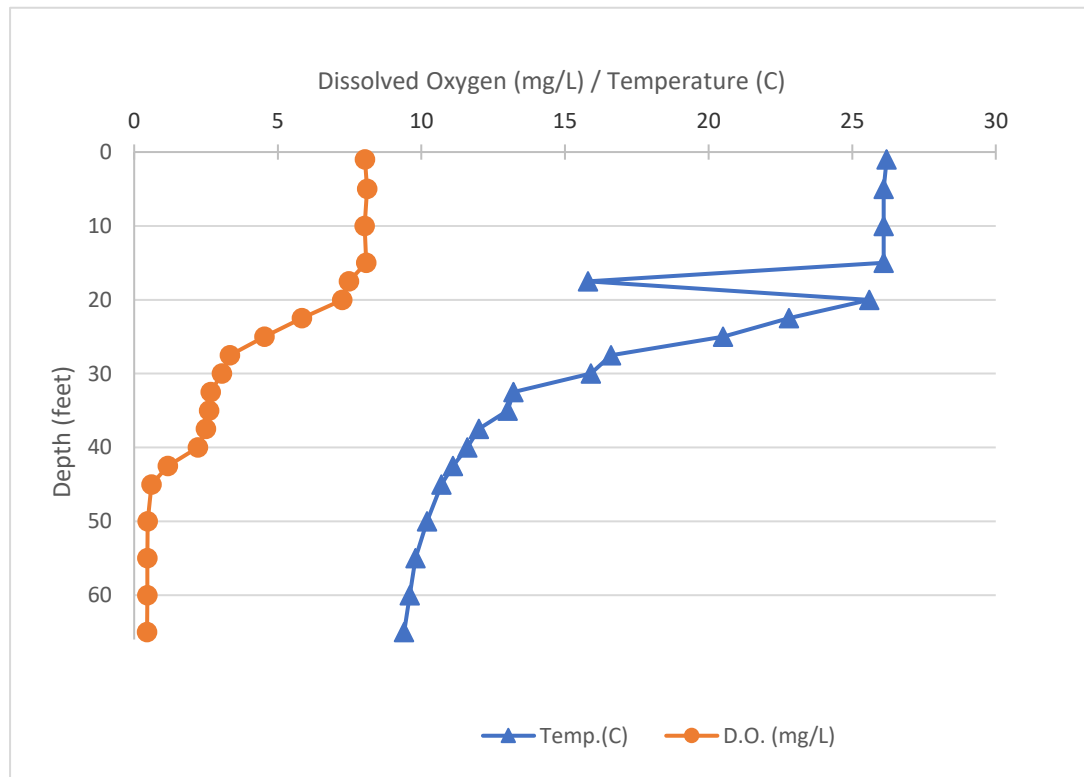
8/14/2019

### Dissolved Oxygen and Temperature Profile

Depth (ft)	Temp.(C)	D.O. (mg/L)
1	26.2	8.04
5	26.1	8.11
10	26.1	8.03
15	26.1	8.08
17.5	15.8	7.48
20	25.6	7.25
22.5	22.8	5.84
25	20.5	4.54
27.5	16.6	3.33
30	15.9	3.05
32.5	13.2	2.66
35	13	2.61
37.5	12	2.5
40	11.6	2.22
42.5	11.1	1.17
45	10.7	0.6
50	10.2	0.47
55	9.8	0.46
60	9.6	0.46
65	9.4	0.45

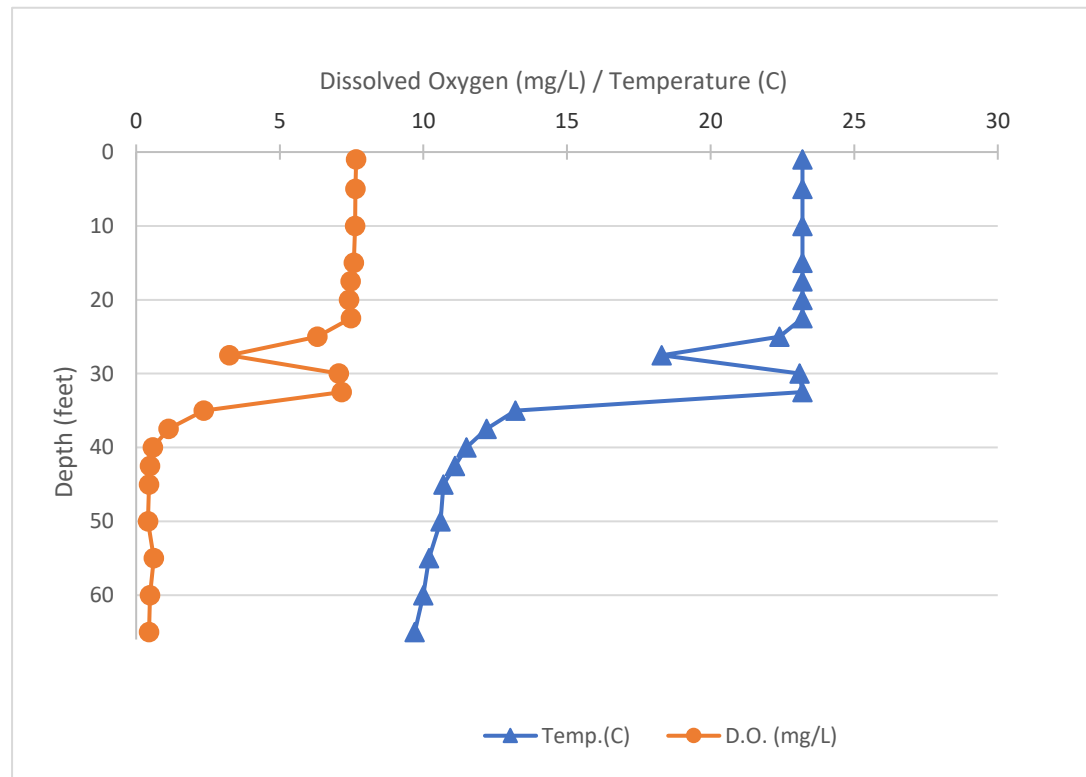
8/28/2019

### Dissolved Oxygen and Temperature Profile

Depth (ft)	Temp.(C)	D.O. (mg/L)
1	23.2	7.66
5	23.2	7.63
10	23.2	7.62
15	23.2	7.58
17.5	23.2	7.47
20	23.2	7.41
22.5	23.2	7.48
25	22.4	6.31
27.5	18.3	3.25
30	23.1	7.06
32.5	23.2	7.16
35	13.2	2.35
37.5	12.2	1.13
40	11.5	0.58
42.5	11.1	0.48
45	10.7	0.45
50	10.6	0.41
55	10.2	0.62
60	10	0.48
65	9.7	0.45

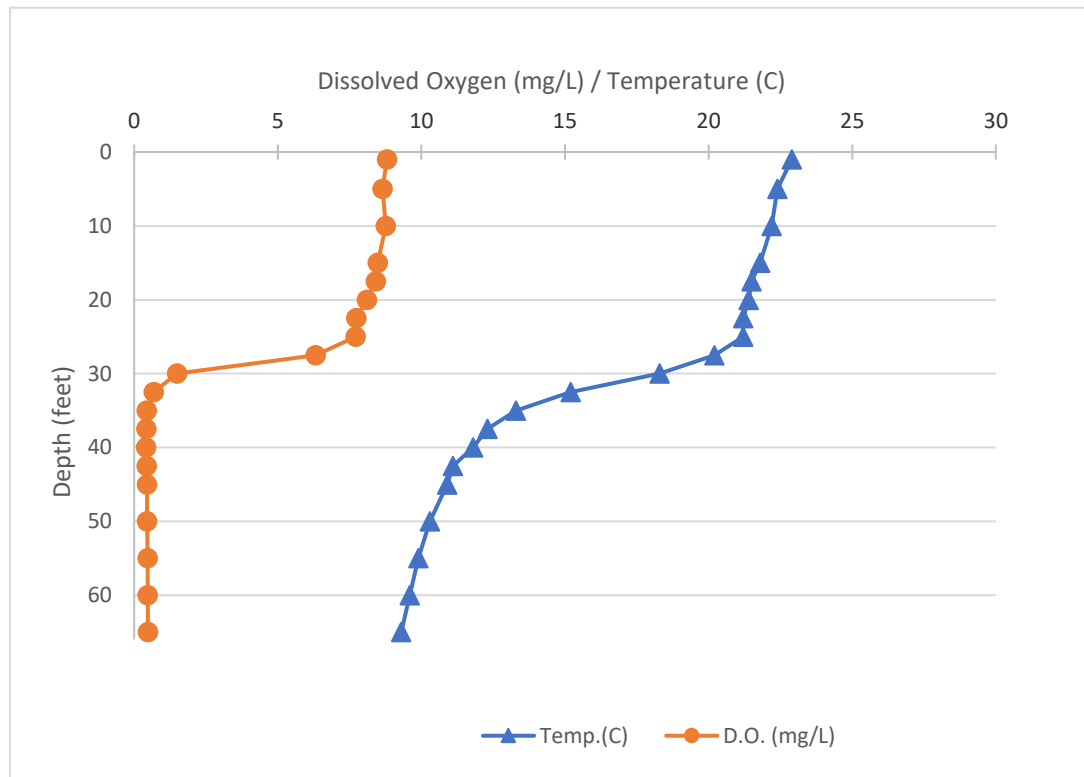
9/11/2019

### Dissolved Oxygen and Temperature Profile

Depth (ft)	Temp.(C)	D.O. (mg/L)
1	22.9	8.8
5	22.4	8.65
10	22.2	8.76
15	21.8	8.48
17.5	21.5	8.42
20	21.4	8.1
22.5	21.2	7.73
25	21.2	7.71
27.5	20.2	6.32
30	18.3	1.49
32.5	15.2	0.68
35	13.3	0.44
37.5	12.3	0.43
40	11.8	0.42
42.5	11.1	0.44
45	10.9	0.45
50	10.3	0.45
55	9.9	0.47
60	9.6	0.47
65	9.3	0.48
